Production status of Test Gaps for RE4 RPCs in Upscope

***J. H. Bae, M. H. Kang, Y. K. Jeng, K. S. Lee,
S. Park, S. S. Shin, & J. Yoon @ KODEL***

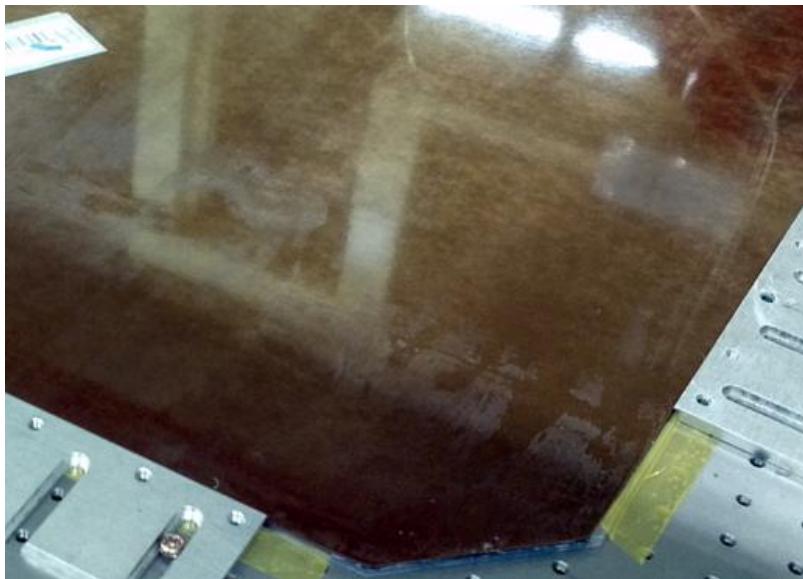
Checked that oil dirt remained on all the HPLs (all batches)

- Found that the stripe pattern created by the cleaning procedure was barely visible and just partially performed.
- At some places of the HPL sheets , the oil dirt still remained was thick.

Before cleaning

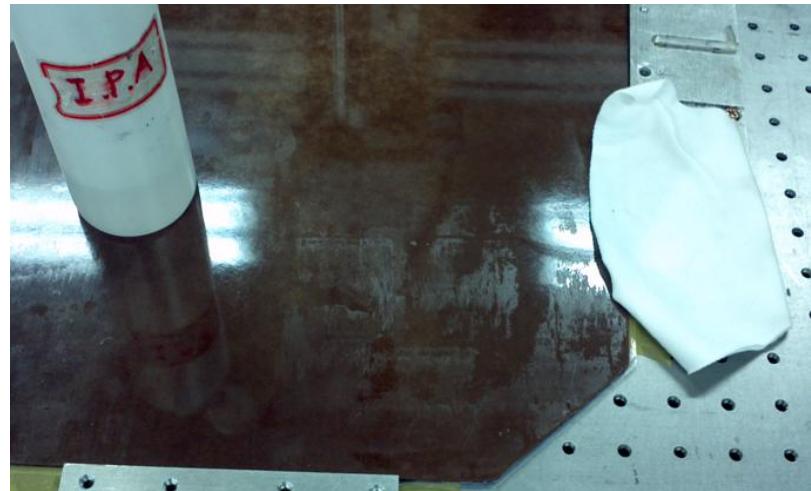
After cleaning by IPA only

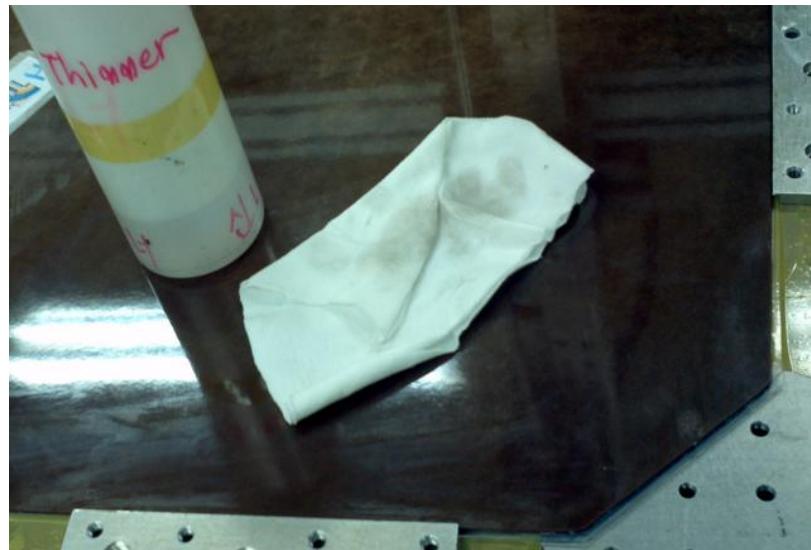
After cleaning by thinner

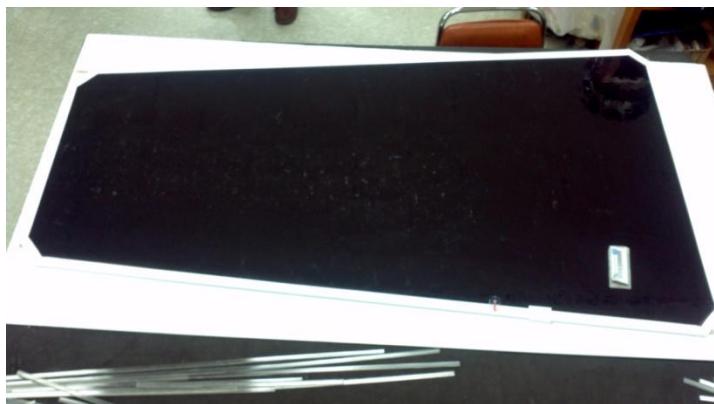
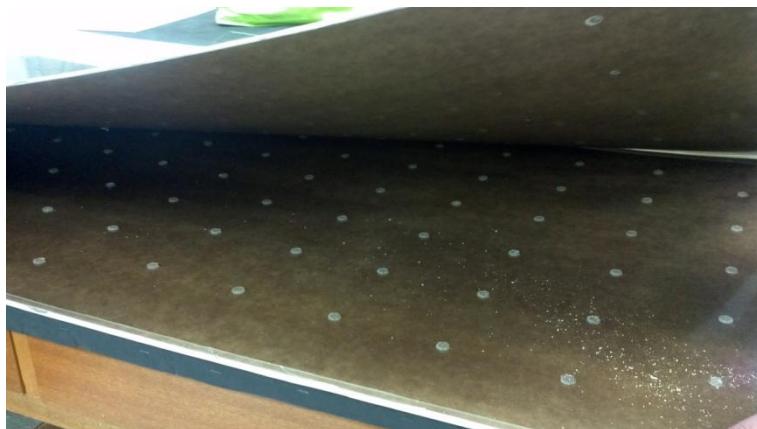
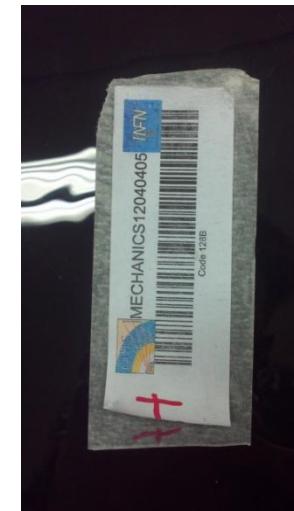
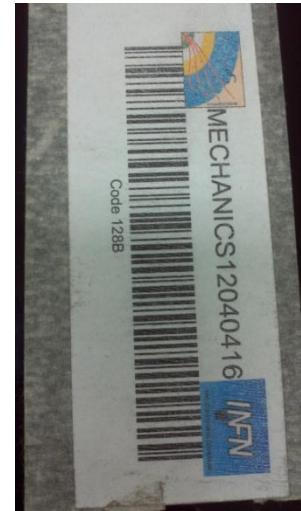
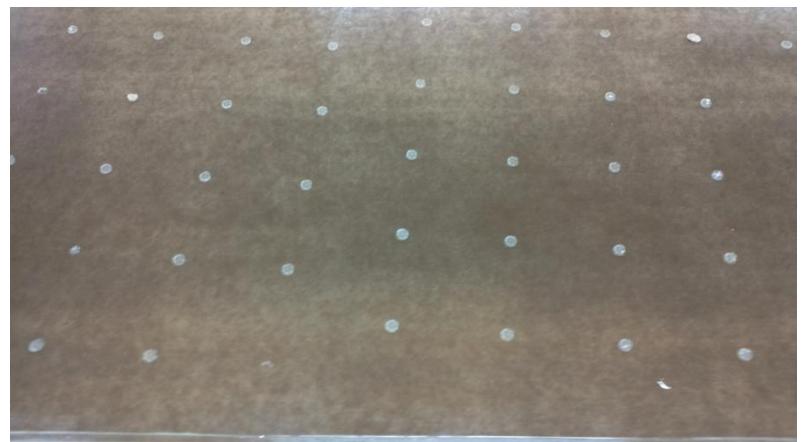
- Opened a RE4/2 test bottom gap (HPLs from batch 12)
- The bonding strength seems to be good enough, but the surface layer of the HPLs were easy detached like a stacked paper layer. (**HPLs are mechanically fragile !**)
 - > Phenol resin seems to be very poorly smeared into the craft papers.
 - Spacers were detached due to lack of the rigidity of the HPLs
- Places where the phenol resin was well smeared -> dark
Otherwise -> bright and having microscopic bright spots

- We expect that the oil pattern could be nicely formed only when the oil/heptane is well attached on the phenol-covered surface of the HPL.
- Bad condensation of the oil could be due to two different factors
 - 1) Oil dirt (microscopically thin layer remained even after cleaned by IPA and thinner)
(Still greasy even after cleaning by thinner & IPA)
 - 2) Poor condition of smeared phenol resin into the craft papers
(The color is brighter and having white microscopic spots)

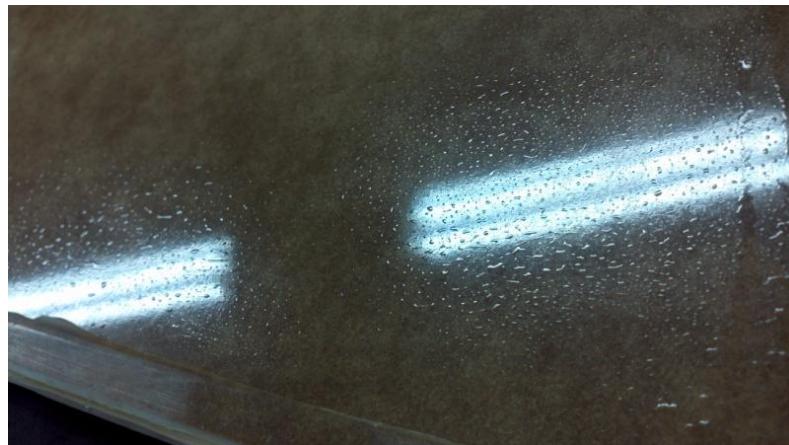
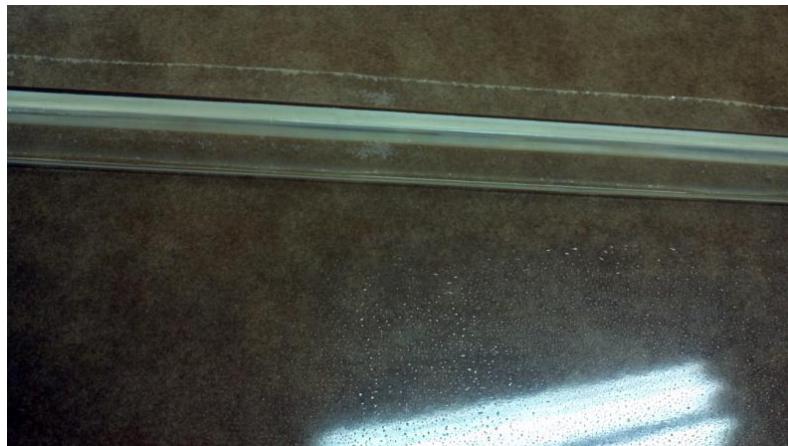
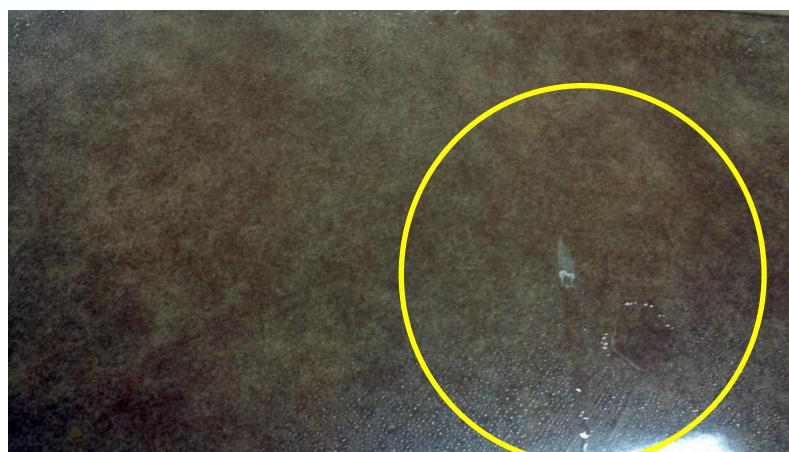
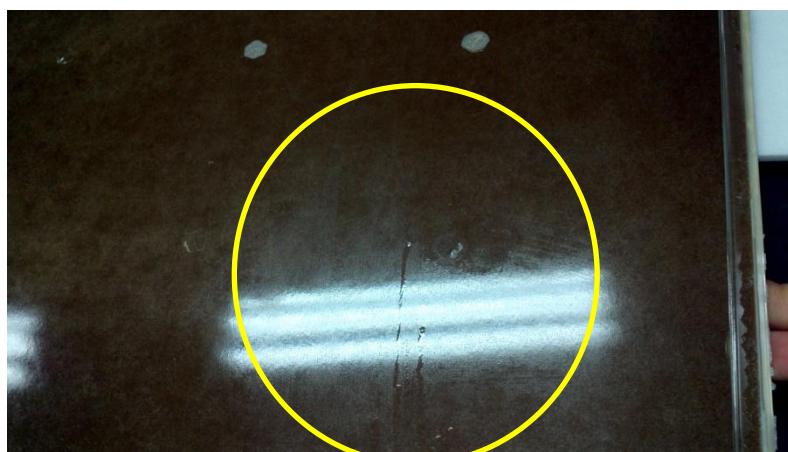
Bad oiled patterns especially on the places that the phenol was poorly smeared.

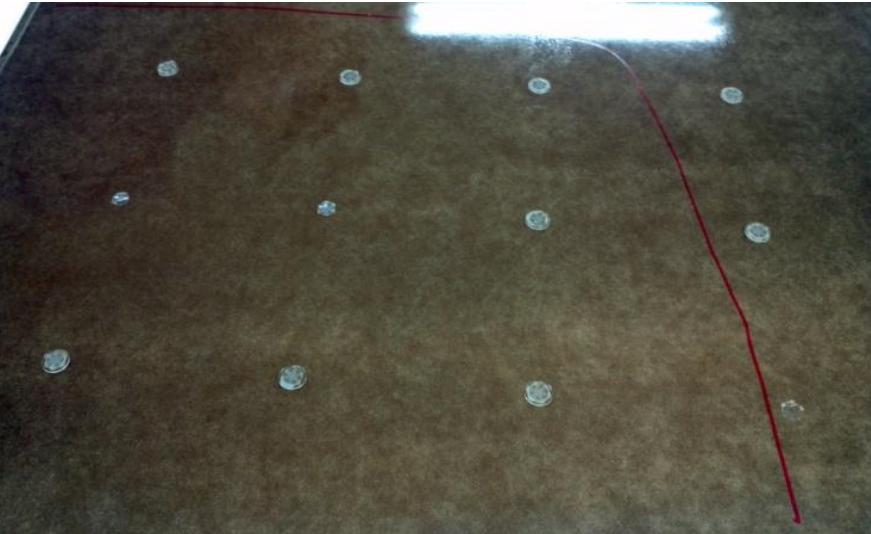
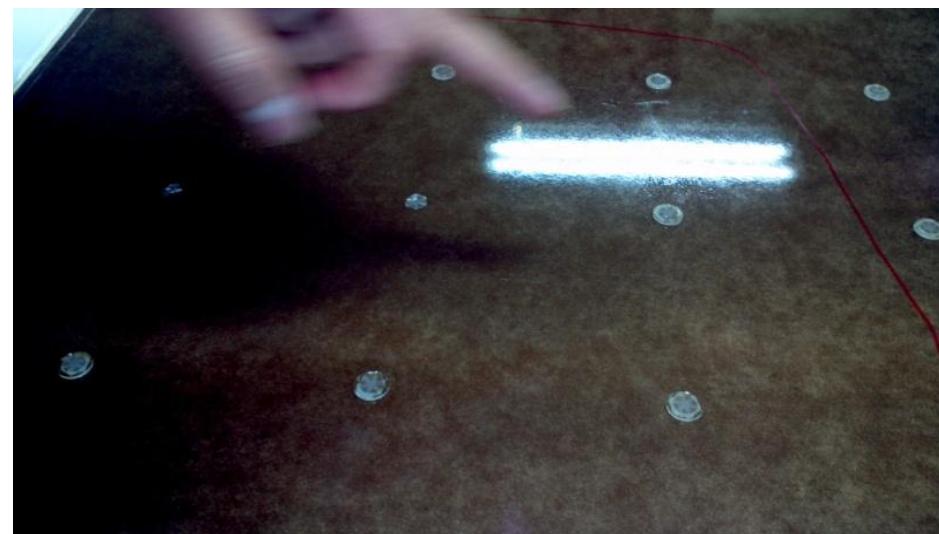
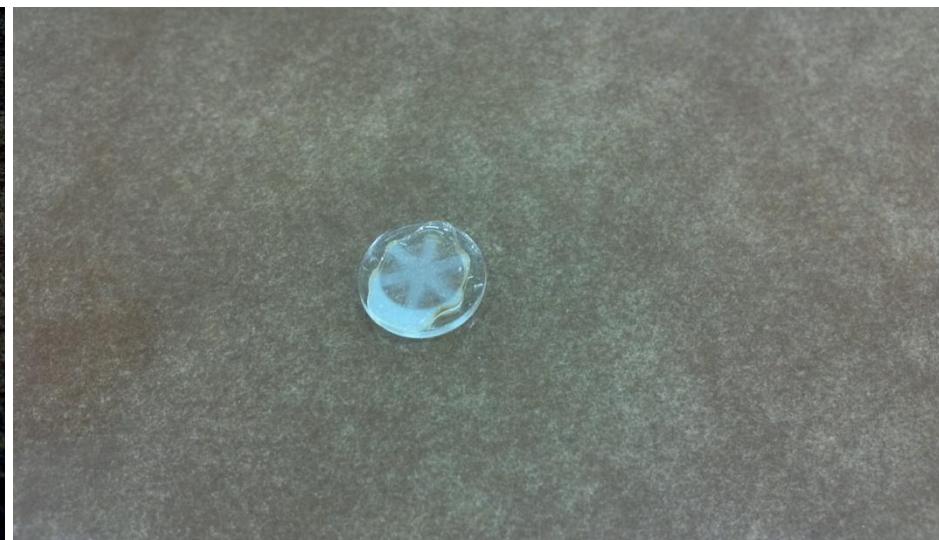
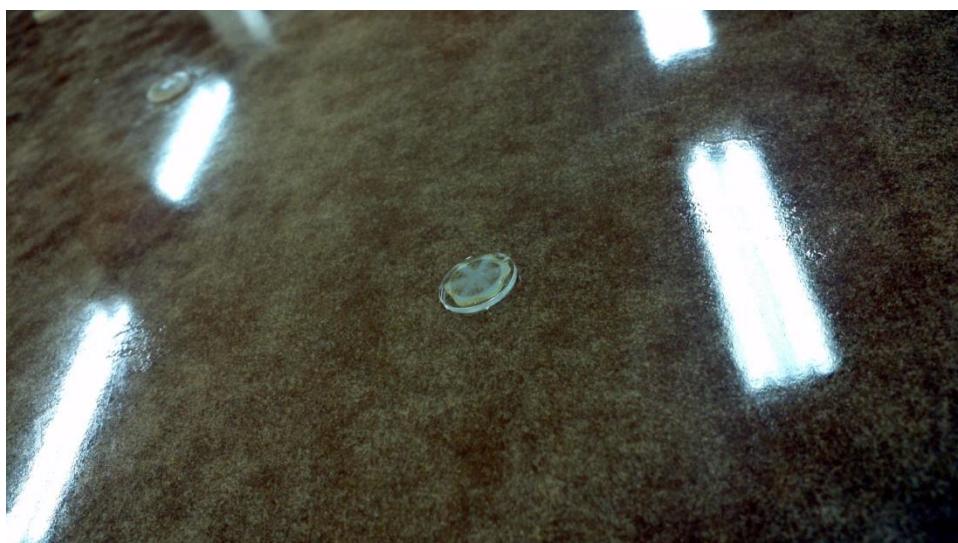
Good oiled patterns on the places that the phenol was relatively well smeared.

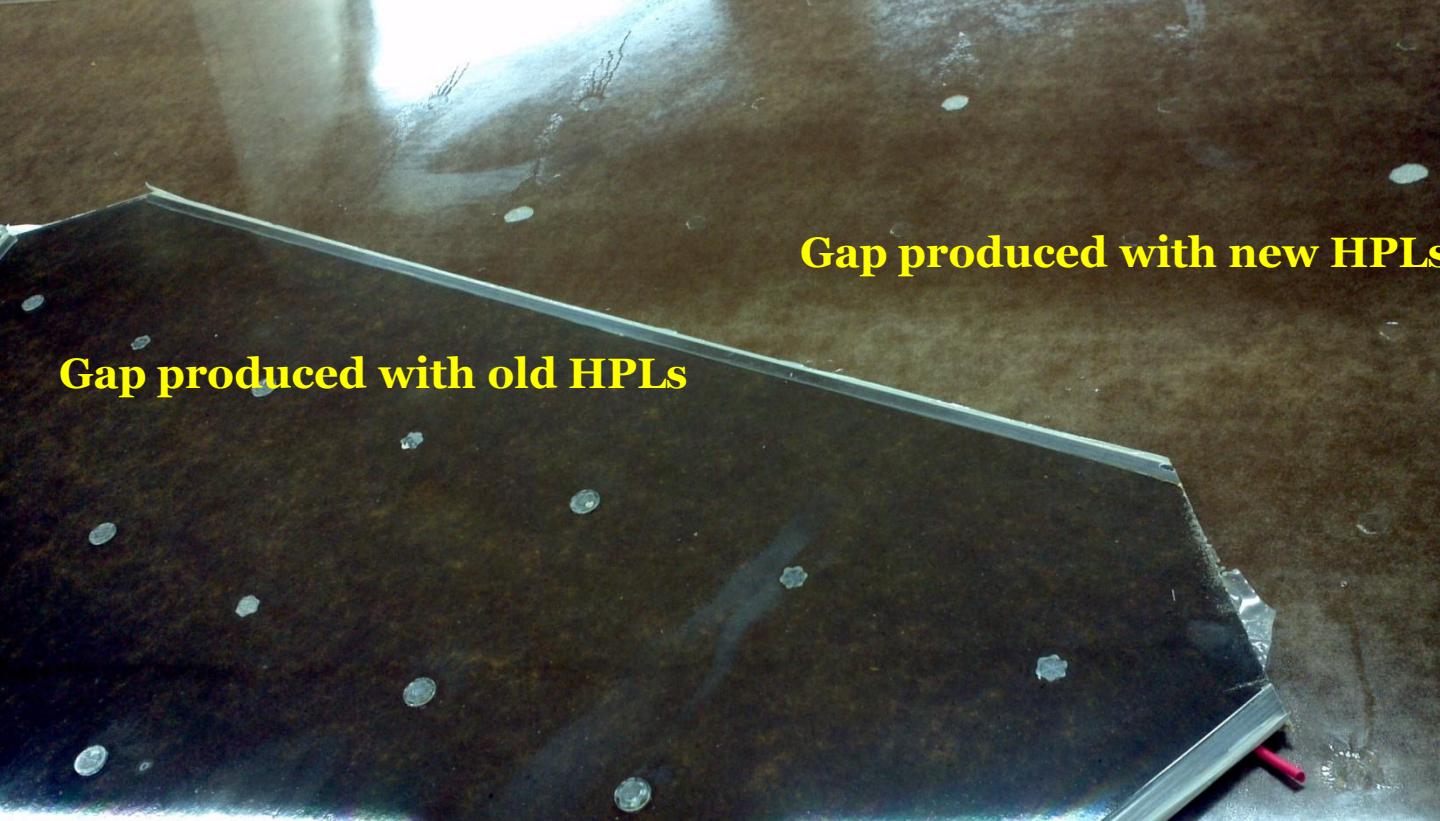
Gap produced with new HPLs

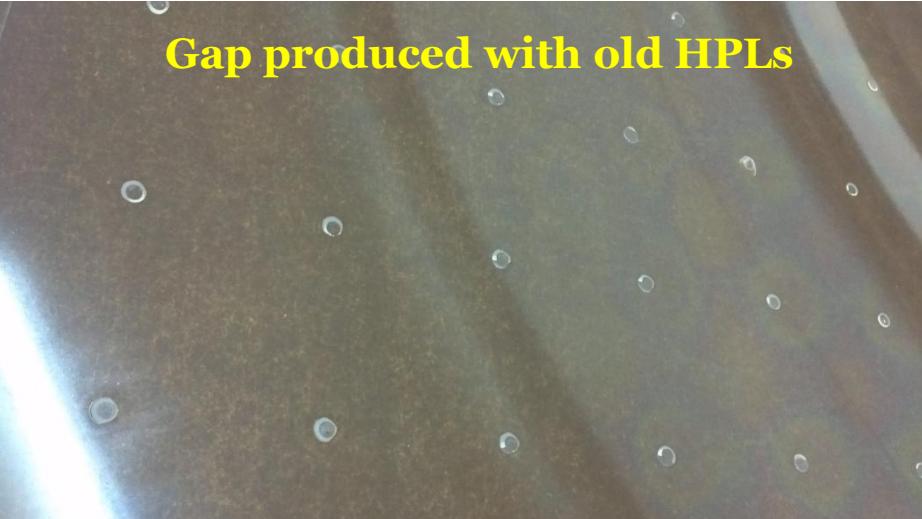
Gap produced with old HPLs

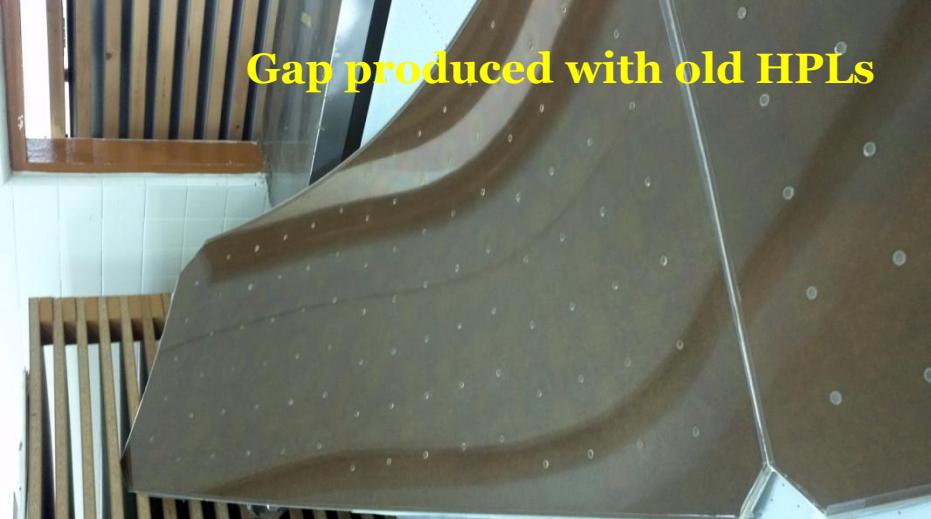
Gap produced with old HPLs

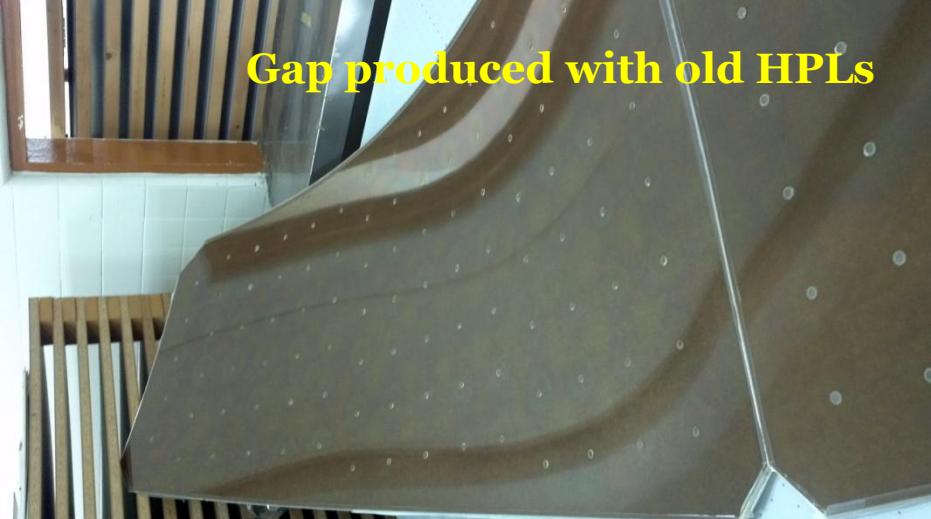
Gap produced with old HPLs

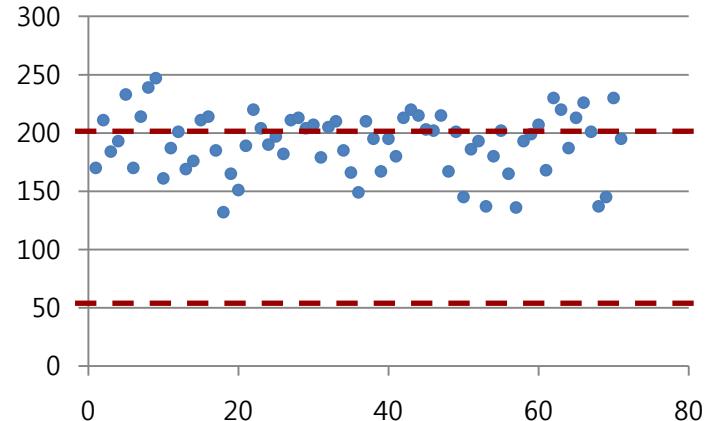
- Mean value of the graphite surface resistivity
= **191.6 ± 26.0 (sigma) k Ω /square**
- The desirable value lies bet. **$50 \sim 200$ k Ω /square**
- The value seems to be ~ twice larger due to cold weather (the temperature ranged $10 \sim 15$ °C)
- The temperature was NOT well controlled during the January shutdown period.

- The condition for the oiled surfaces looks too poor compared to the previous gaps produced in the old production.
- Cleaning thinner & IPA is NOT a right solution for the delivered HPLs.
- The cleaning procedure might not properly done for the current HPL delivered on the last December.
For the next HPLs to be delivered to KODEL, we ask the same cleaning process done for the old HPLs used in the previous gap production.
- The surface resistivity should be in a range from 50 to 200 kOhm/square.
-> Temperature control problem will be fixed.

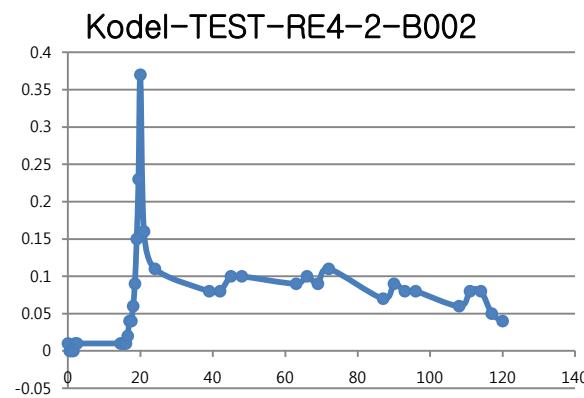
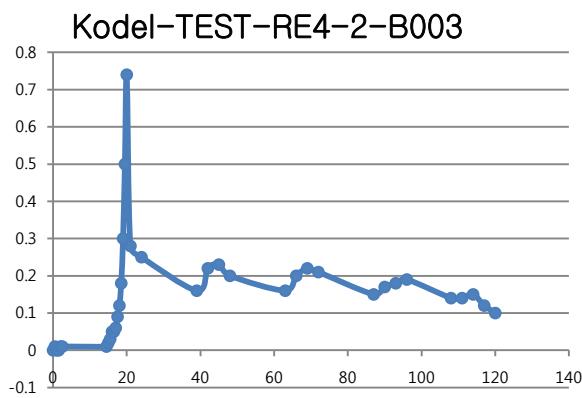
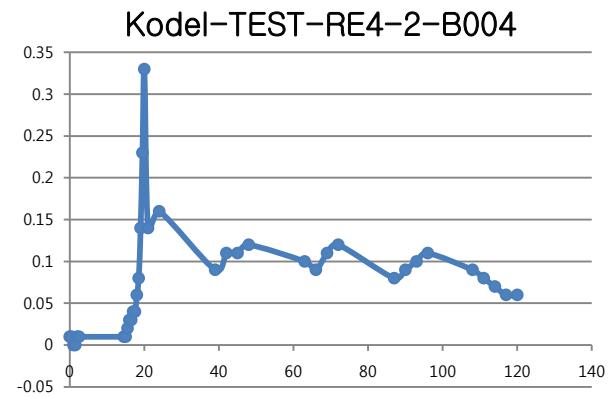
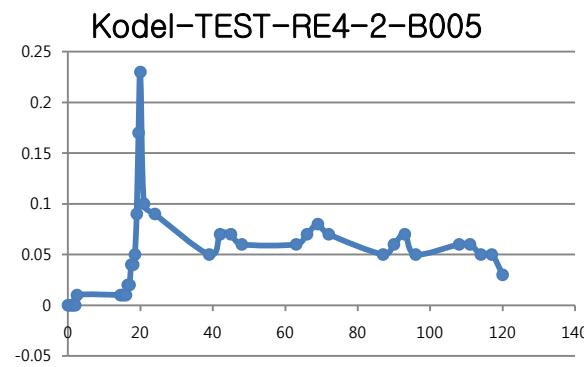
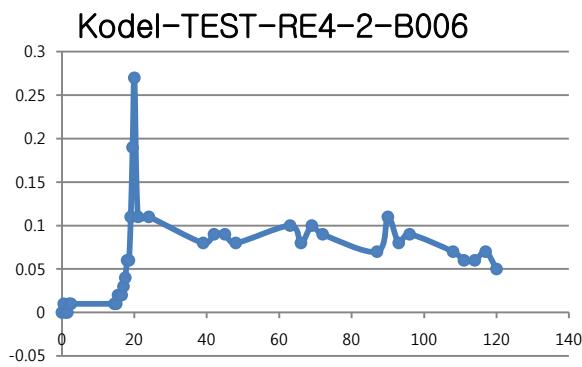
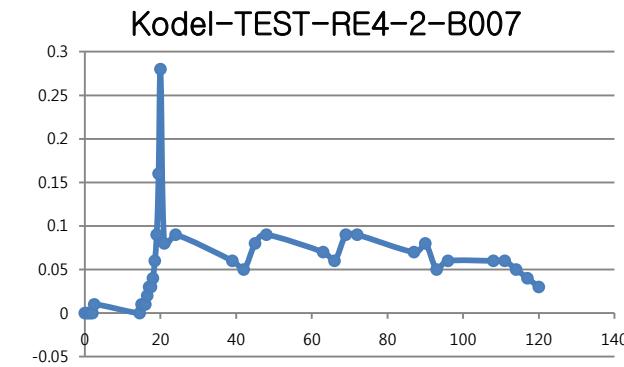
- The first HV test for 10 RE4/2 test bottom gaps seems to be good.
- One gap was disconnected from HV cabling at somewhere -> drop it !
- All the rest 9 gaps were QC certified !
- At 6.0 kV, $i \sim 0.2 \mu\text{A}$ for all the gaps
At 10.0 kV, maximum $i = 0.74 \mu\text{A}$
 $i(120\text{h})/i(63\text{h}) < 1.0$ for all the gap
- But we expected the currents of the test gaps should be smaller than the normal gaps to be built with a right resistivity range !
(the resistivity of the HPLs in batch 12 is higher)
- The good HV test results for just 7 days results do not guarantee long-term stability without solving oil problem.

Set at 10.0 kV at $t = 20.0$ h, and at 9.6 kV from 21 to 120 h for the long-term test.
