Cleaning up of the RE4 Mechanics.

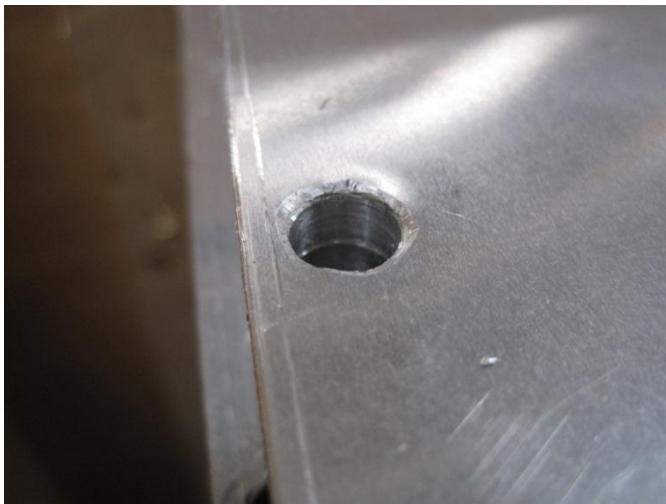
Chamfers on inner face of M6 screw holes

The chamfered holes should be redone with the correct tool that is not clogged with swarf.

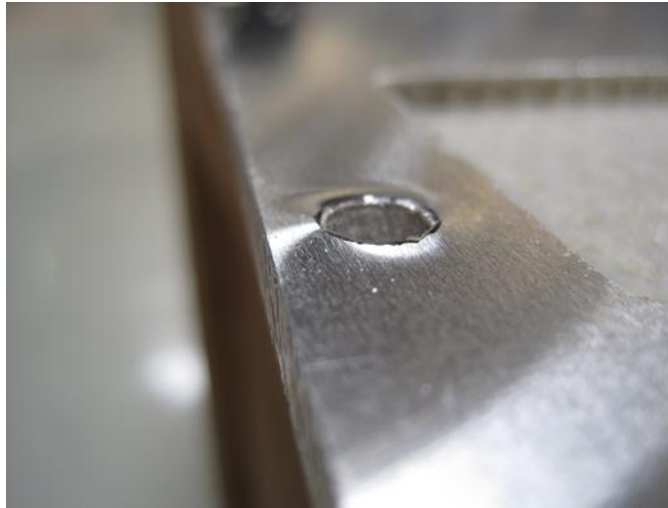
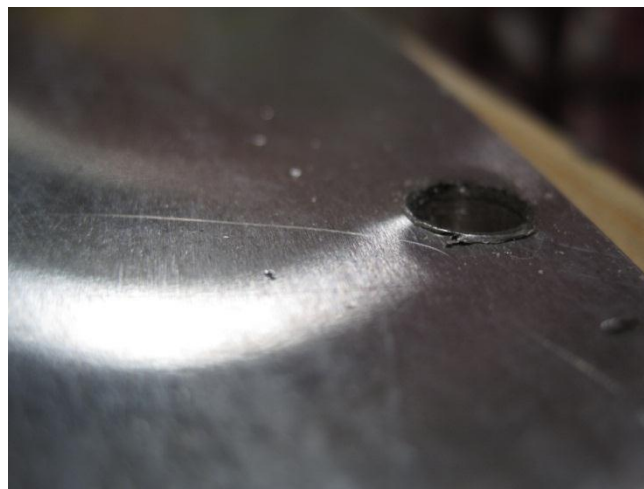
A example of delamination while drilling through the panel.

Here the inner skin of the HCP has lifted and will not go back in place as the interstice has been filled with machine chippings/swarf. The increased height must be removed. Firstly the hole is chamberfered down to twice the skin thickness, namely 2mm. This is most easily determined by comparing with the exposed skin. This action does not remove the deformation of the skin and so a second step is the abrasion of the surface as it is quicker and easier than machining leaving more material in place.

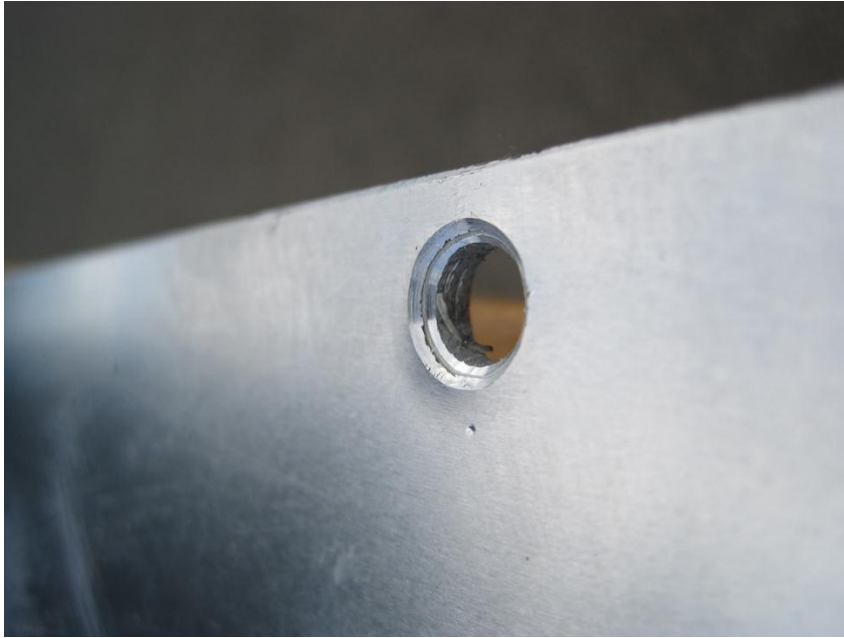
The first step of counter sinking the hole to twice the depth of the HCP skin.

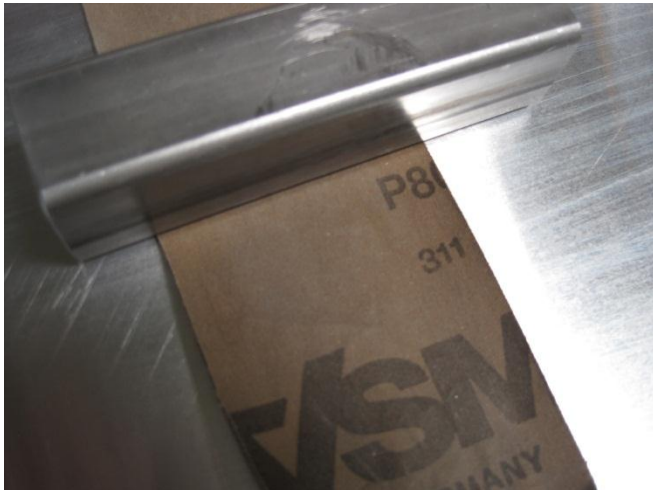
The second step using 80 grade paper and a hard sanding block. Wood blocks are not sufficient. The process is hand driven requiring physical strength.

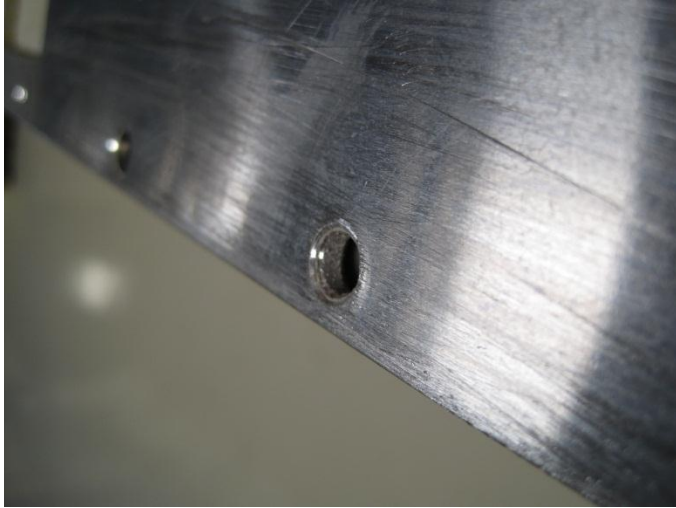
The result. The surface will be abraded right up to the edge over a radius of approx. 40mm. The ridge must be completely removed as indicated by a uniformly abraded surface.

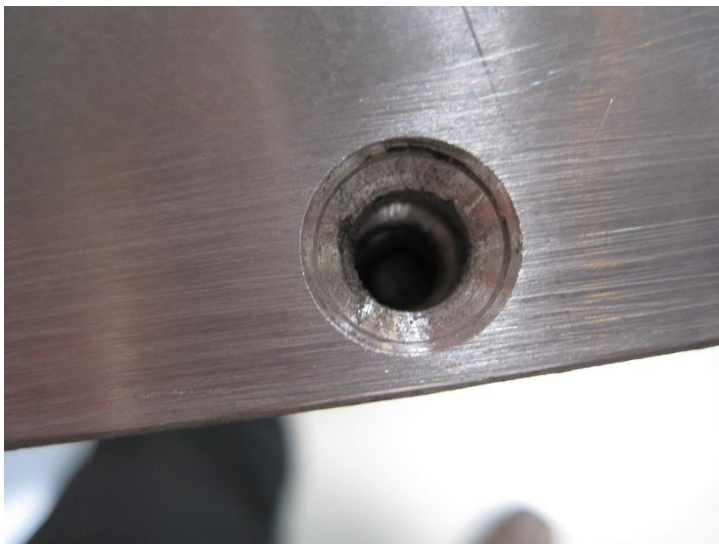
These Counter sunk M6 holes are mostly sufficient for the purpose of lowering the head to be flush with the HCP outer surface. A quick going over with the 80 grade paper and the hard (Metal or plastic) block to remove any sharp edges is sufficient.

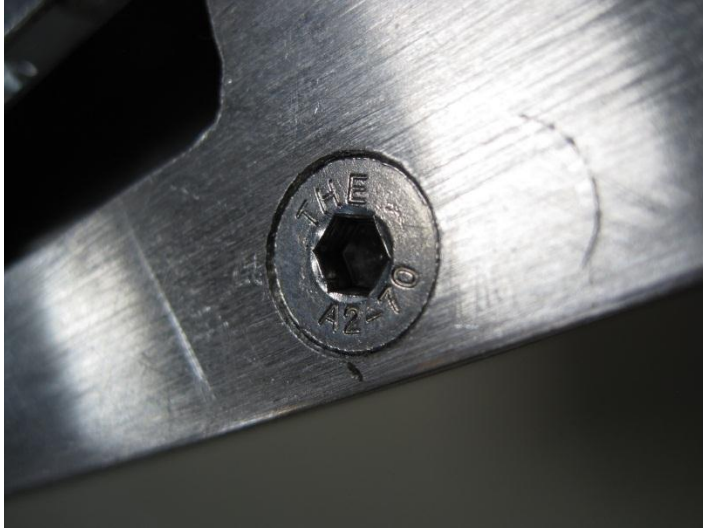
The Philips/cross head screws that come with the chamber are inappropriate to a for a high torque screw load (10Nm). The female hex head screw will ensure more rapid and easier chamber assembly.

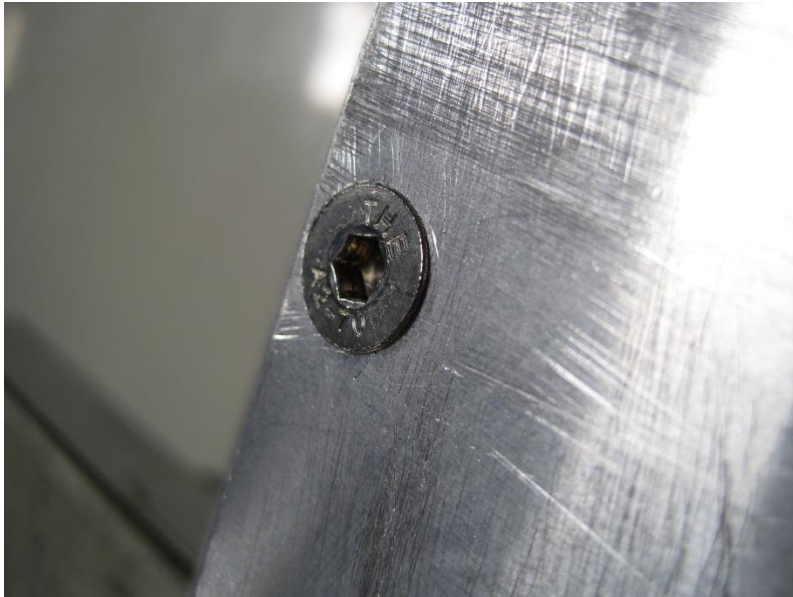
An insufficiently sunk head but the work necessary to correct this is too great, so 1mm of the head beyond the surface is considered as a pass.

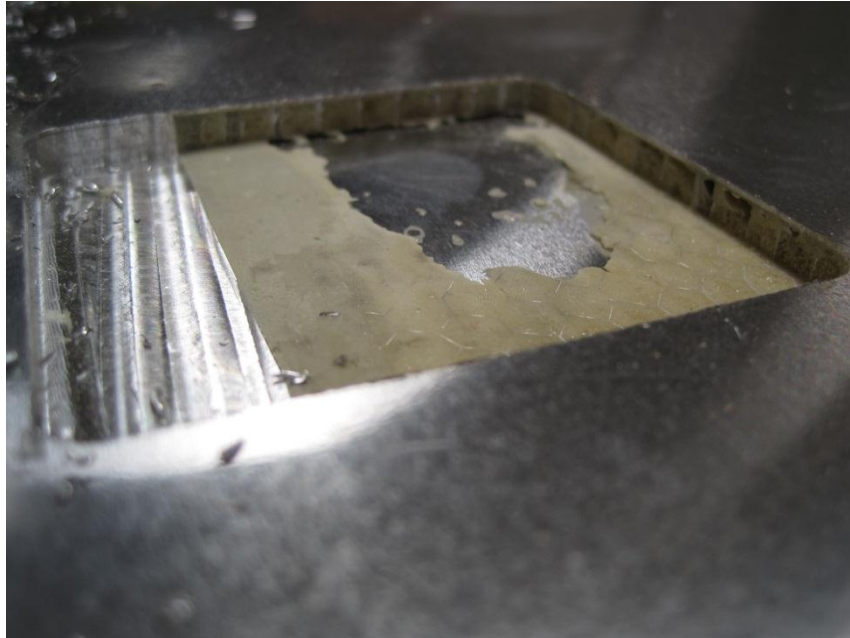
Here the slot is as cut direct from the machine

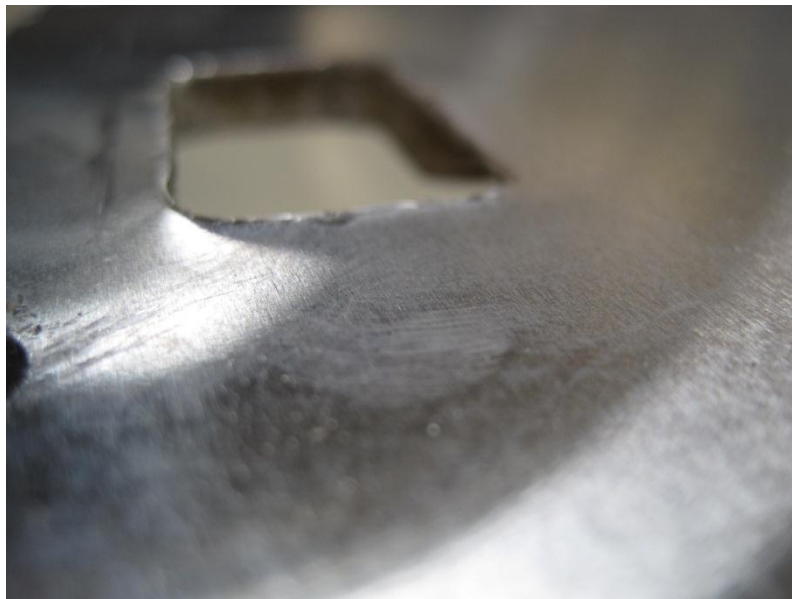
Below is an example of what will compromise the HV insulation and put pressure on the gap.

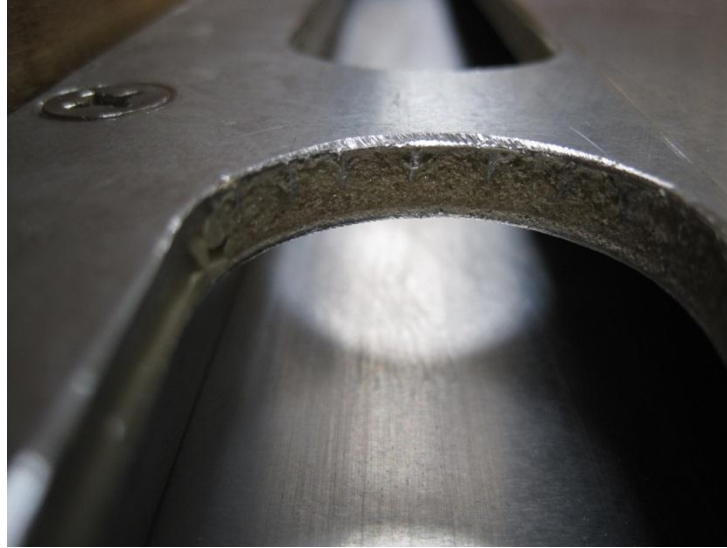
The chamfering is difficult to do correctly by hand but as shown below is sufficient.

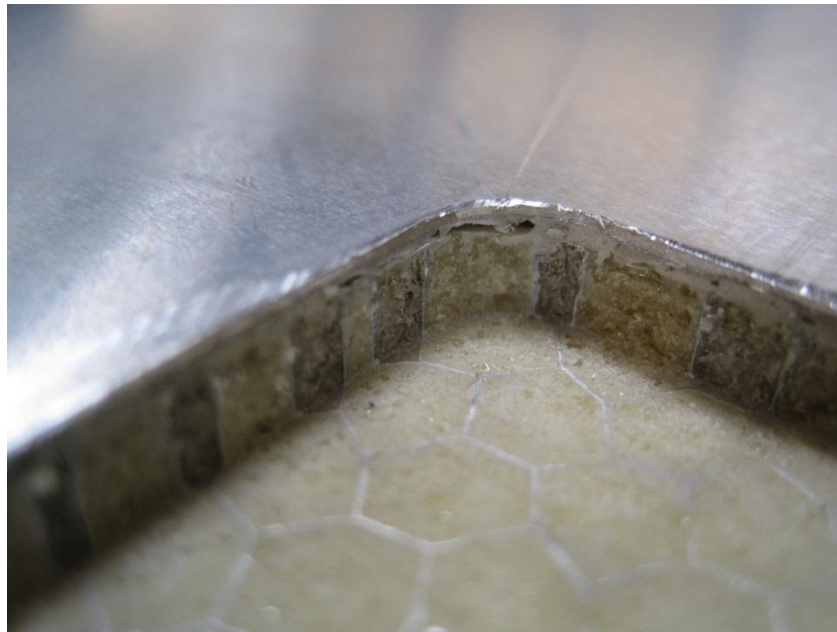
Here , below the chamfering is only just sufficient.

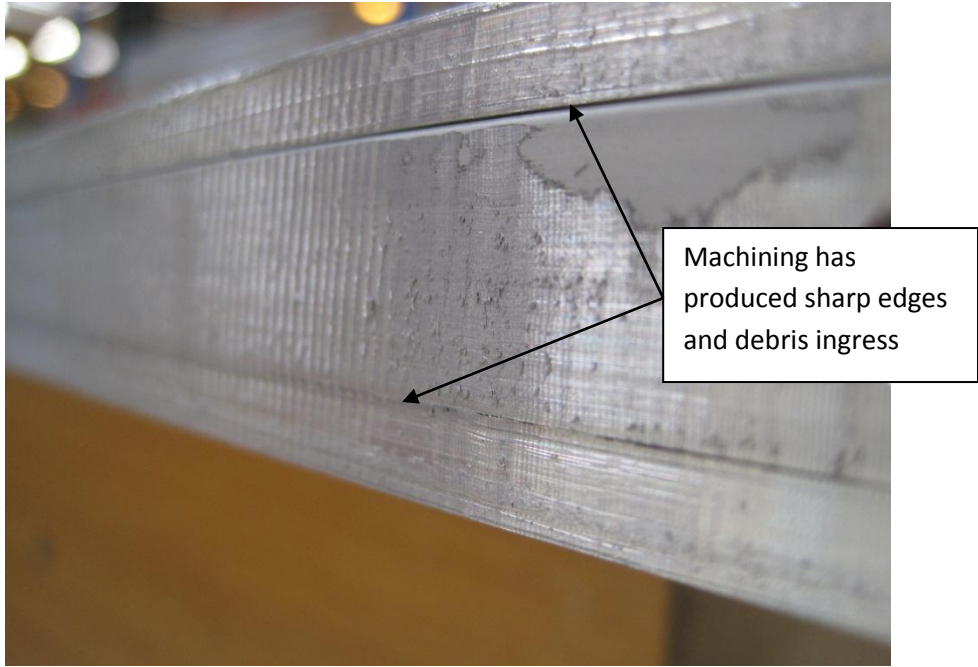
Inner edges of bars & HCP that have been machined.

These damaged edges are to be removed so that the HCPs and panel will mate properly, this will be done with a band sander and 80 grade abrasive paper.

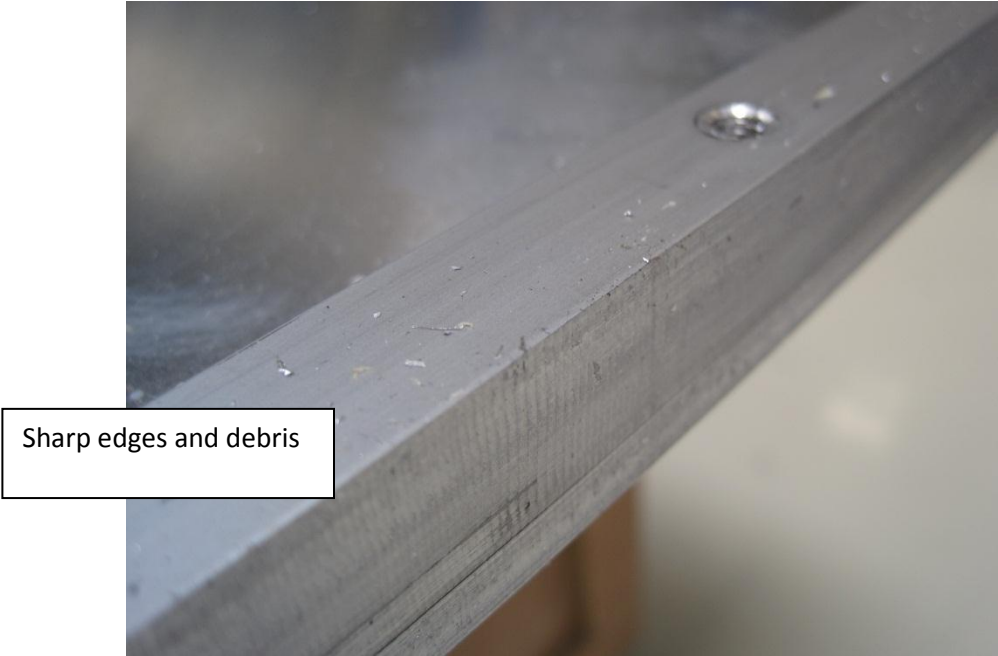
Machining carried out in the ISR.

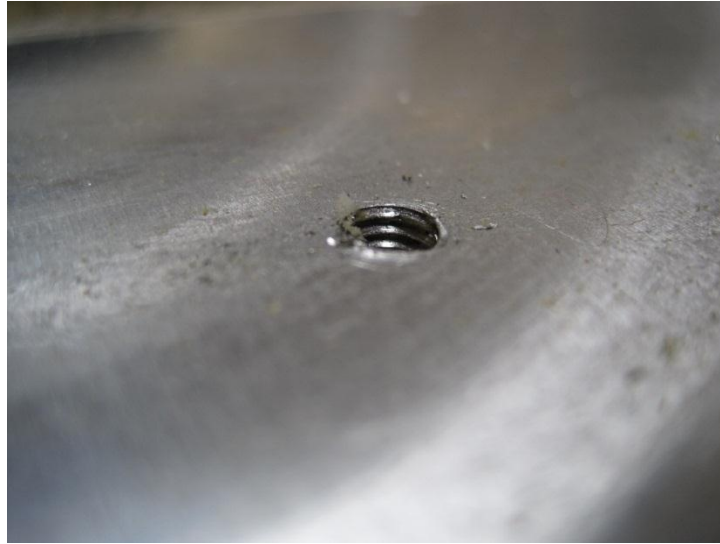
Threaded M5 holes on inner face, missing threads and chamfers

A sharp counter sink tool tool be used to remove the excess material

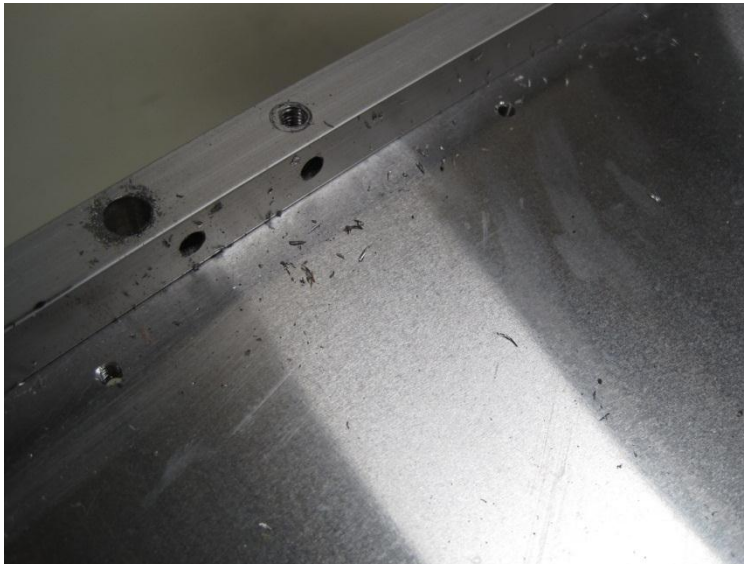
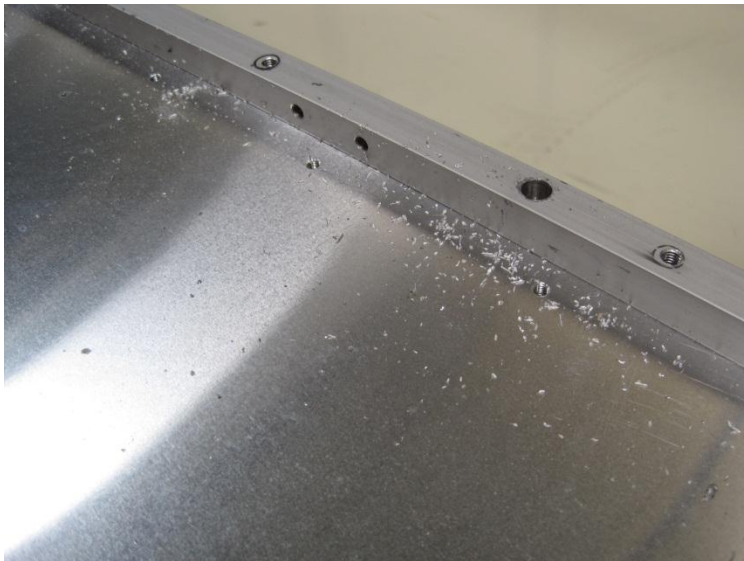
There is plenty of metallic debris in all chamber mechanics so far opened. This is associated with grease based smears , presumably from some cutting oil used during the drilling. All these products must be removed with a degreaser, whether hydro carbon based (Line 61 in the Chamber component list) or water (eg Typol, see the component list line number 60). Final cleaning is with IPA, clearly done after all the other corrective measures. A vacuum cleaner or compressed air can be used ONLY once all elements have been dissociated to avoid forcing debris into holes and interstices. Compressed air is dangerous and those involved should be informed and protected.

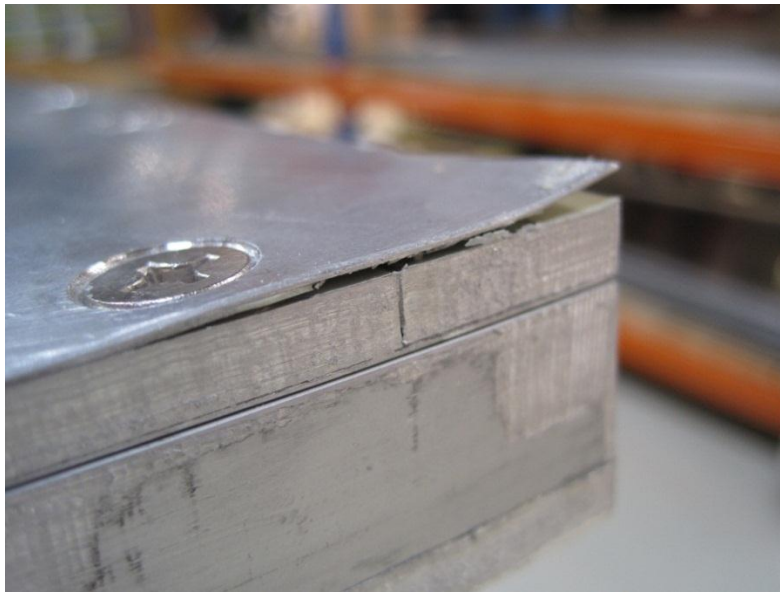
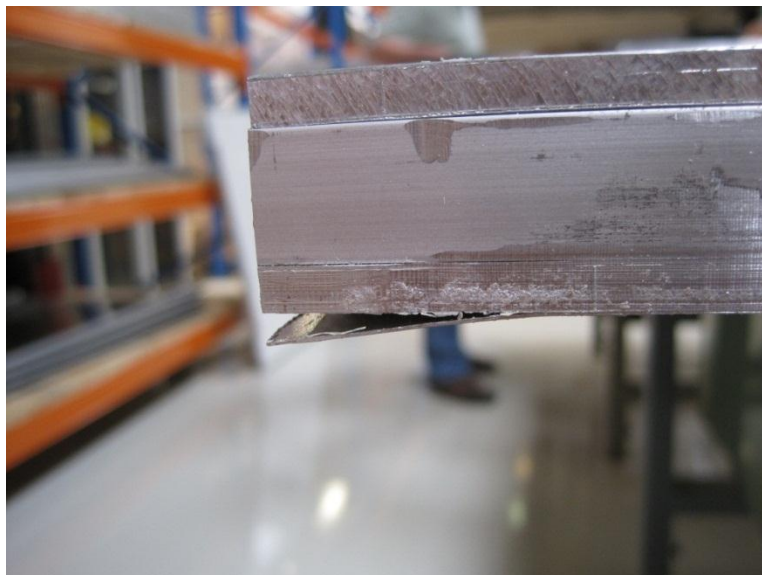
Recent faults, delamination. On the edges/corners perhaps aggravated by handling methods involving dragging across the bench/support. Other failures recently identified are bulging. The amplitude is significant wrt the space inside the mechanics for the gaps, namely 1.5mm in a number of locations on the inner faces of the HCPs. The number of affected mechanics will be known once all the retrofitting has been carried out.

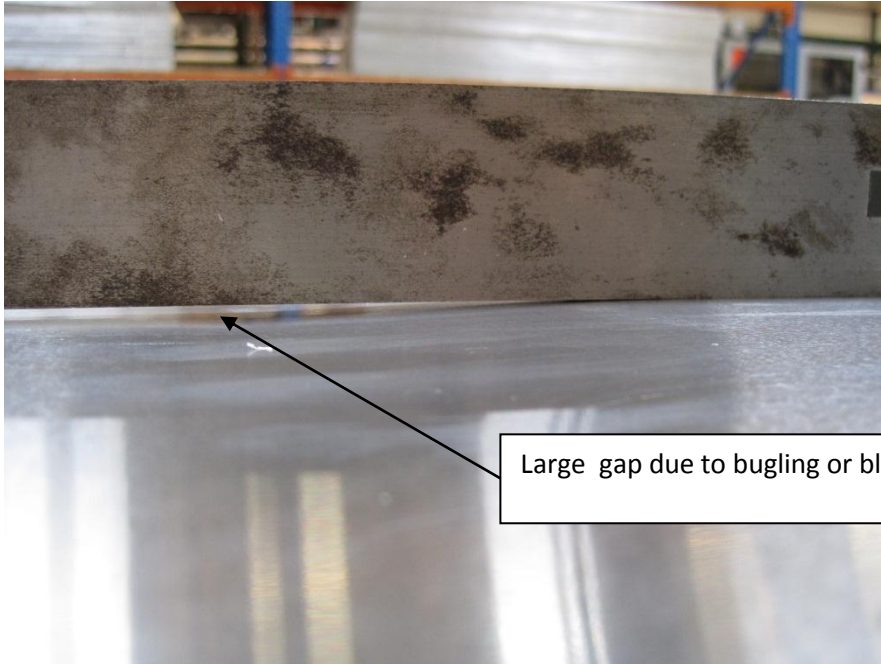
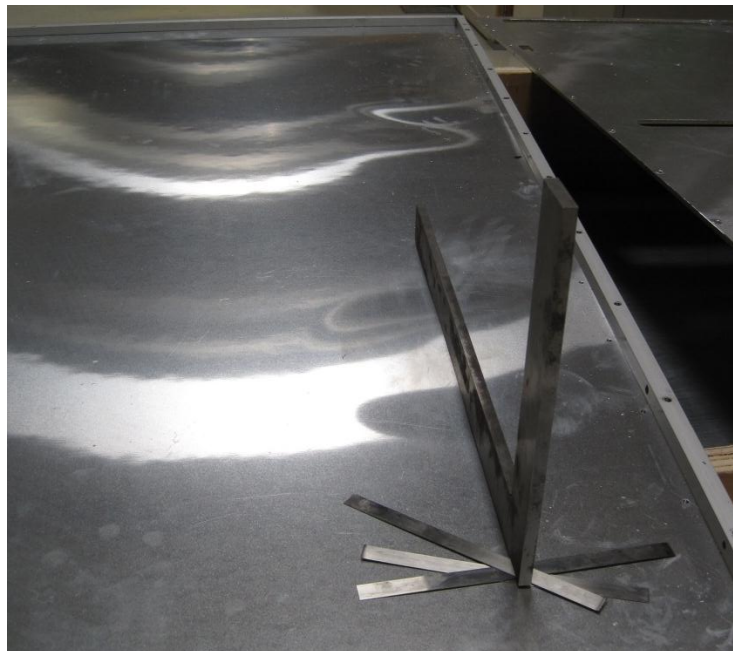
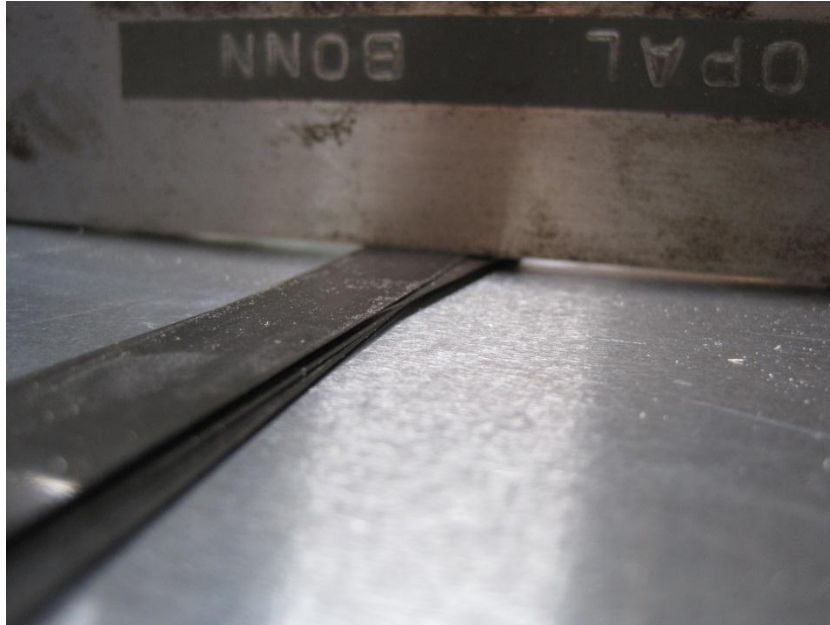
Delamination due to insufficient bonding as a result of lack of glue.

These panels should be rejected.

Recovery of this problem is perhaps possible but would involve drilling numerous holes in the skin, injecting an epoxy and pressing with a vacuum bag technic, as the panel sizes involved are serious. Care and an empirical approach would be needed to remove excess injected glue. Lets hope that this fault is not time dependant, meaning these errors will not appear in the future !

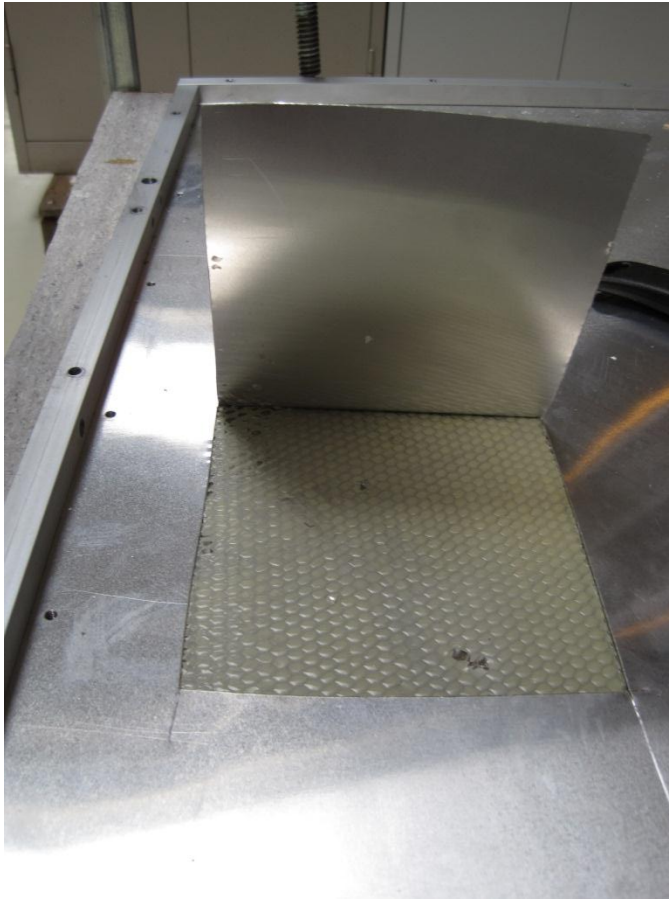
Opening of one panel with the worst case so far found (1.5mm) over an area some 300mm across.

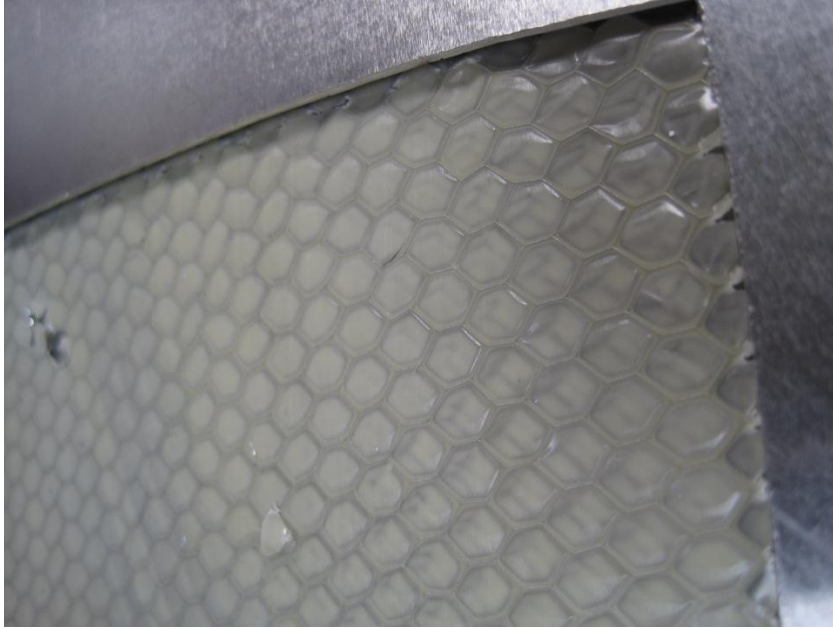
There is no indication of bonding in any of the exposed area.

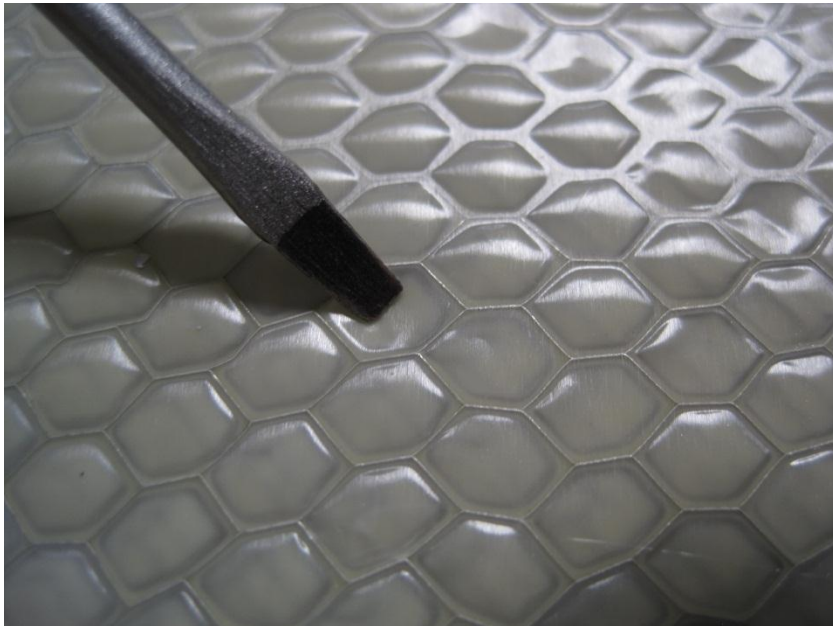
Below indications of an over pressure wrt atmosphere here at CERN. The fabrication was probably done at a lower altitude.

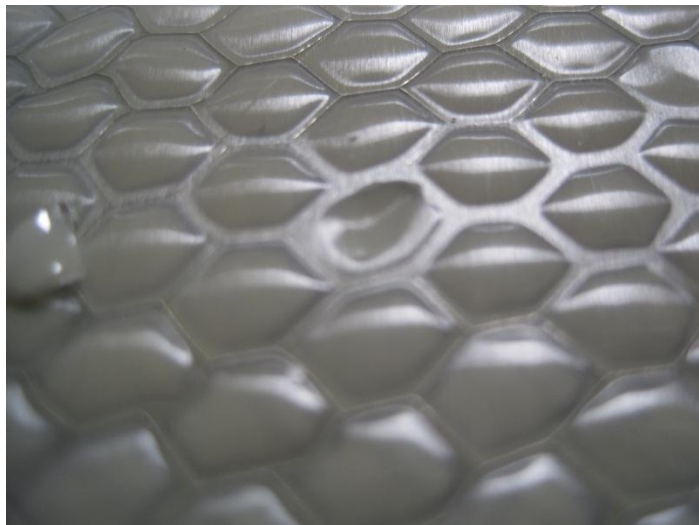
If the adhesive skin is punctured the surface is no longer elastic

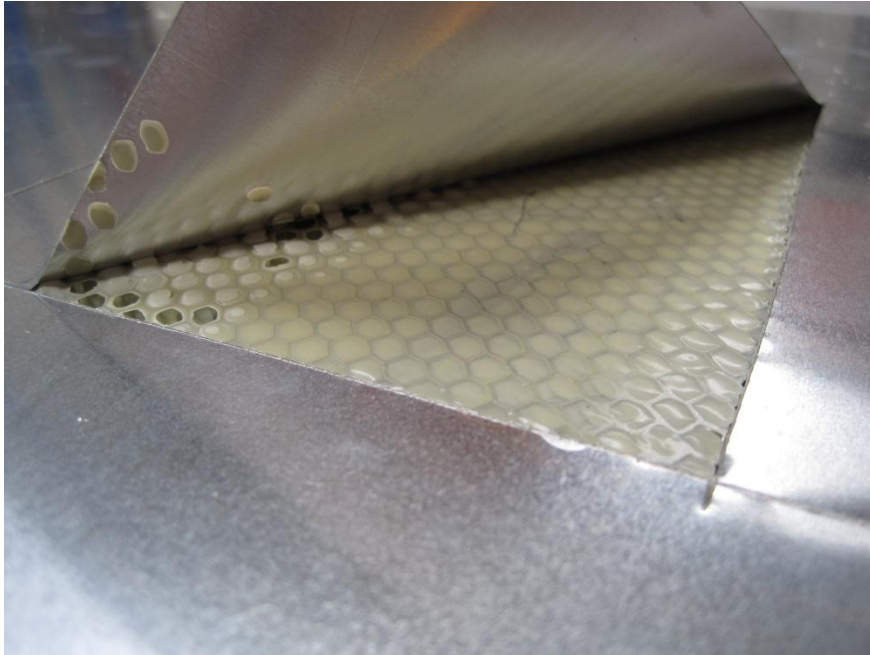
It is of concern that what should be bonded is not only over a smaller area. The bonded area is indicated by the torn open cells.

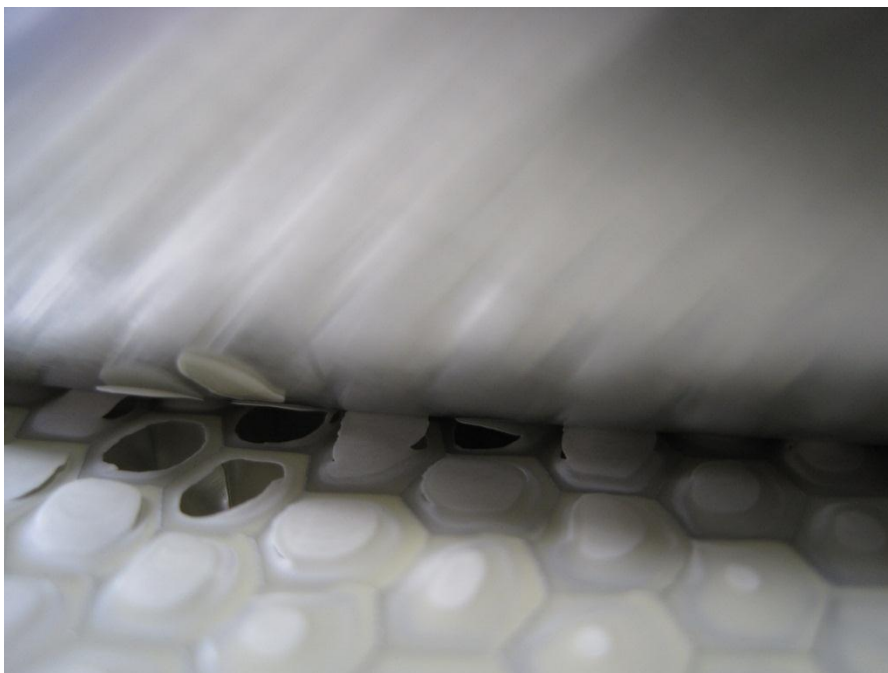
It is clear that the adhesive , after opening , is not attached over the full area of the cell, this may be due to over pressure inside the cell or partial failure of the alu/adhesive interface. Insufficient pressure during the full cure time of the adhesive may also produce such faults, namely incomplete bond area.

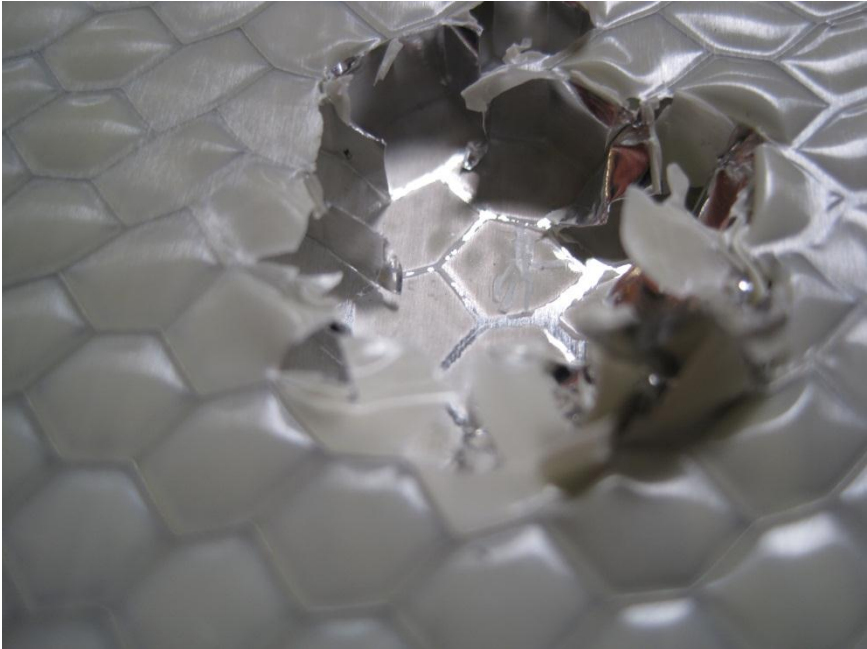
Going back to the fully unbonded area , on the opposite face, under the opened one, the bond is good over the entire surface, negating the previous argument.

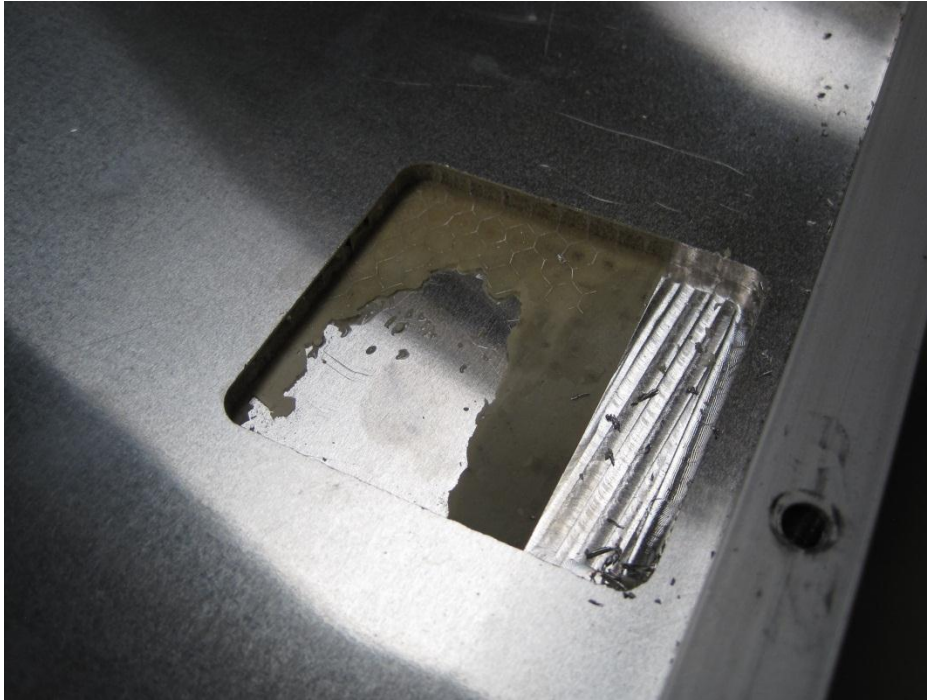
Other nonbonded areas are to be found around the cut-out slots as shown. This could be argued as coming from the pressure exerted during the machining.

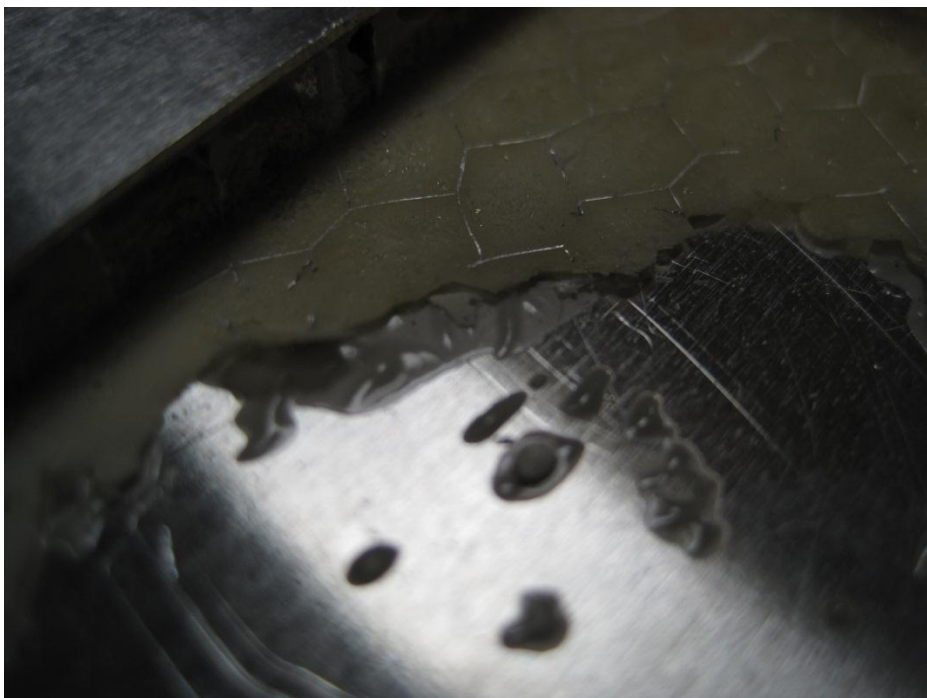
Here in the centre there are indications of a good bond but a thick layer of adhesive, poor pressure application ?

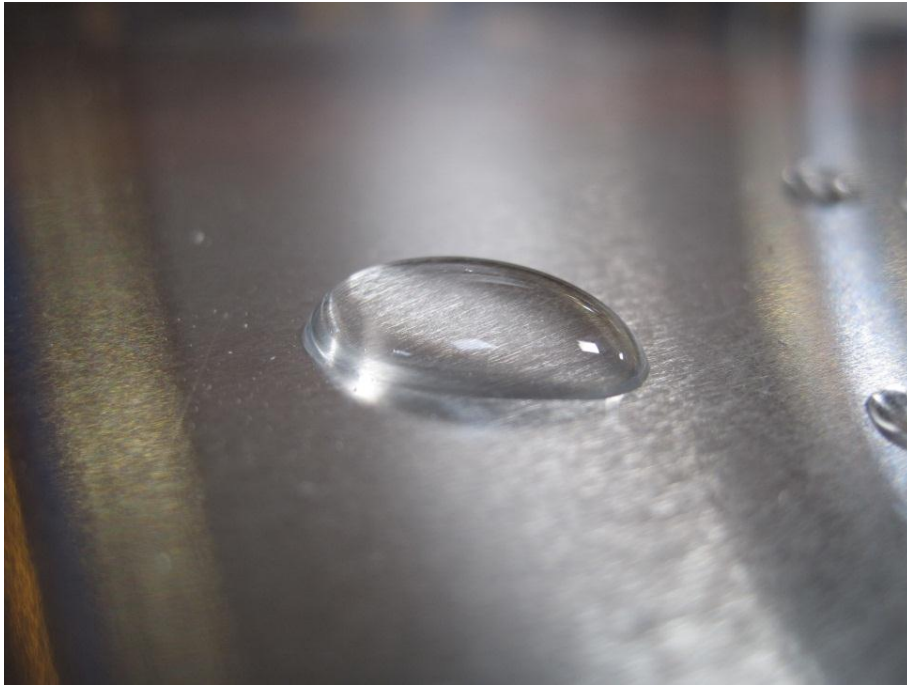
Water on the outer surface of the panel, illustrating a high contact angle.

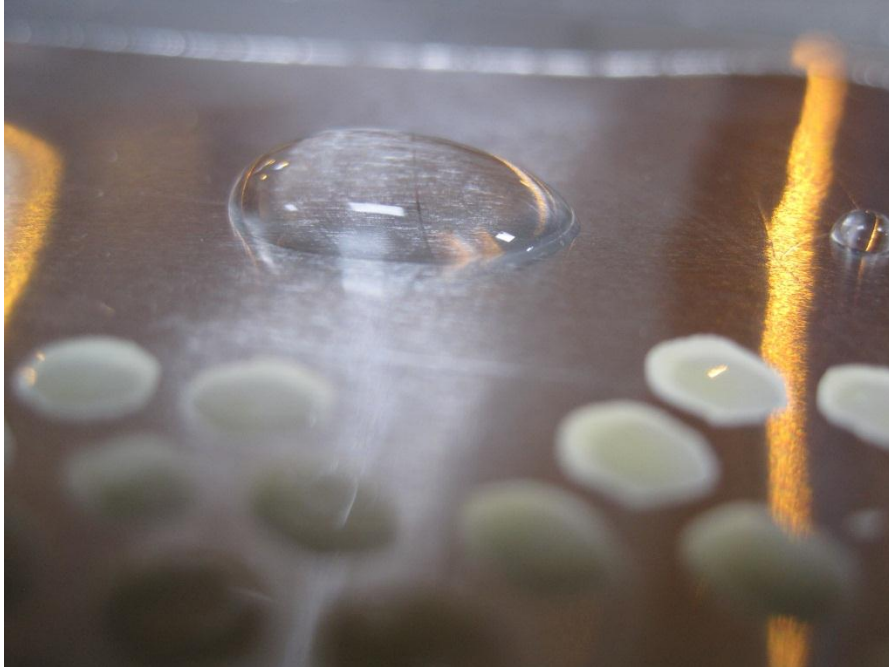
Next to the bonded area the contact angles are similar to the untouched outside surface indicating minimal surface preparation.

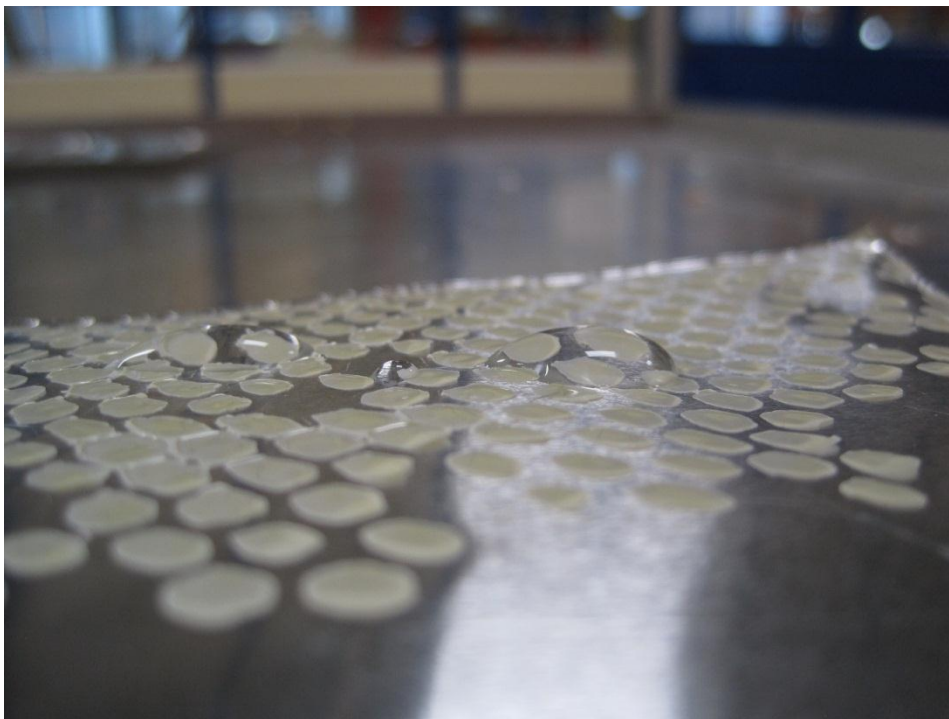
That is similar to the bonded area, so here is also minimal preparation.

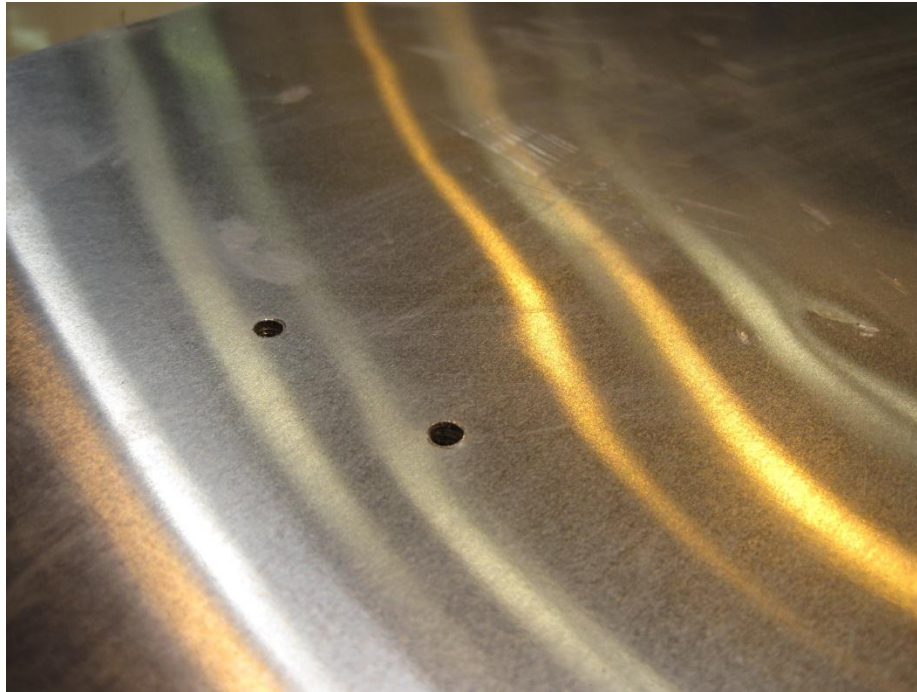
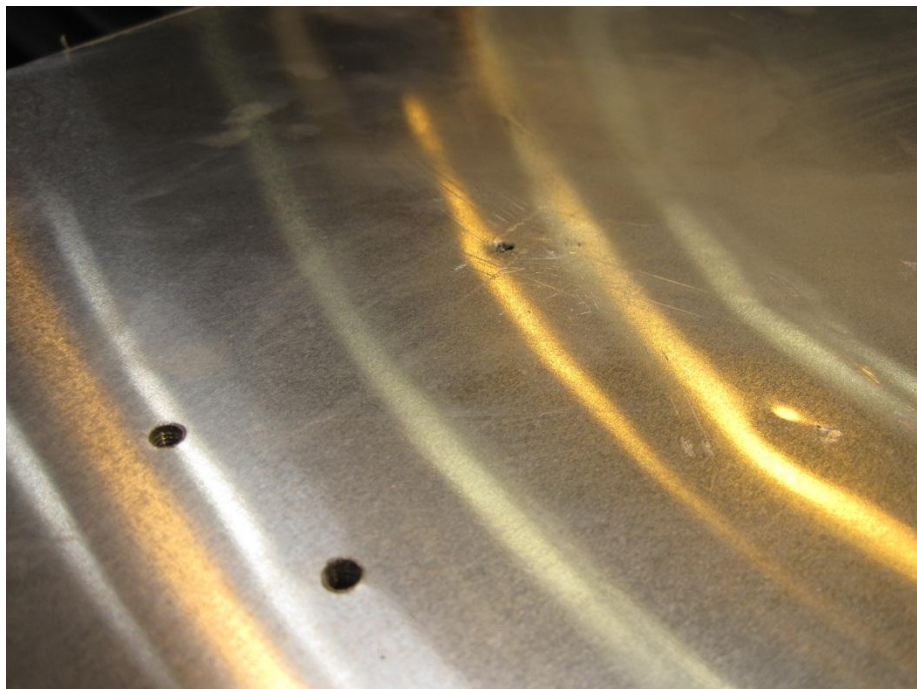
Here is a relatively small example, The yellow reflection gives some idea of the deformed area, before;

Numerous holes were drilled in approx. 5 blisters and in almost all the blister could be made to collapse.
