Cleaning up of the RE4 Mechanics.

SM mounting holes.

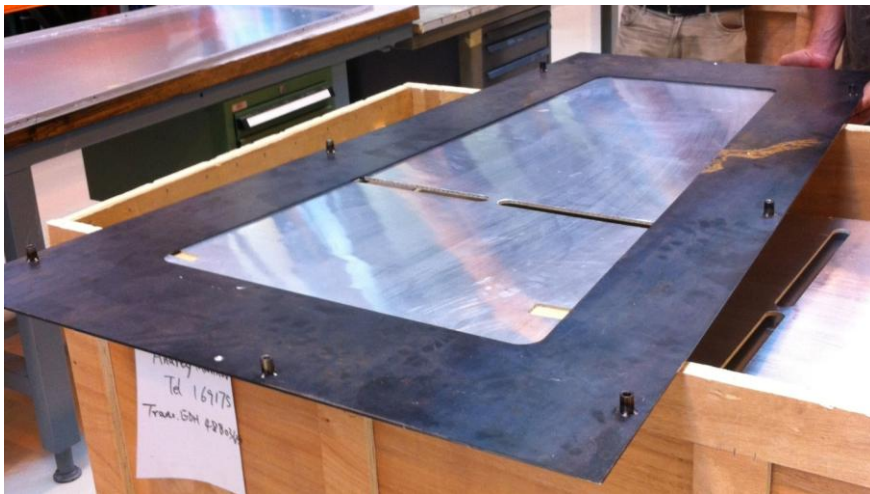
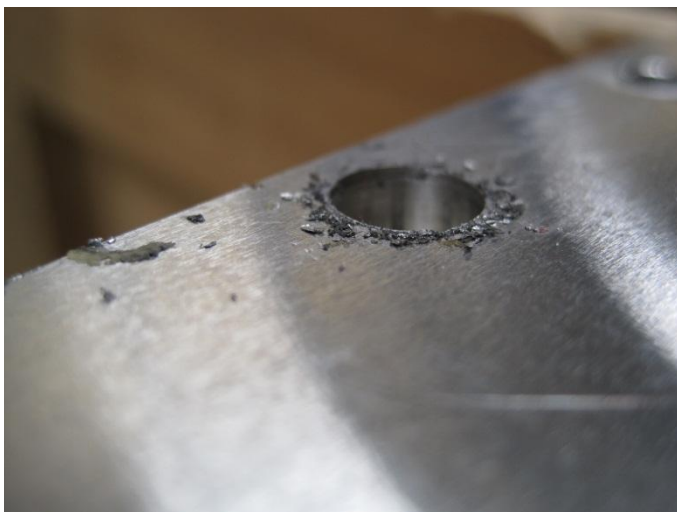
They will then be deburred and couter sunk as specified in the drawing. The value given is XXmm.

The template as designed by Luc must be used, it must be secured at each end of the HCP by 2 M6 screws. All the 7 holes will be drilled through to 8.5mm diameter.

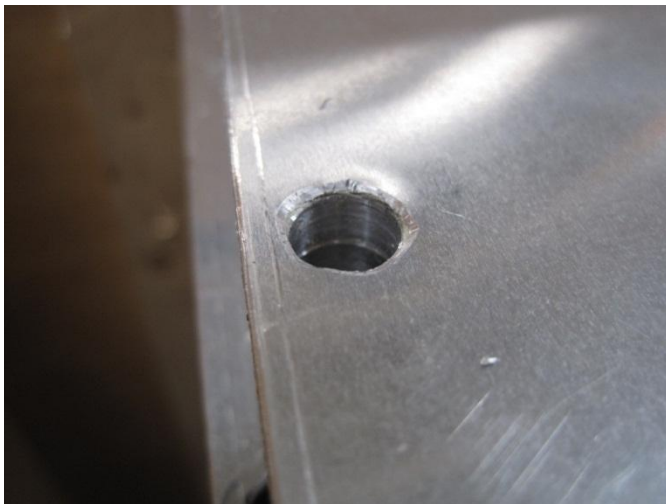
This work will ensure the structural rigidity of the assembled mechanics with the HPL load inside.

The chamfered holes should be redone with the correct tool that is not clogged with swarf.

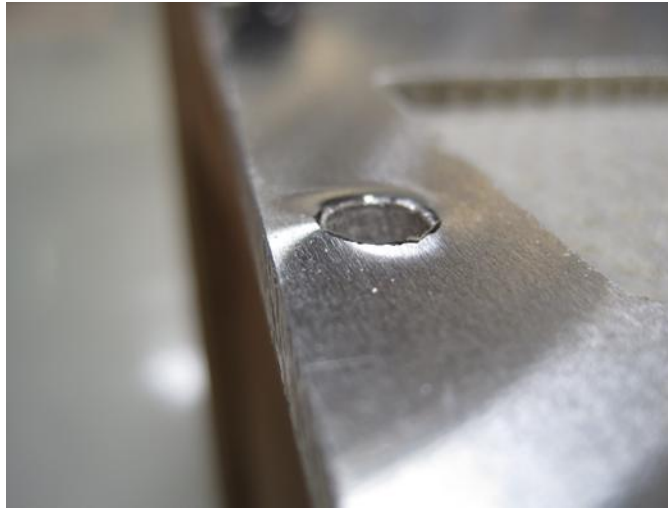
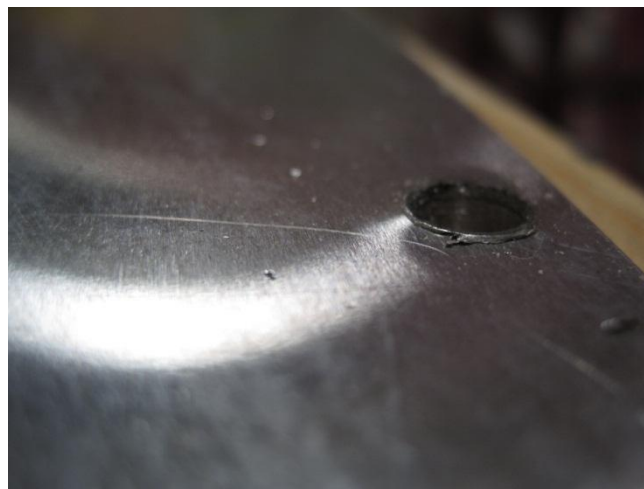
An example of delamination while drilling through the panel.

Here the inner skin of the HCP has lifted and will not go back in place as the interstice has been filled with machine chippings/swarf. The increased height must be removed. Firstly the hole is chamfered down to twice the skin thickness, namely 2mm. This is most easily determined by comparing with the exposed skin. This action does not remove the deformation of the skin and so a second step is the abrasion of the surface as it is quicker and easier than machining leaving more material in place.

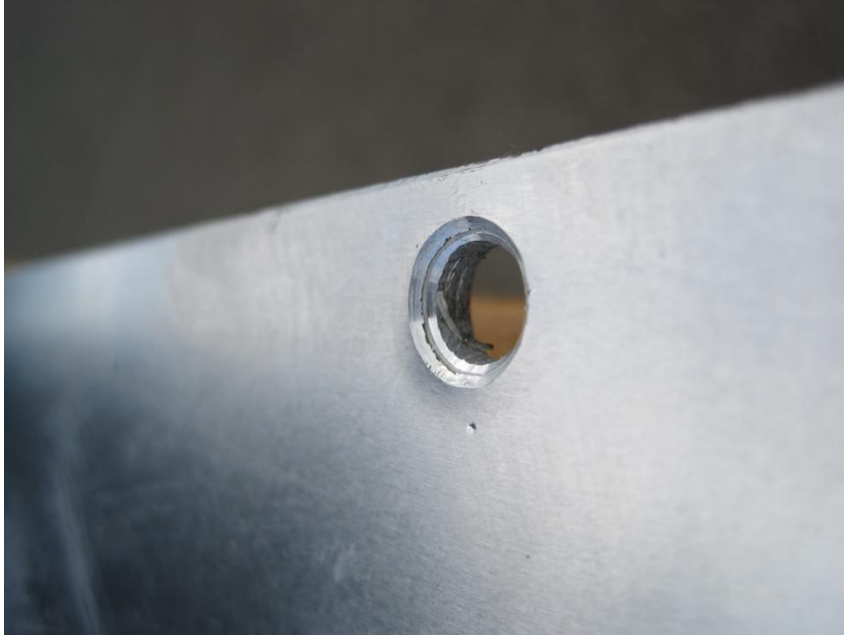
The first step of counter sinking the hole to twice the depth of the HCP skin.

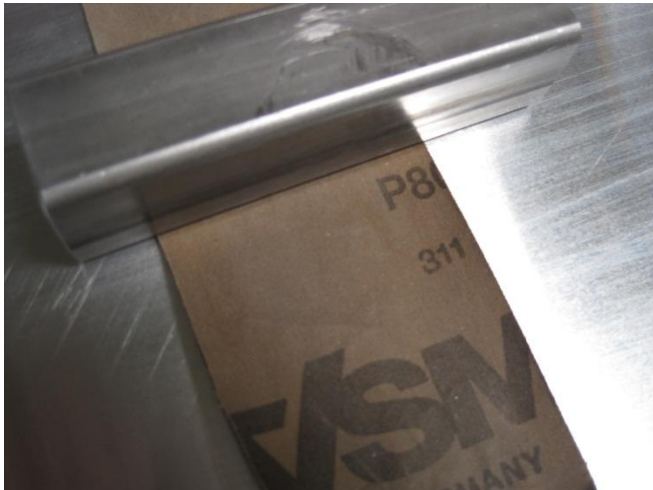
The second step using 80 grade paper and a hard sanding block. Wood blocks are not sufficient. The process is hand driven requiring physical strength.

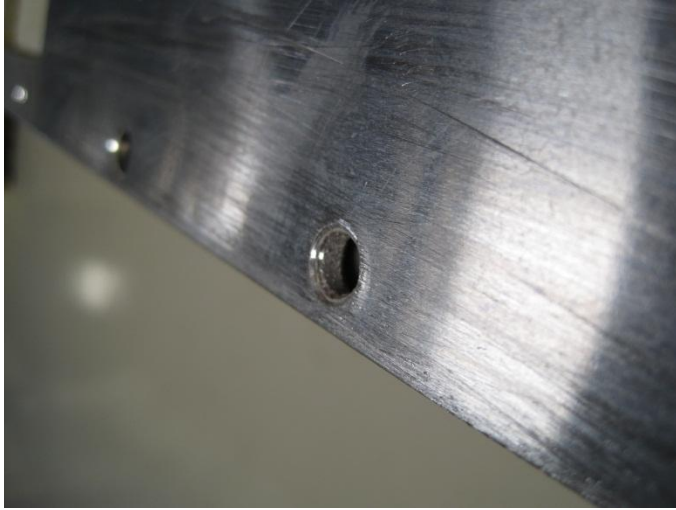
The result. The surface will be abraded right up to the edge over a radius of approx. 40mm. The ridge must be completely removed as indicated by a uniformly abraded surface.

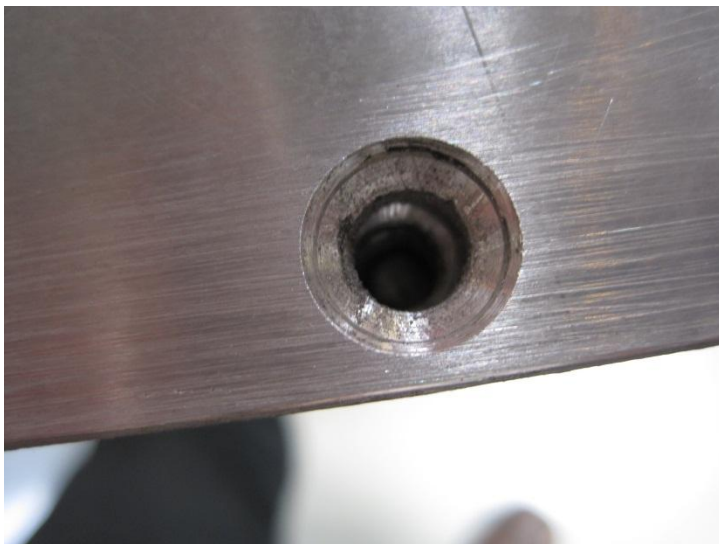
These Counter sunk M6 holes are mostly sufficient for the purpose of lowering the head to be flush with the HCP outer surface. A quick going over with the 80 grade paper and the hard (Metal or plastic) block to remove any sharp edges is sufficient.

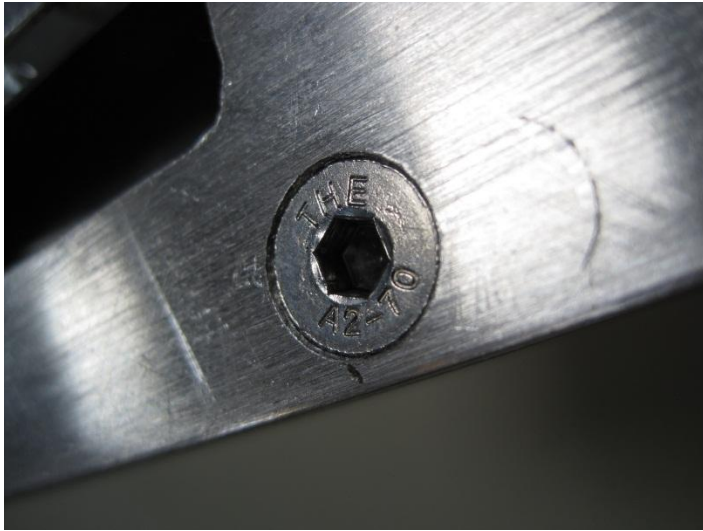
The Philips/cross head screws that come with the chamber are inappropriate to a for a high torque screw load (10Nm). The female hex head screw will ensure more rapid and easier chamber assembly.

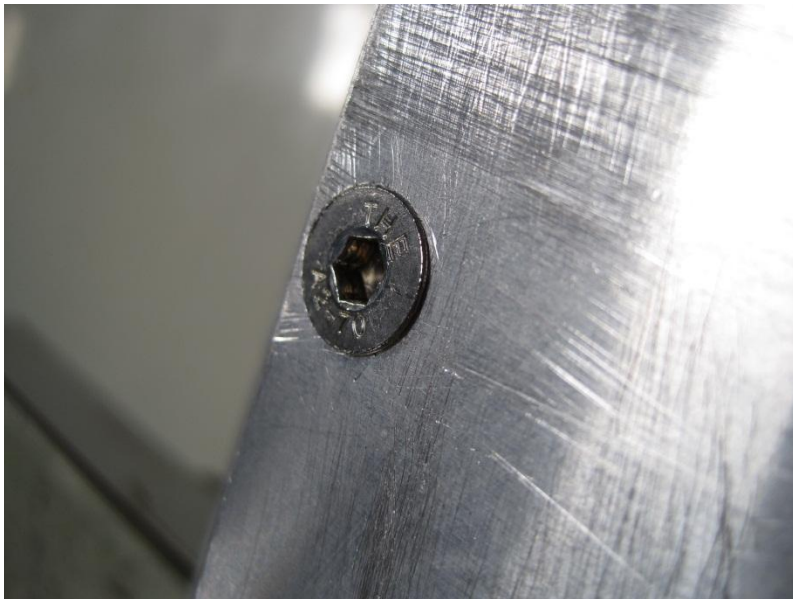
A perfect case

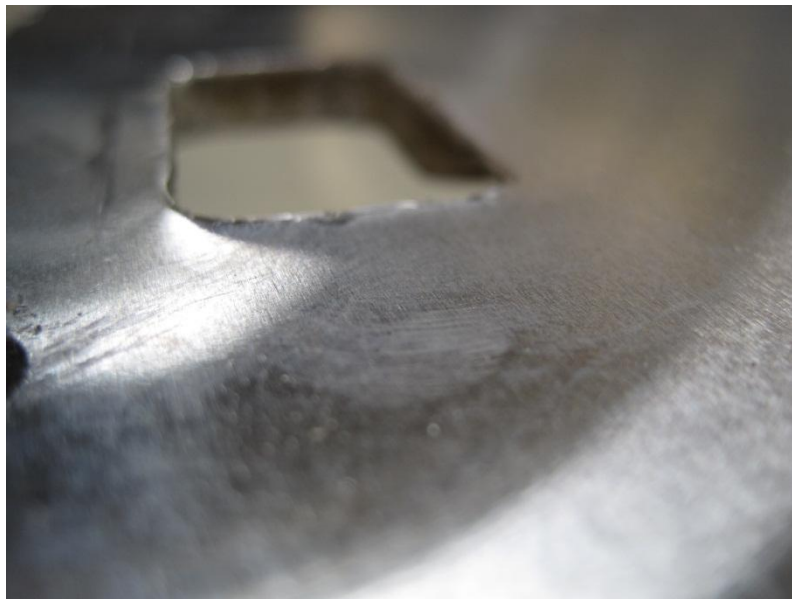
Below is an example of what will compromise the HV insulation and put pressure on the gap.

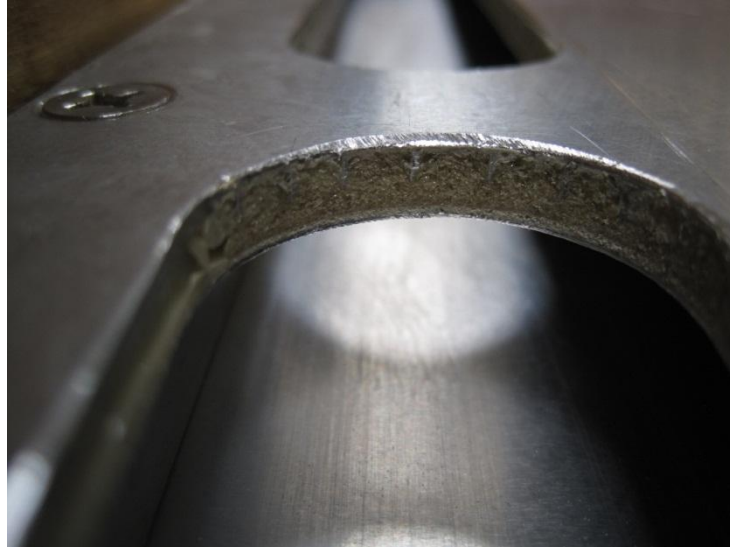
The chamfering is difficult to do correctly by hand but as shown below is sufficient.

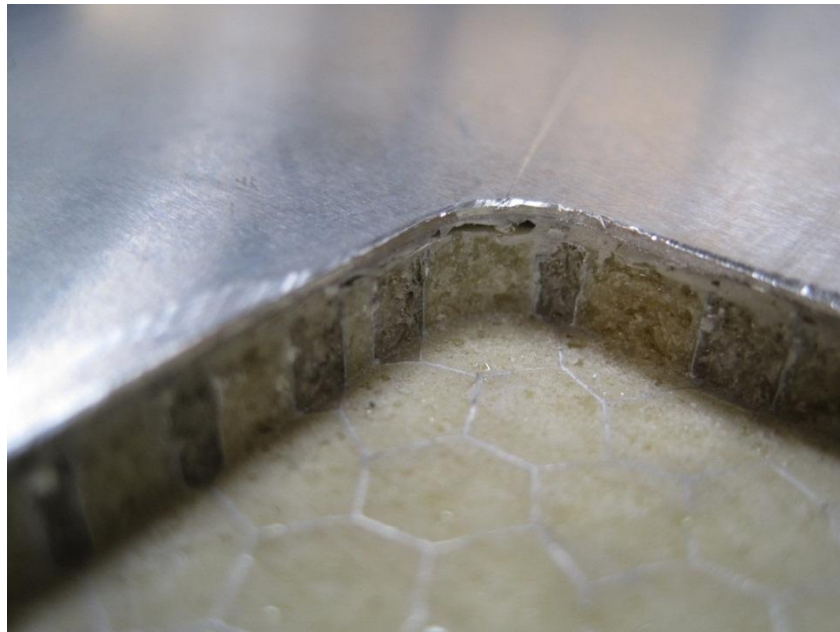
Here, below the chamfering is only just sufficient.

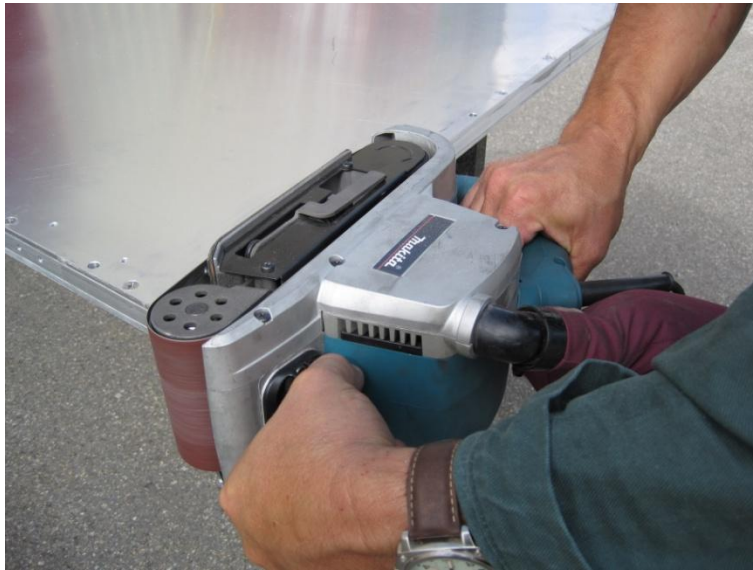
Removal of sharp edges to ensure the HCP and bars mate correctly and also injuries are avoided

These damaged edges are to be removed so that the HCPs and panel will mate properly, this will be done with a band sander and 80 grade abrasive paper.

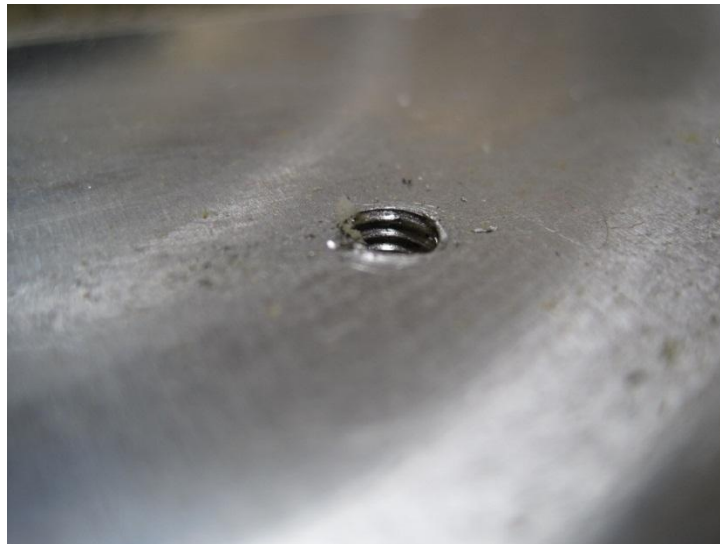
Threaded M5 holes on inner face, missing threads and chamfers

A sharp counter sink tool is used to remove the excess material

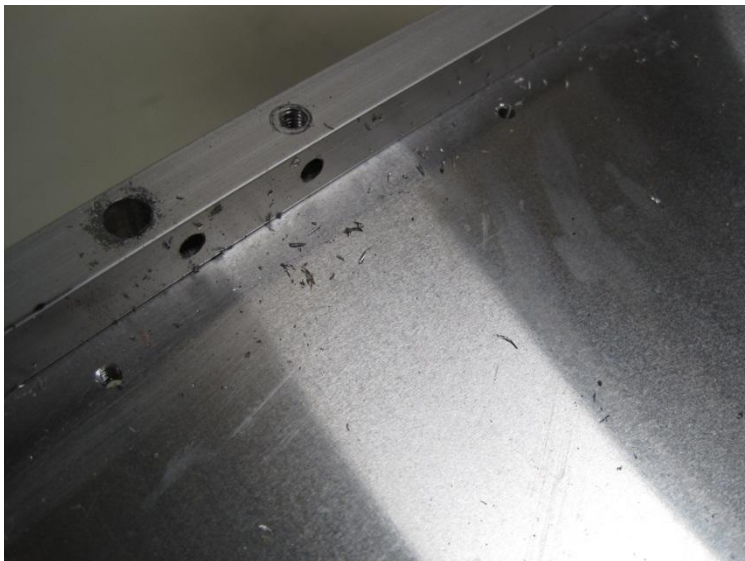
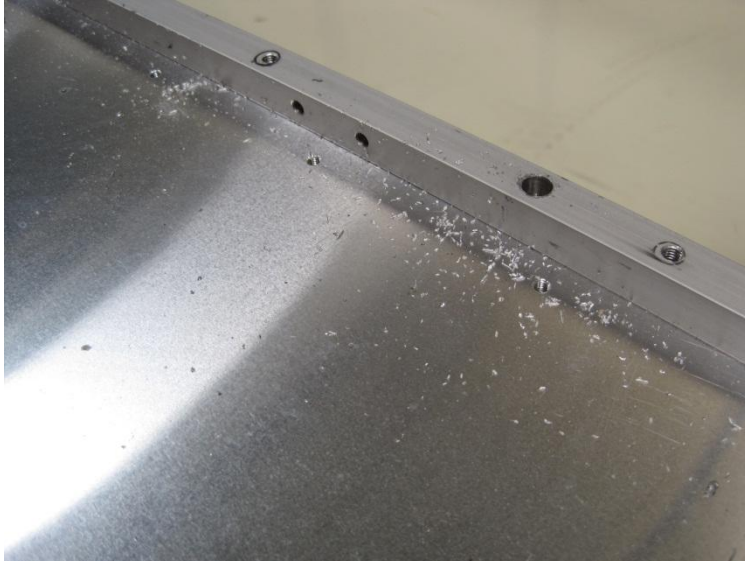
There is plenty of metallic debris in all chamber mechanics so far opened. This is associated with grease based smears, presumably from some cutting oil used during the drilling. All these products must be removed with a degreaser, whether hydro carbon based (Line 61 in the Chamber component list) or water (eg Typol, see the component list line number 60). Final cleaning is with IPA, clearly done after all the other corrective measures. A vacuum cleaner or compressed air can be used **ONLY** once all elements have been dissociated to avoid forcing debris into holes and interstices. Compressed air is dangerous and those involved should be informed and protected.

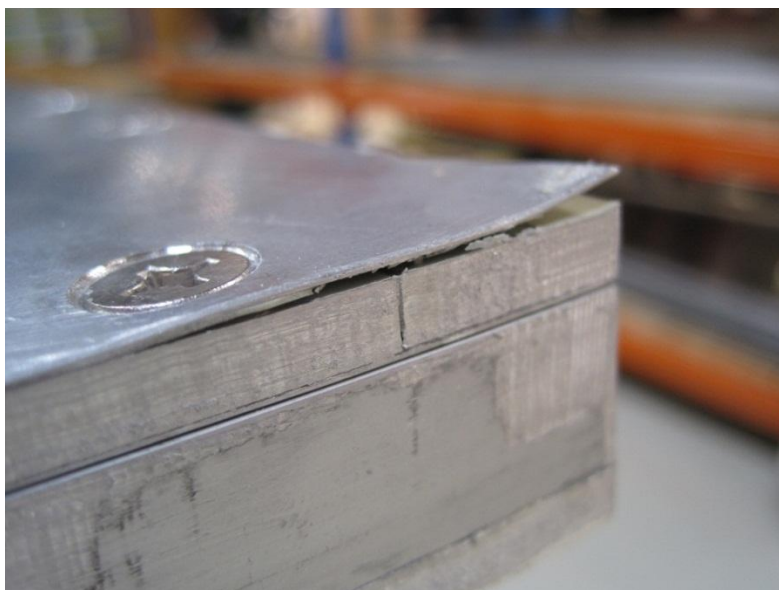
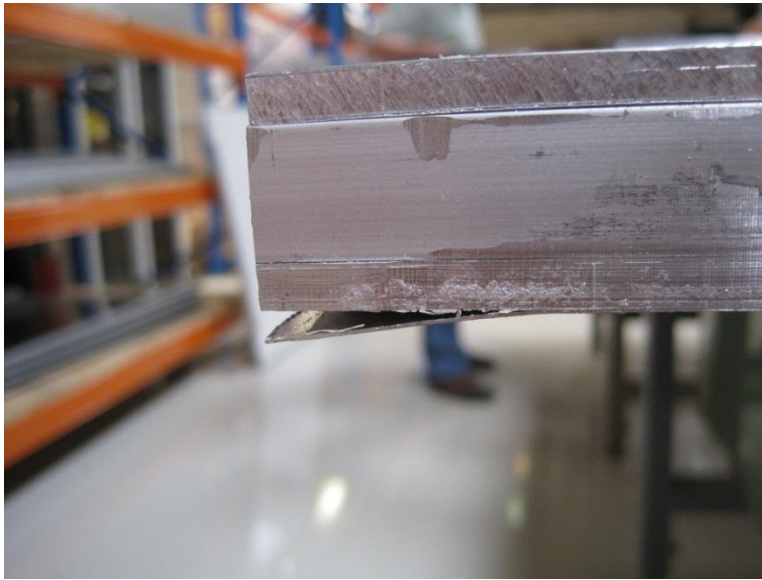
Recent faults, delamination. On the edges/corners perhaps aggravated by handling methods involving dragging across the bench/support. Other failures recently identified are bulging. The amplitude is significant wrt the space inside the mechanics for the gaps, namely 1.5mm in a number of locations on the inner faces of the HCPs. The number of affected mechanics will be known once all the retrofitting has been carried out.

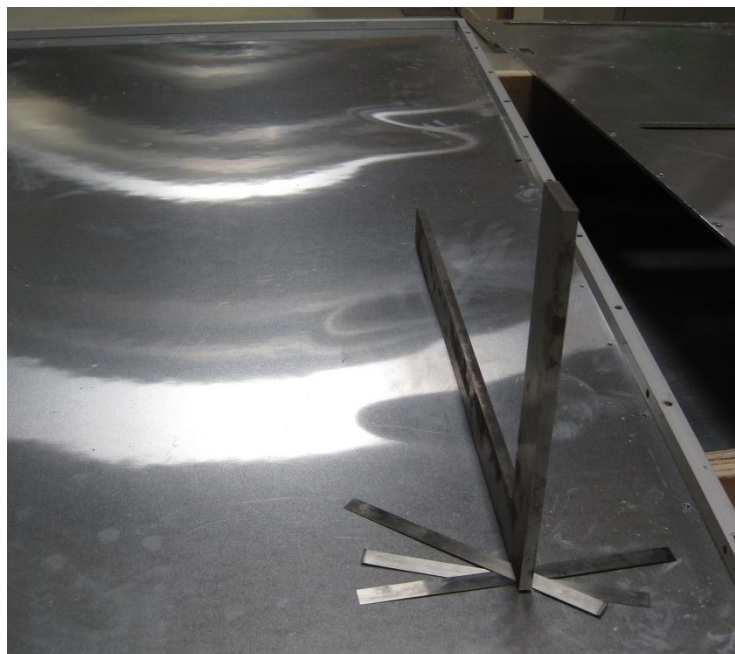
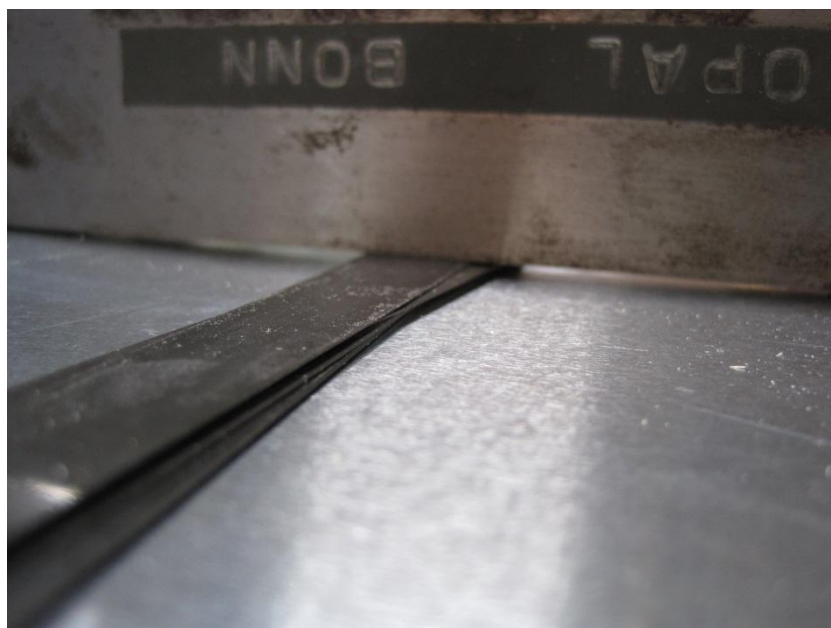
Large gap due to bugling or blistering

These panels should be rejected.

Recovery of this problem is perhaps possible but would involve drilling numerous holes in the skin, injecting an epoxy and pressing with a vacuum bag technique, as the panel sizes involved are serious. Care and an empirical approach would be needed to remove excess injected glue. Let's hope that this fault is not time dependant, meaning these errors will not appear in the future!

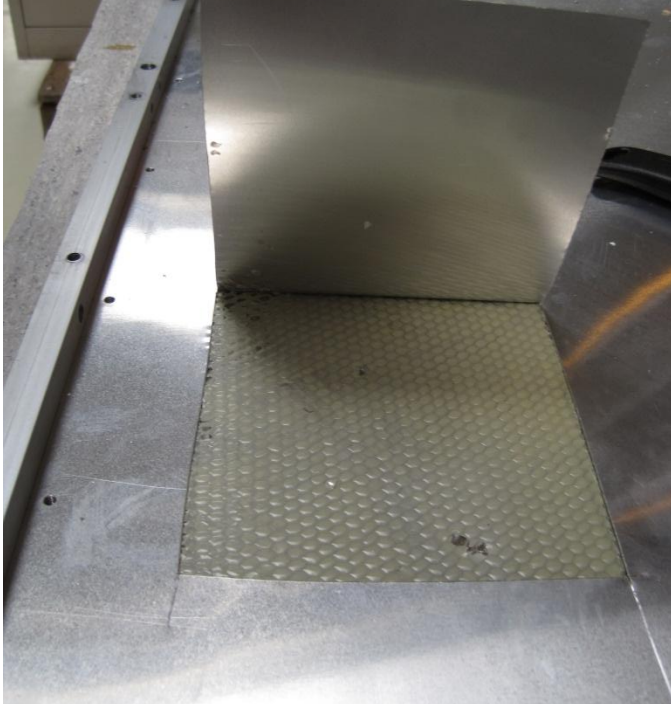
Opening of one panel with the worst case so far found (1.5mm) over an area some 300mm across.

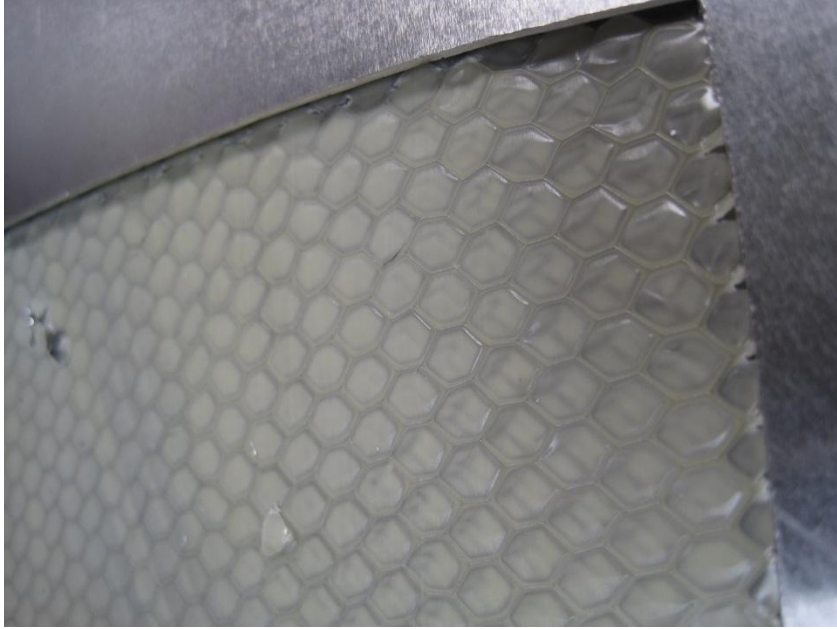
There is no indication of bonding in any of the exposed area.

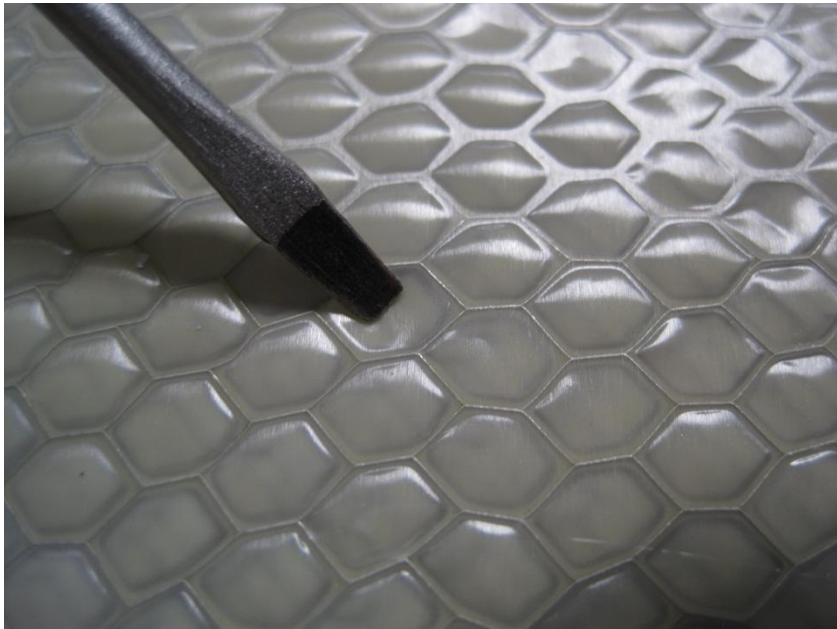
Below indications of an over pressure wrt atmosphere here at CERN. The fabrication was probably done at a lower altitude.

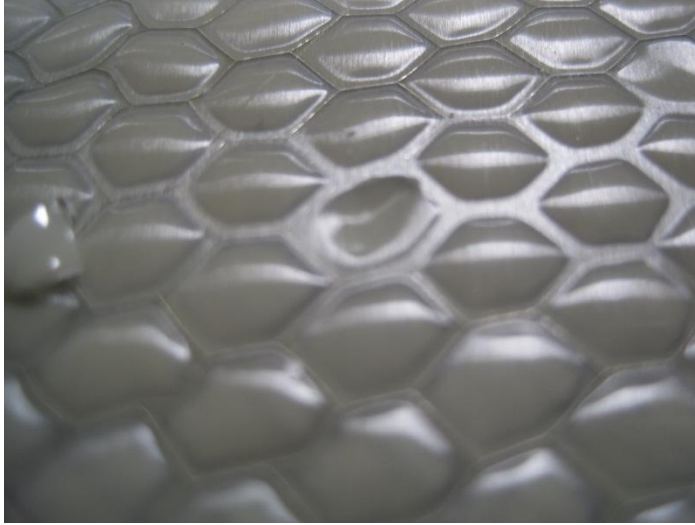
If the adhesive skin is punctured the surface is no longer elastic

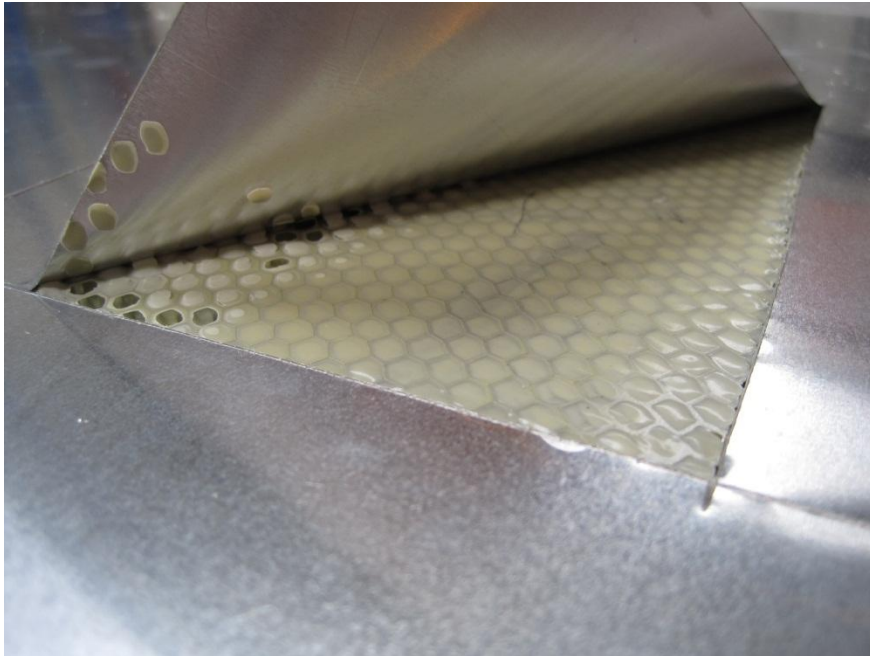
It is of concern that what should be bonded is not only over a smaller area. The bonded area is indicated by the torn open cells.

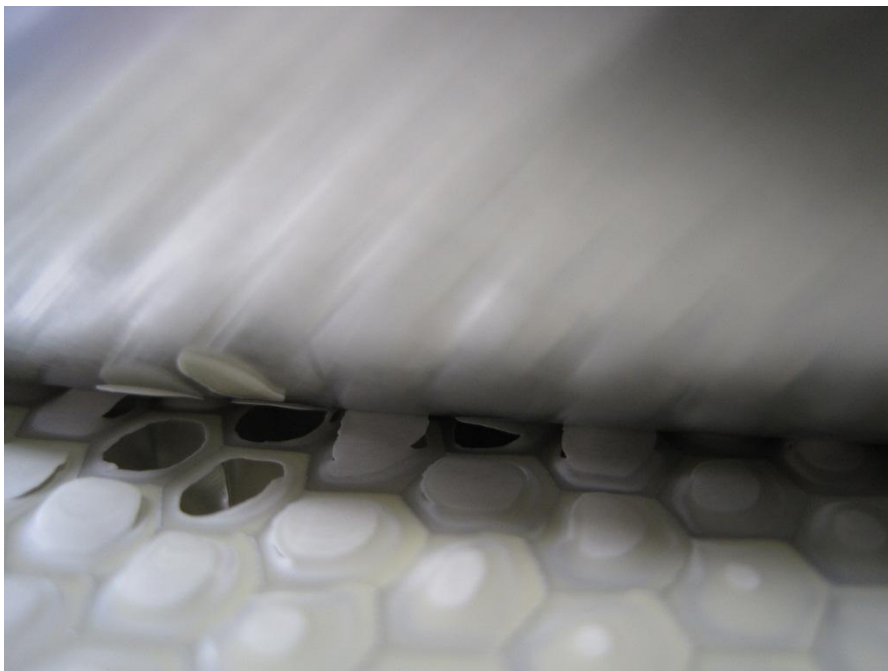
It is clear that the adhesive , after opening , is not attached over the full area of the cell, this may be due to over pressure inside the cell or partial failure of the alum/adhesive interface. Insufficient pressure during the full cure time of the adhesive may also produce such faults, namely incomplete bond area.

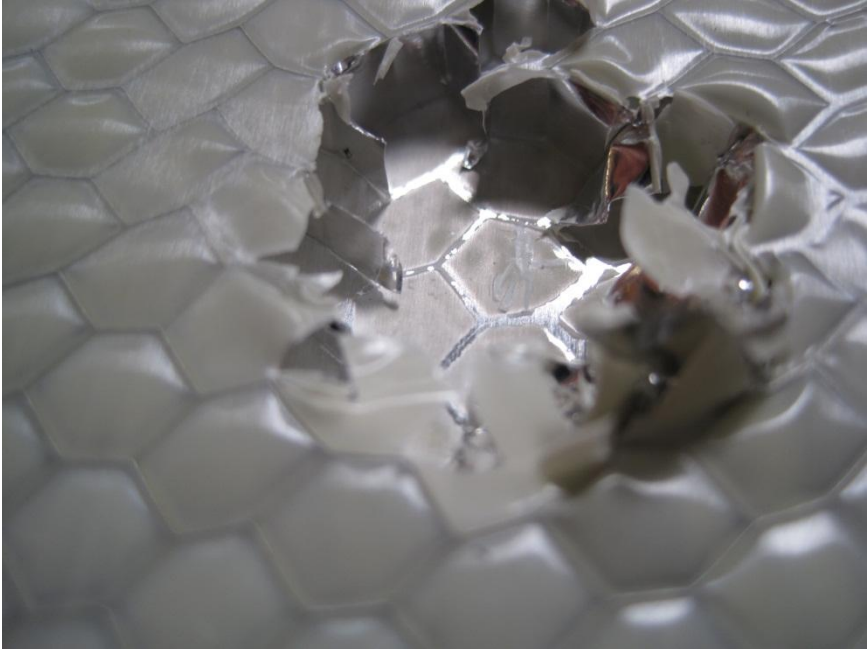
Going back to the fully unbonded area, on the opposite face, under the opened one, the bond is good over the entire surface, negating the previous argument.

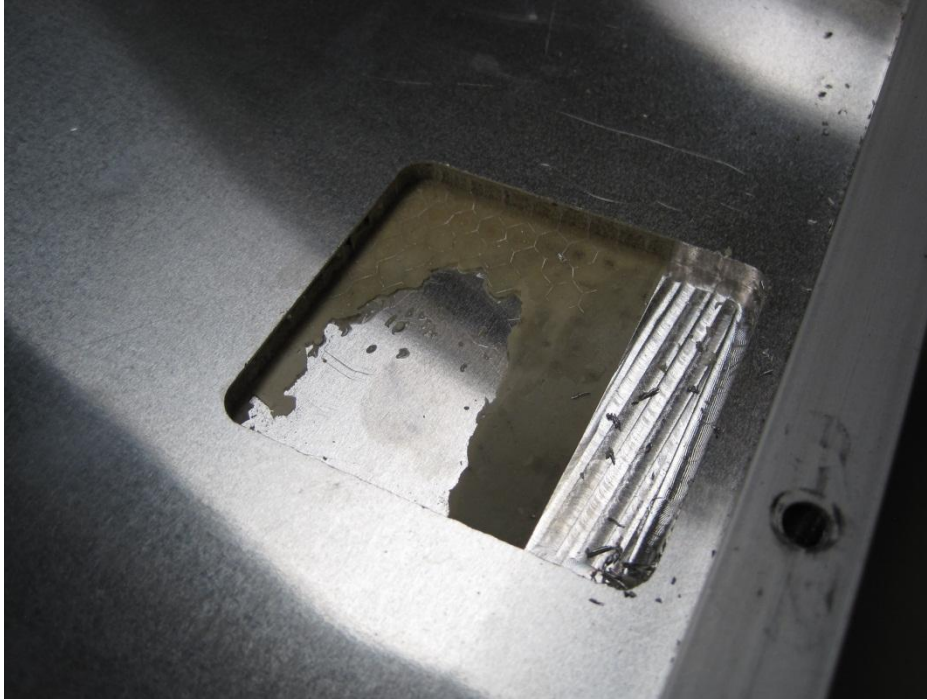
Other nonbonded areas are to be found around the cut-out slots as shown. This could be argued as coming from the pressure exerted during the machining.

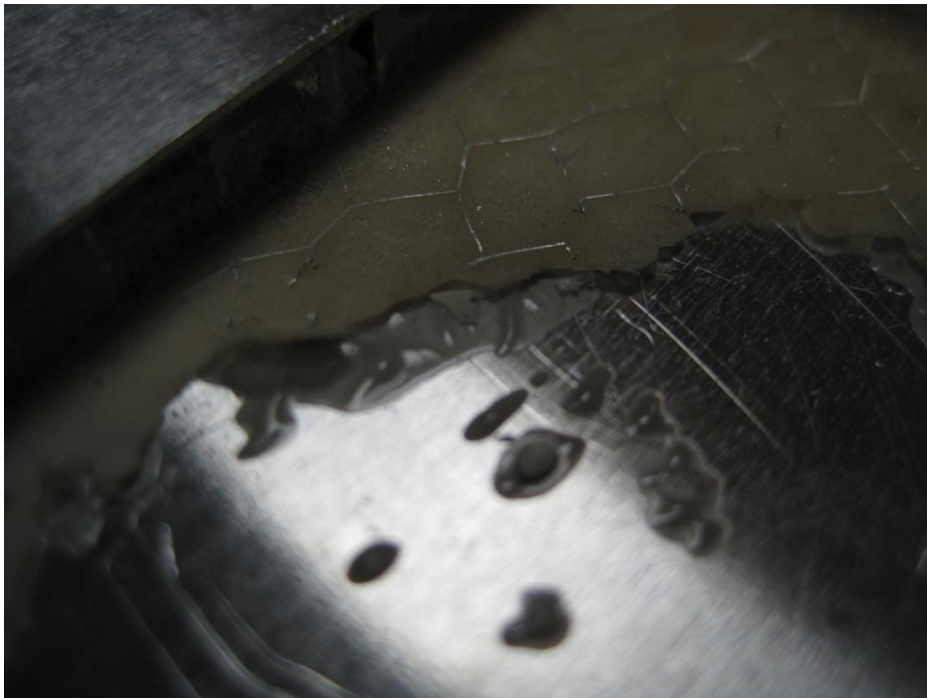
Here in the centre there are indications of a good bond but a thick layer of adhesive, poor pressure application ?

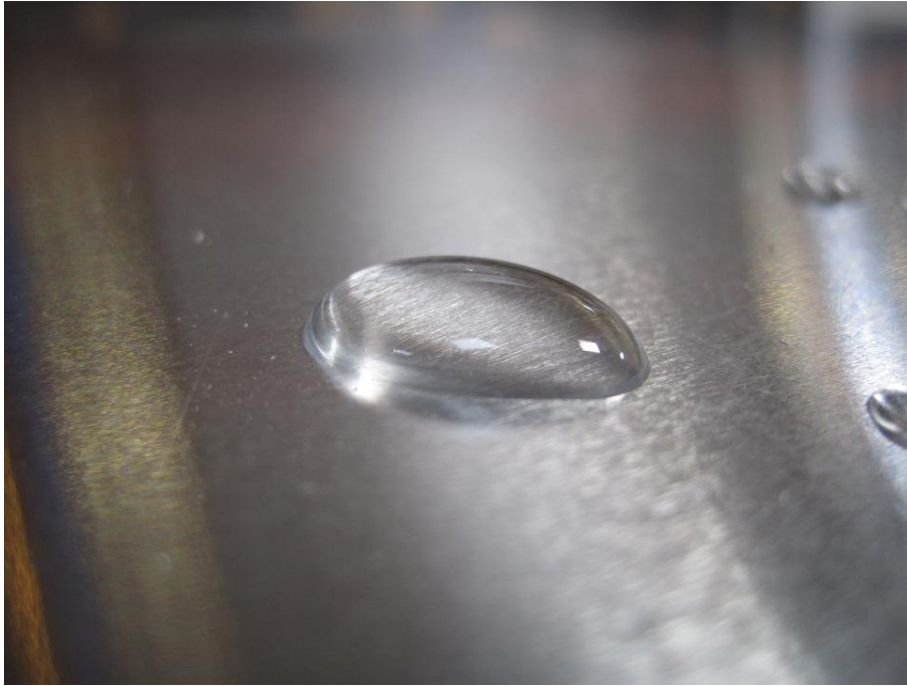
Water on the outer surface of the panel, illustrating a high contact angle.

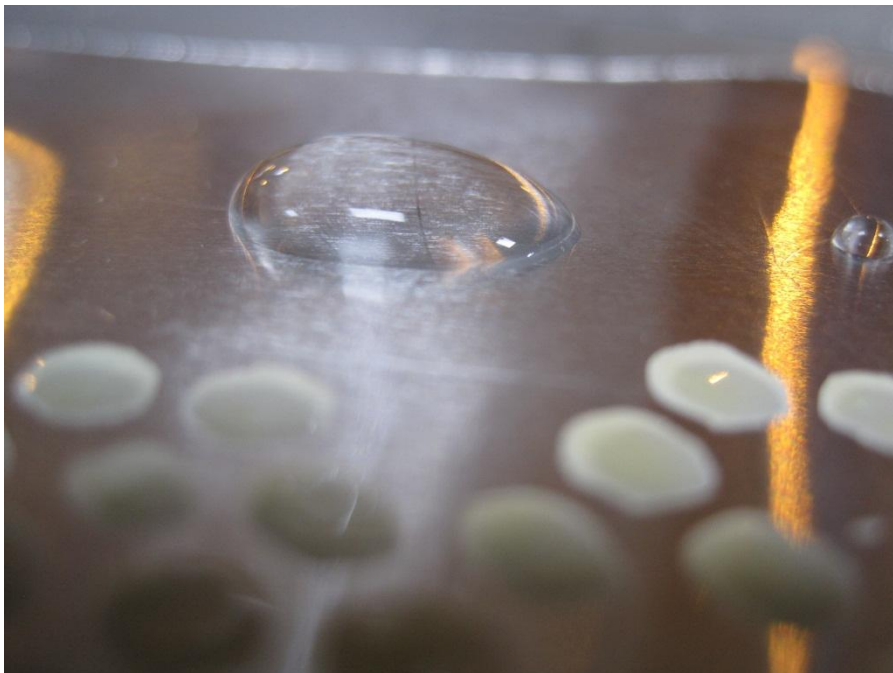
Next to the bonded area the contact angles are similar to the untouched outside surface indicating minimal surface preparation.

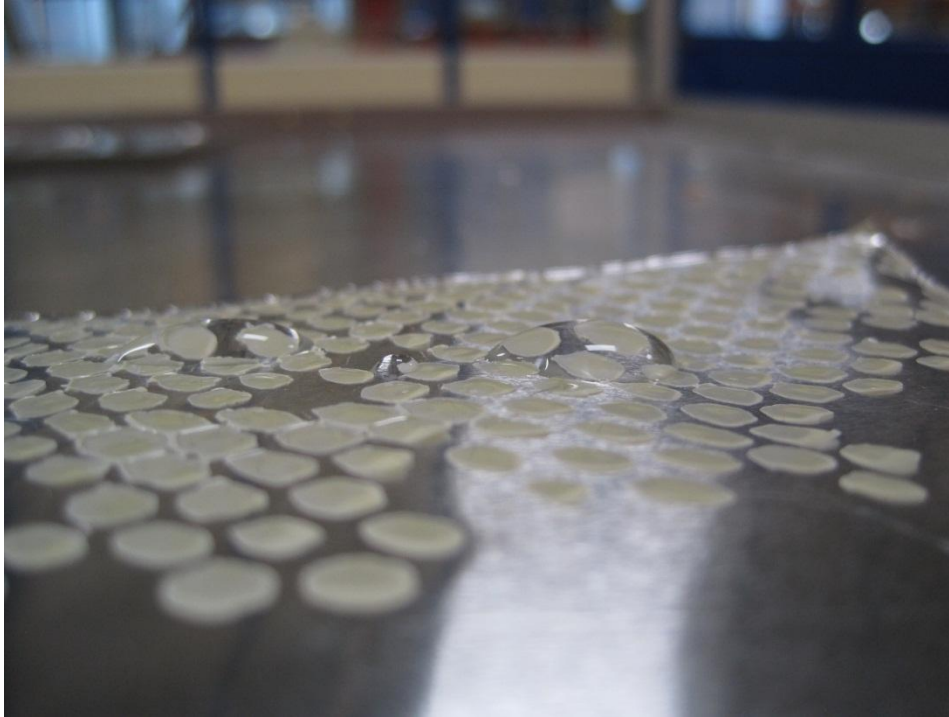
That is similar to the bonded area, so here is also minimal preparation.

It would appear that very little surface preparation has been carried out before HCP manufacture.

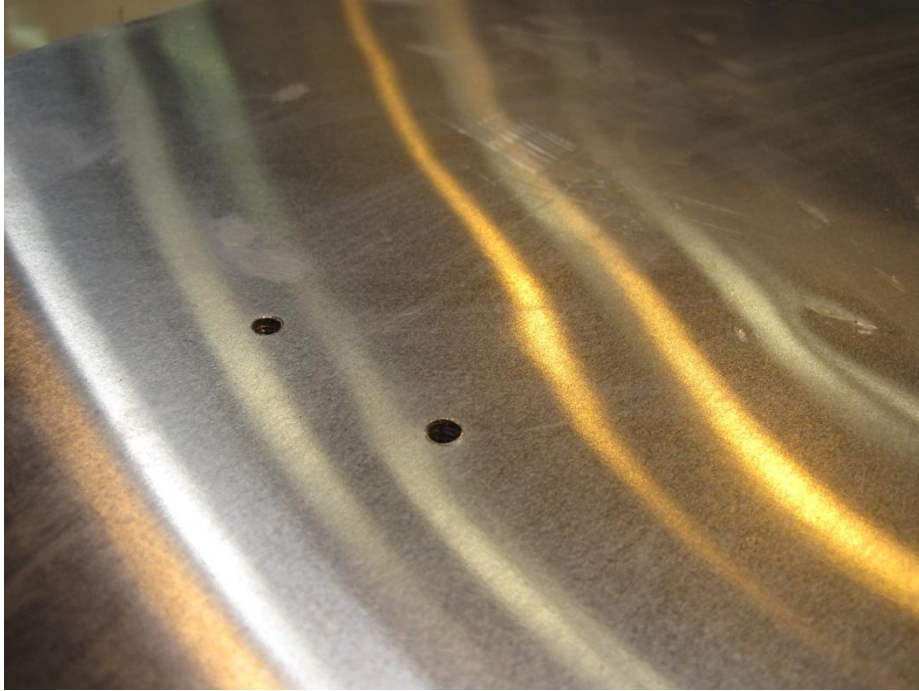
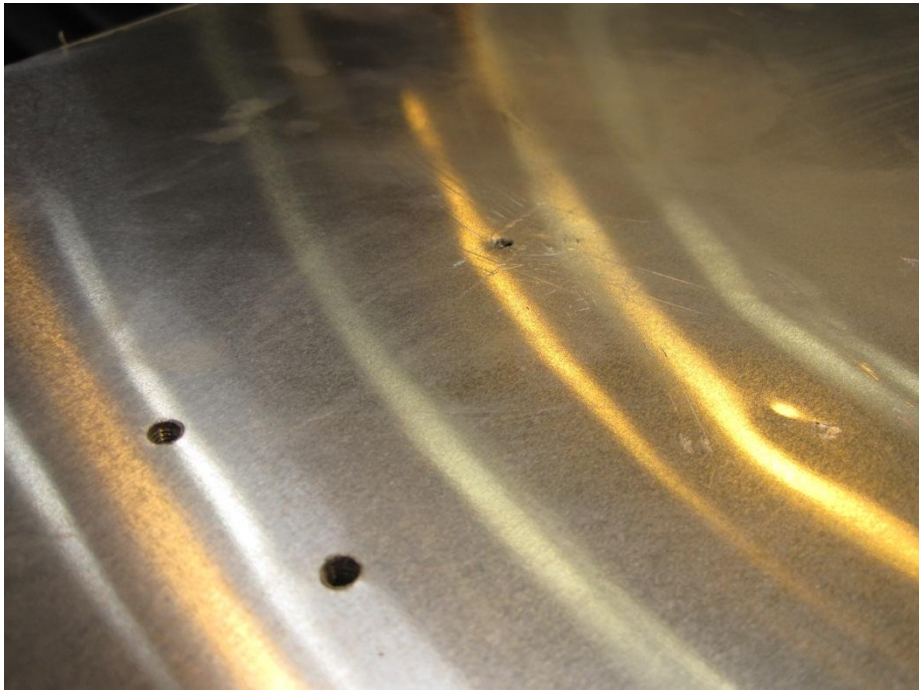
Here is a relatively small example; the yellow reflection gives some idea of the deformed area, before;

Numerous holes were drilled in approx. 5 blisters and in almost all the blister could be made to collapse.
