New CPE 3 Pole HV connector

Inspected on 13 Jan 2012

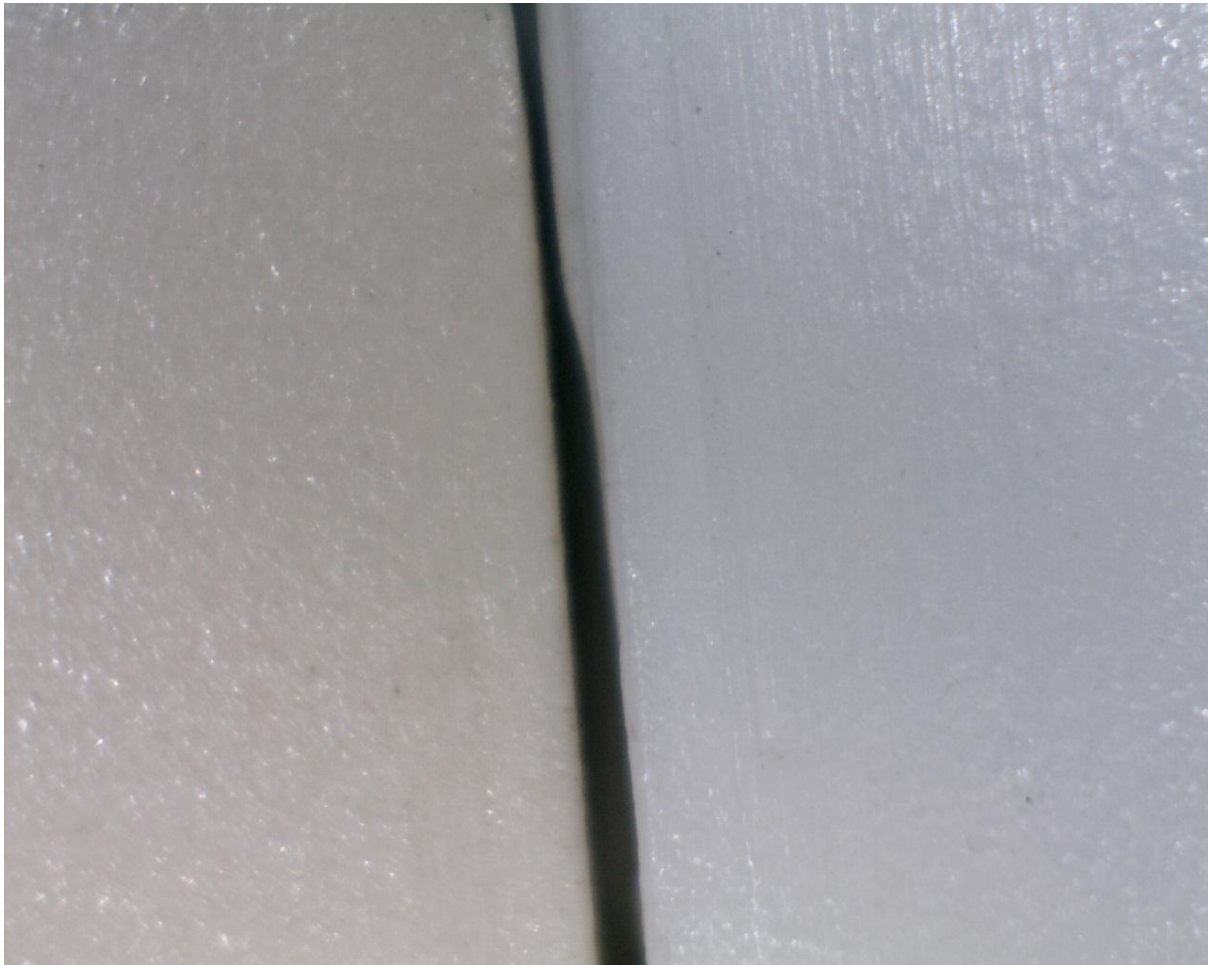
The moulding geometry seems identical to all previous versions. However the colour is of a more fawn hue with less reflection in the visible light range.

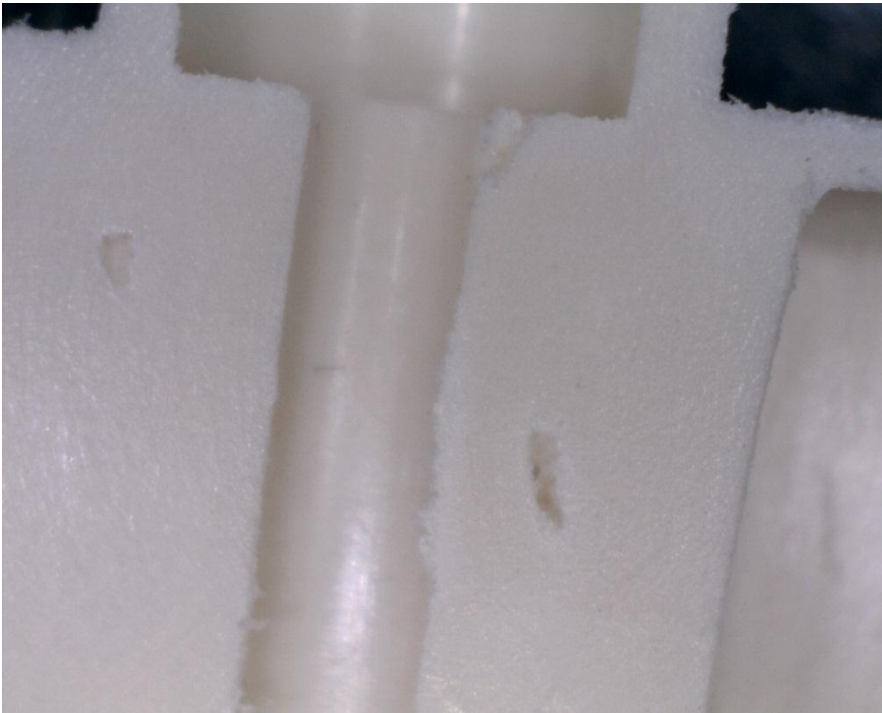
The void size is clearly smaller than all other versions $\sim 0.2\text{mm}$.

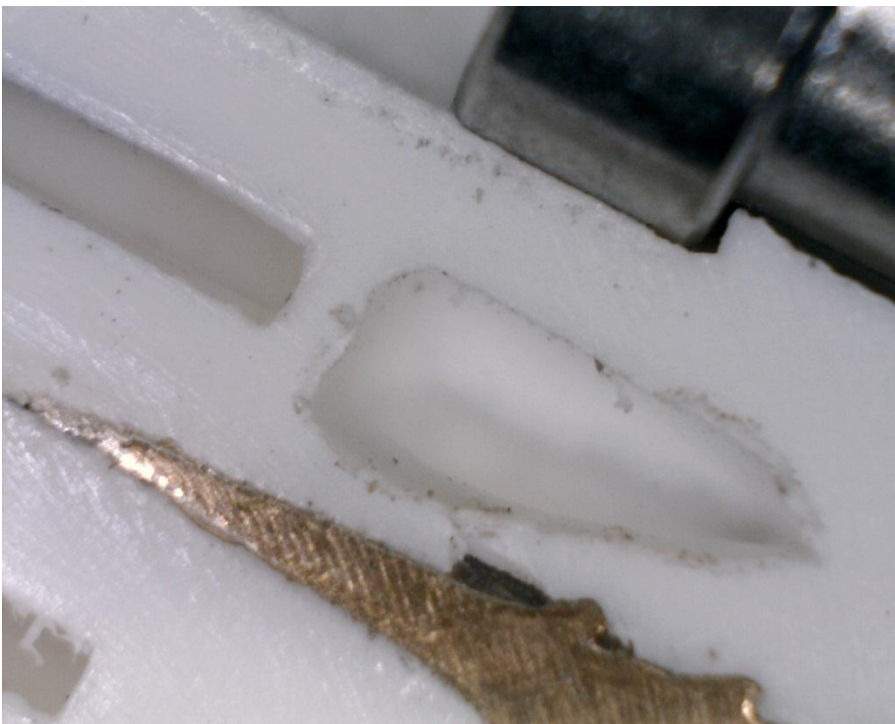
The older versions $>1\text{mm}$;

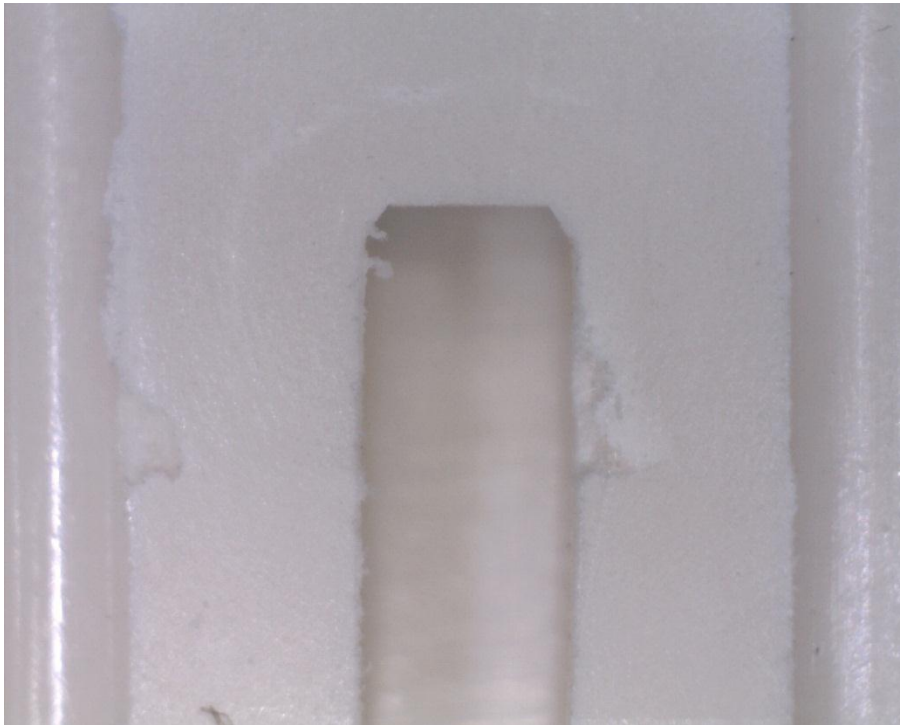
However there are other defects on the insides of the mould;

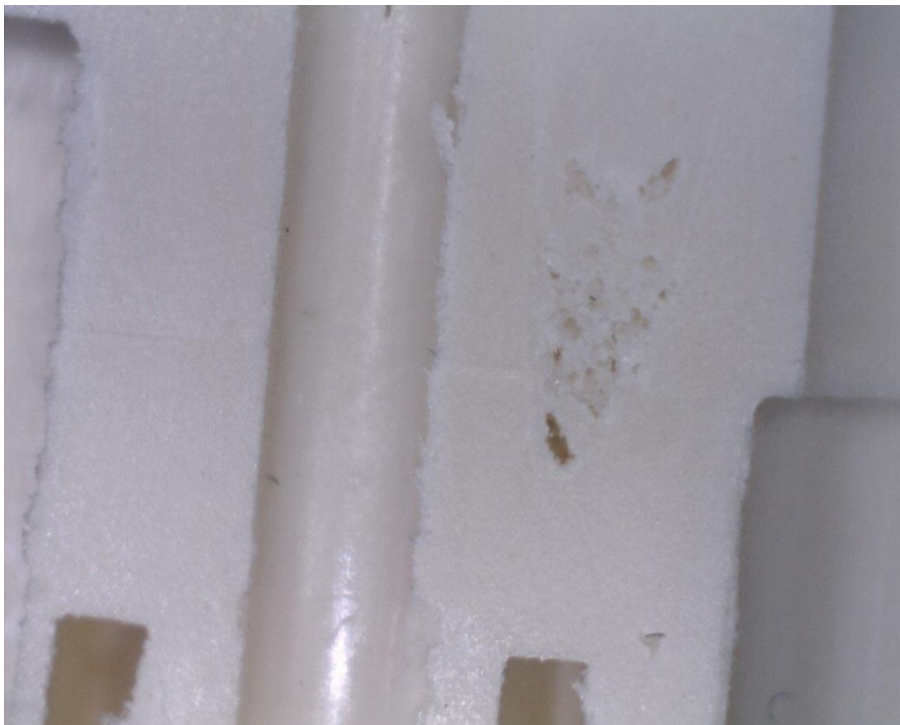
Porosity over 0.9mm in length.

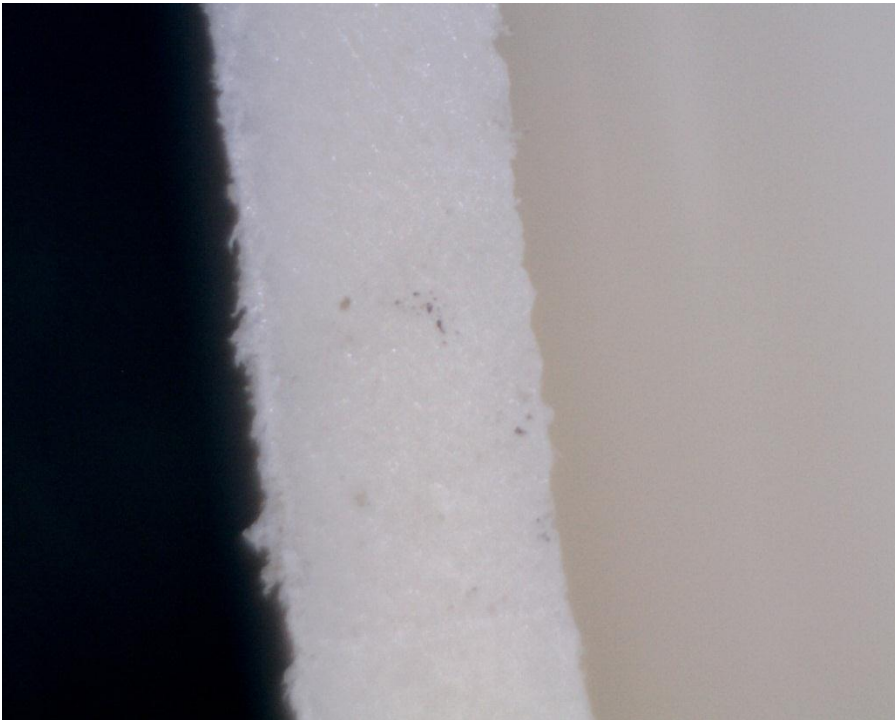
Closer inspection reveals rough surfaces ?;

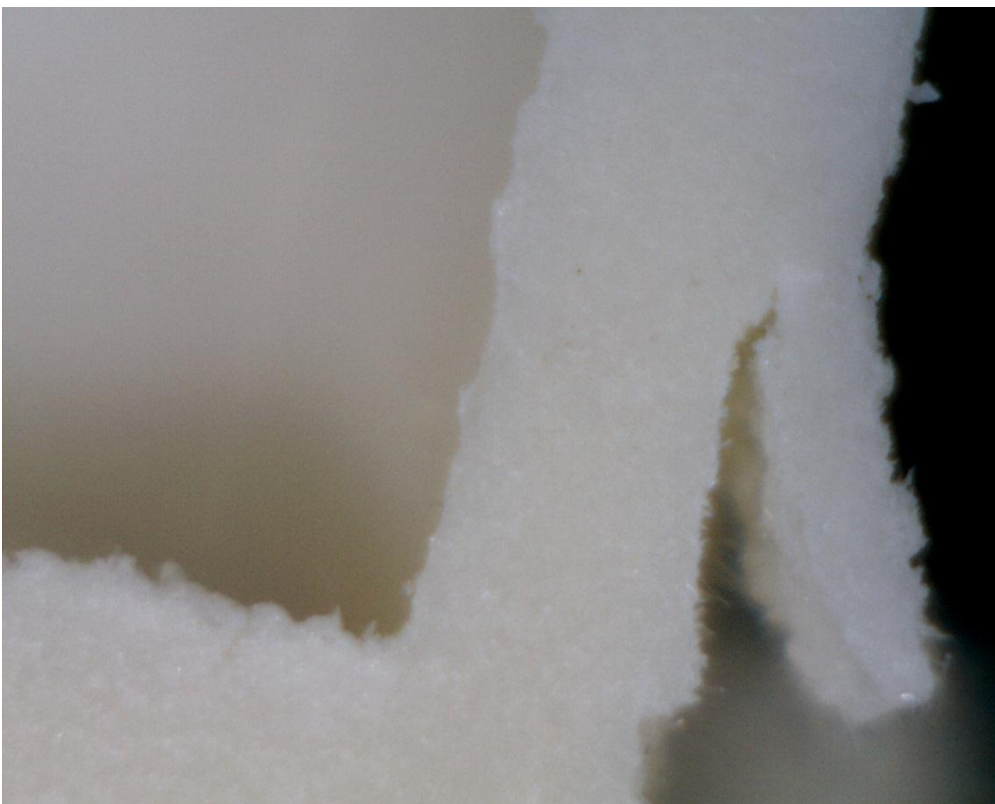
And brittle fracture growth.

It would appear that the new version has been heat treated in a manner to form excess crystal growth, in an attempt to make the material more fluid for better mould filling as opposed to the older versions that remain more amorphous. The higher crystalline content may decrease electrical conductivity while reducing breakdown voltage.

I would not recommend this material/heat treatment for the 3 pole HV connector.

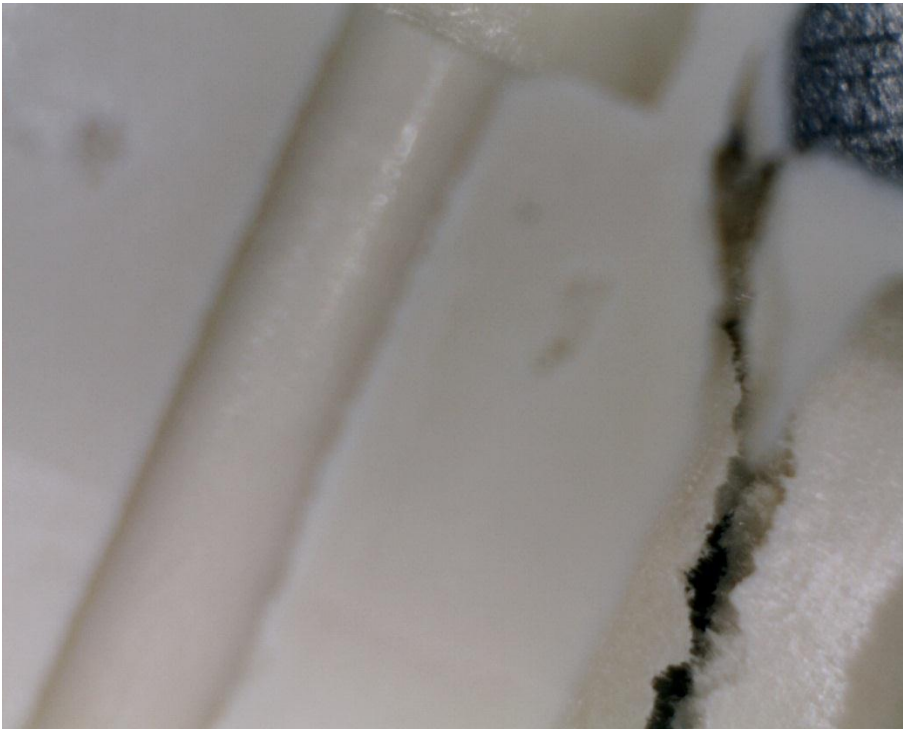
The pieces are non-pliable, unlike the older versions that are very elastic.

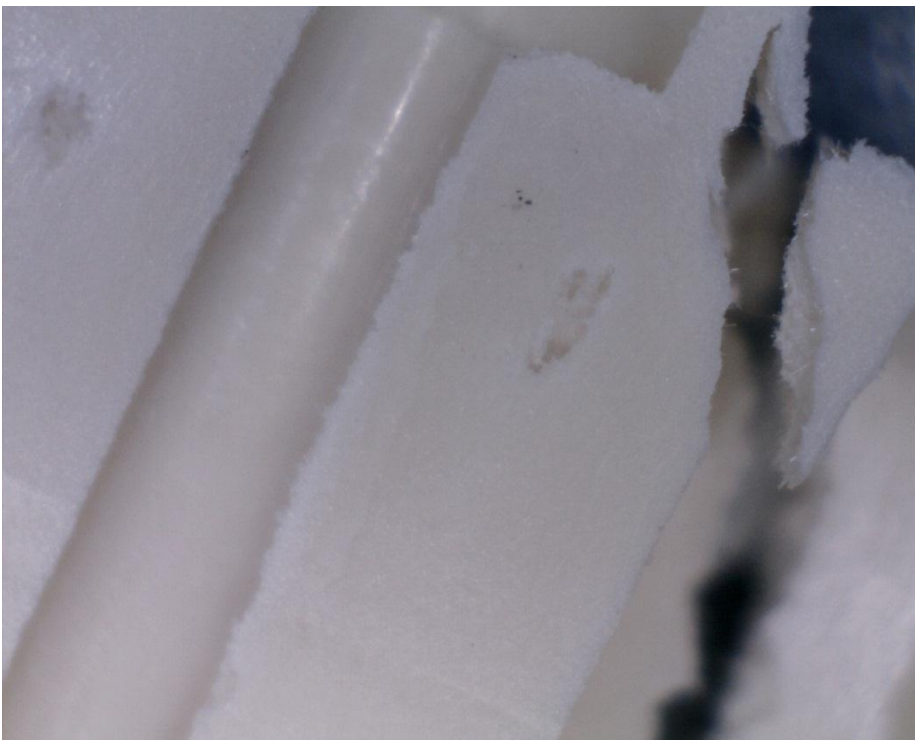
Brittle fracture is evident with low strength.

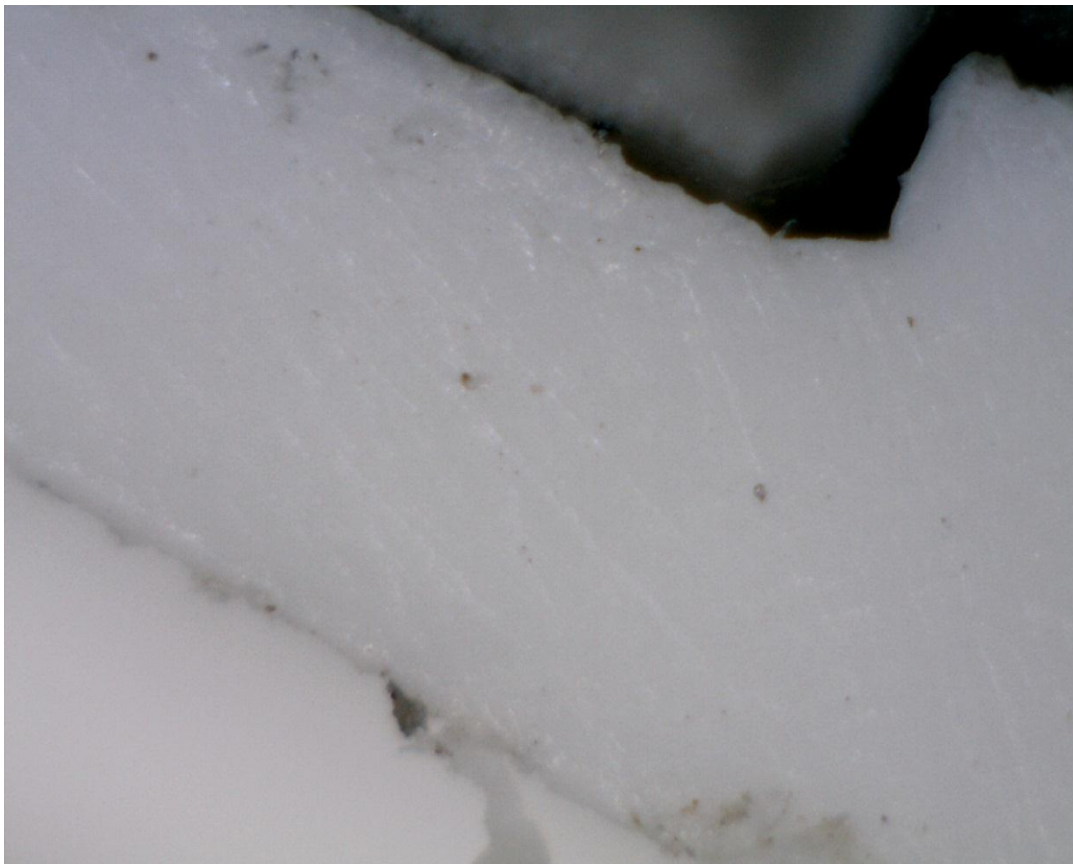
In comparison to the older versions;
