Inspection of new 3 Pole moulding from C.P.E. Milano

22 March 2013

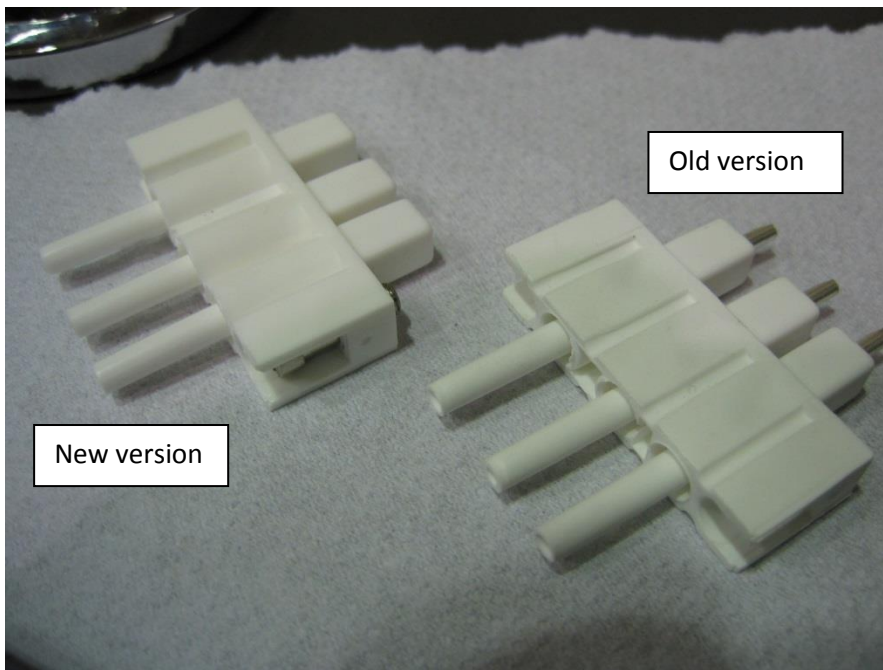
The moulding geometry has changed.

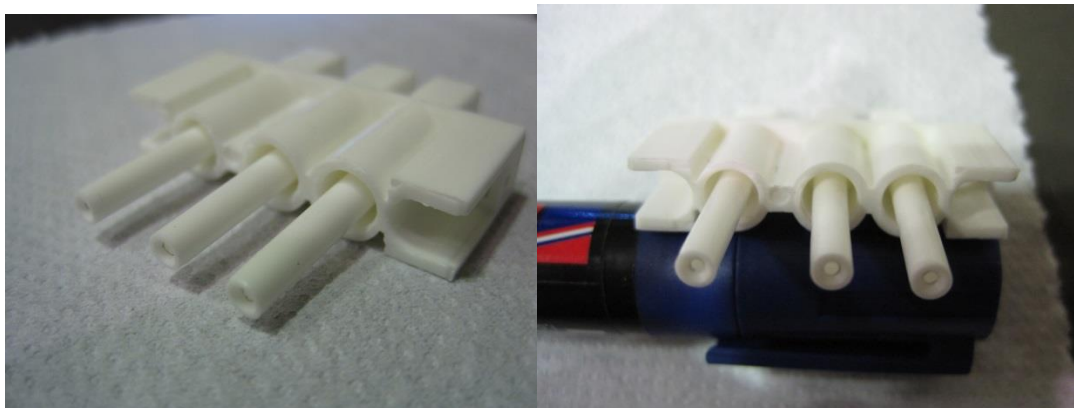
The new version

Moulding differences.

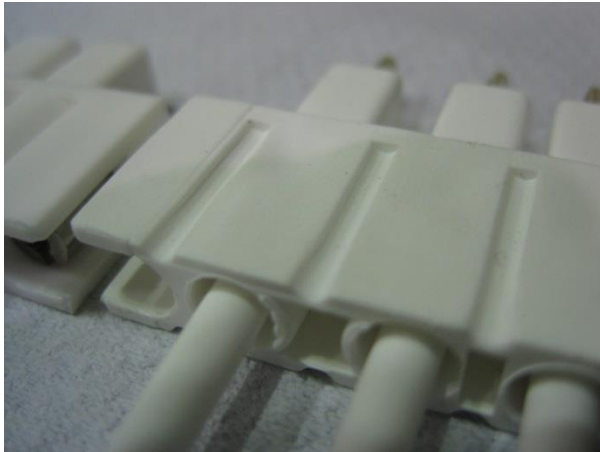
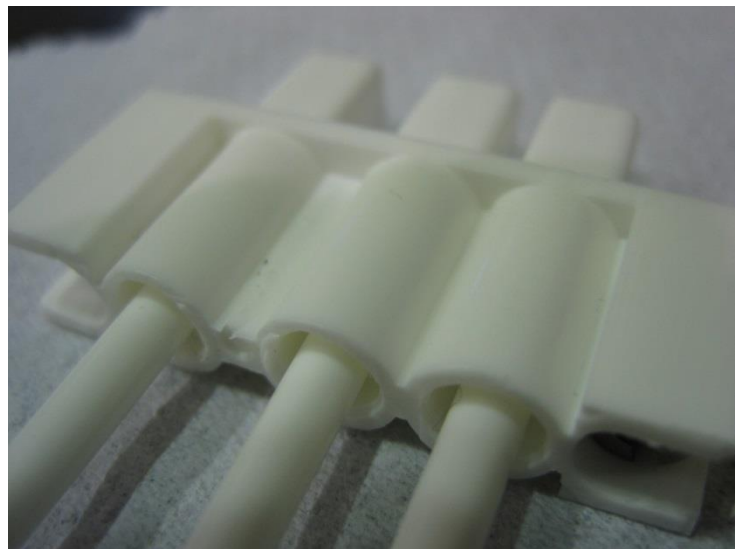
On the left the old version has flat areas over the pin areas where voids have been noticed with a lack of depression. On the right the area around the pin is coaxial with little area/volume for shrinkage or contraction to occur as the thickness of material remaining is small.

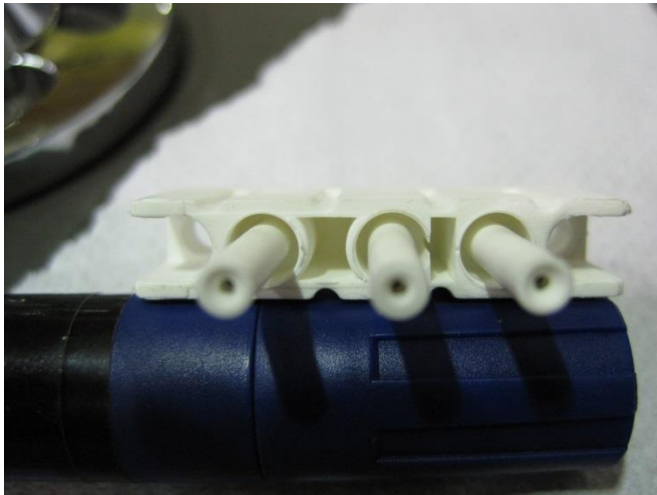
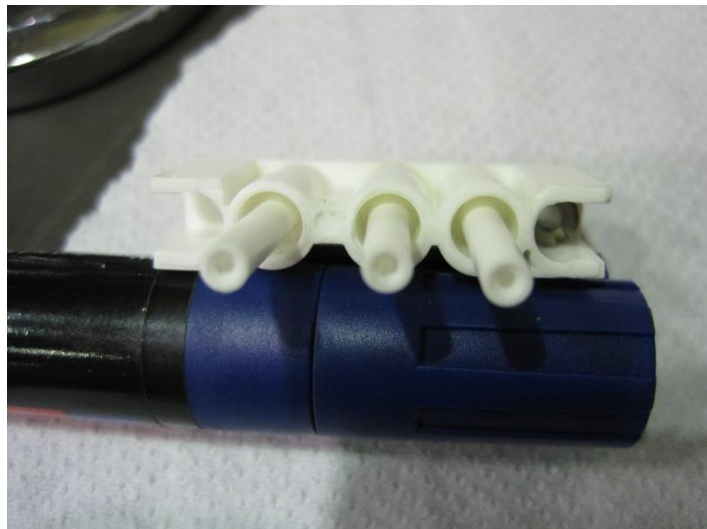
Different views, end on, showing that the intentional cavities between the pins has on the old version has now been removed and put into the “rear” of the connector where the potting will occur.

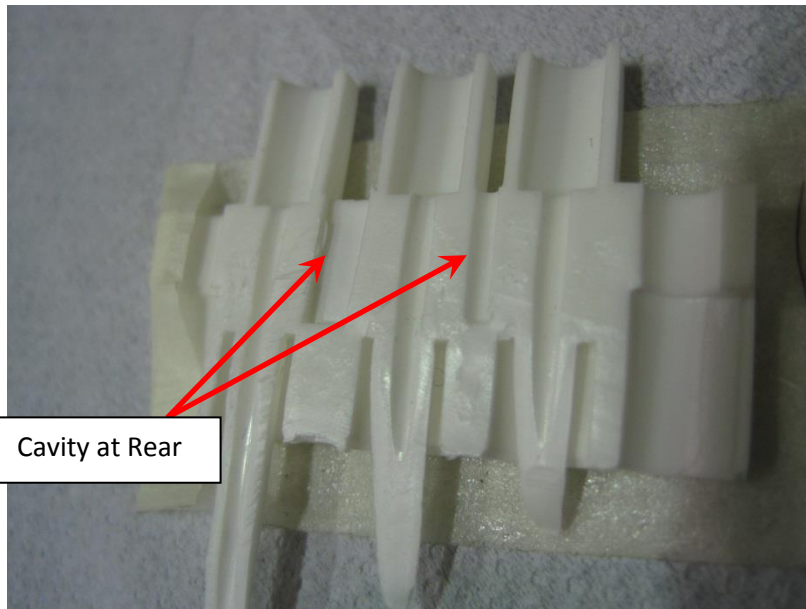
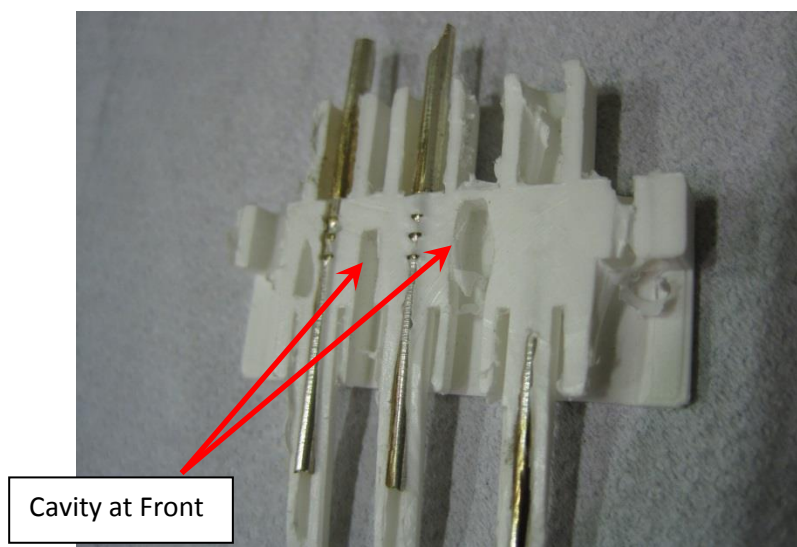
The connector cut open shows the entry of the cavities between the pins has moved to the rear of the connector.

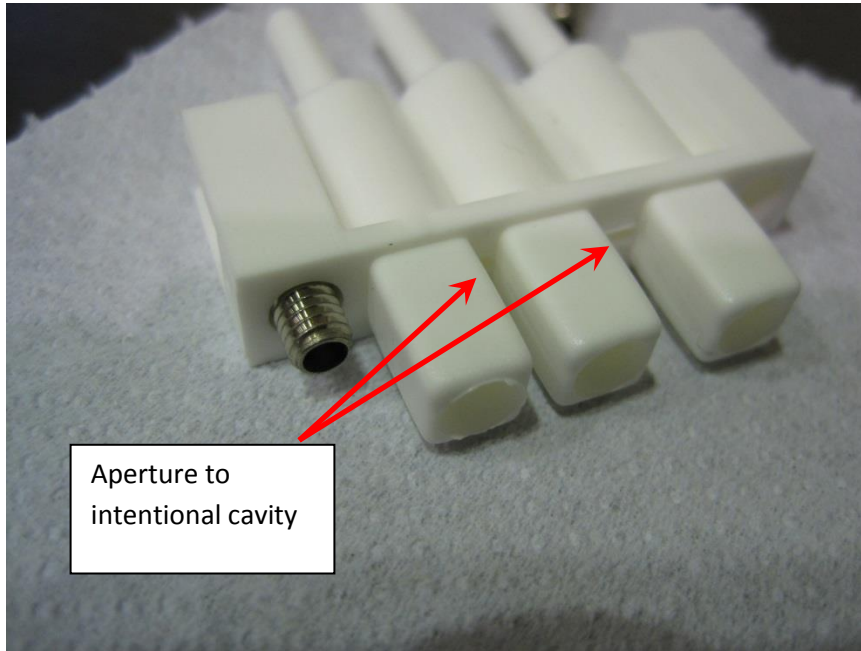
This then leaves rather small apertures (see below) for the potting liquid to enter and the air to escape. If the air cannot escape cavities will remain. This is in the area, as before, of the barbs on the pins, see later comments. In the new version the possible cavities will be more controlled in size.

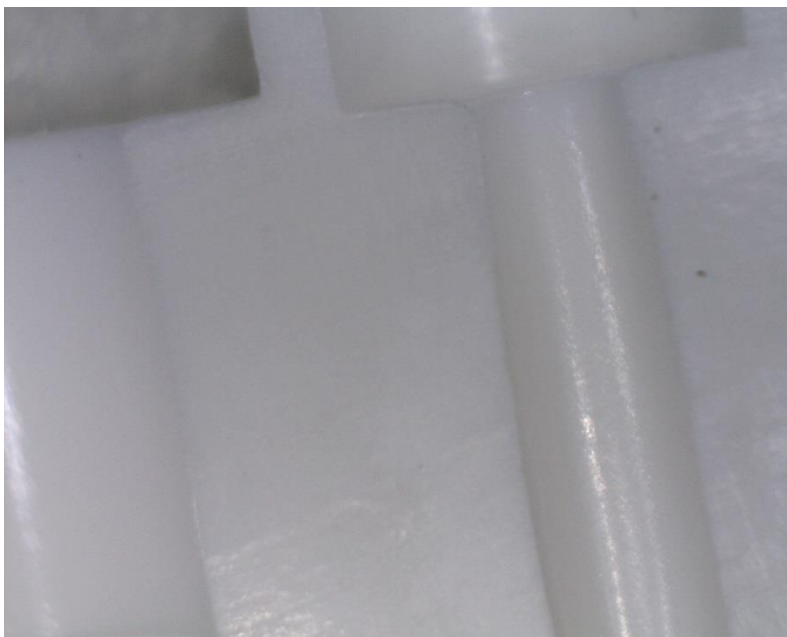
Voids due to poor moulding between outer pins and securing pins

The area can appear to present no indications of voids

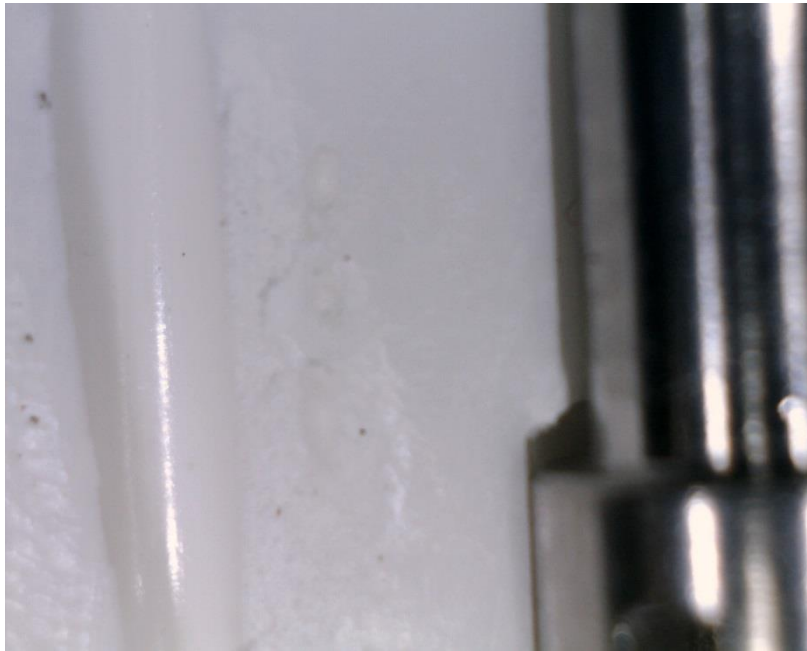
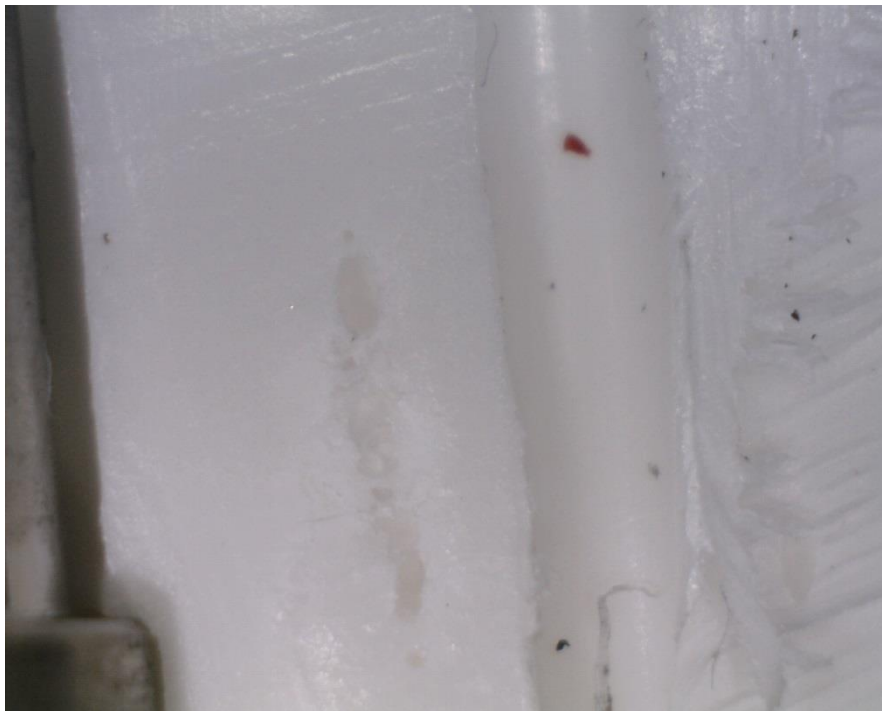
However of the 3 connectors opened, there are visible voids of smaller size than before.

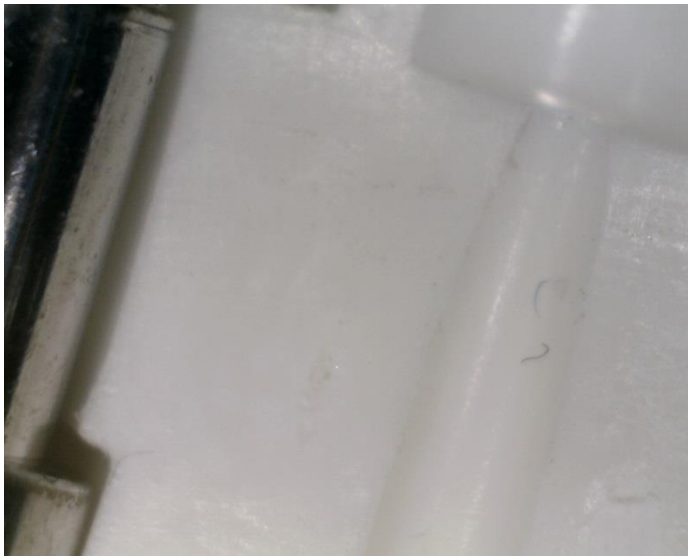
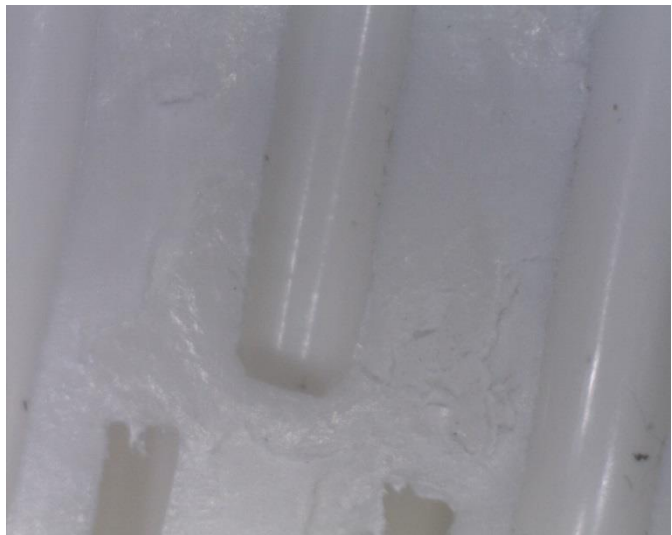
Another connector with possible void

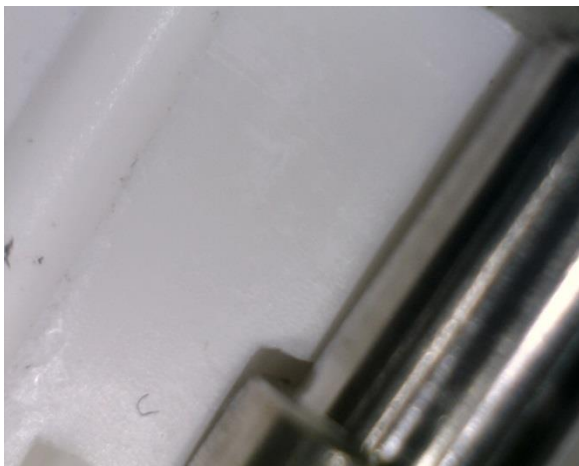
And nothing.....

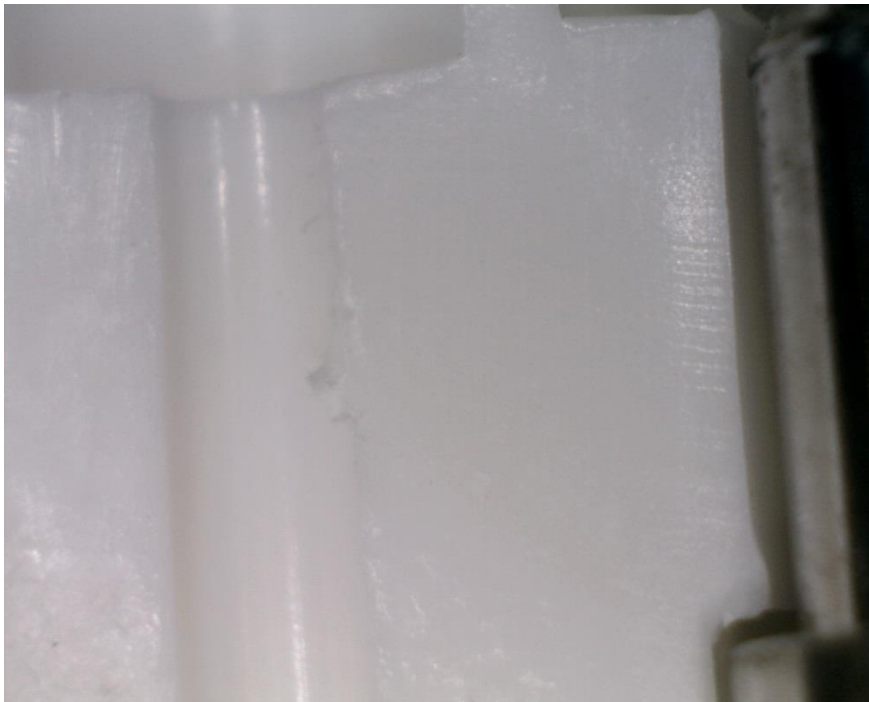
The third connector appears clean

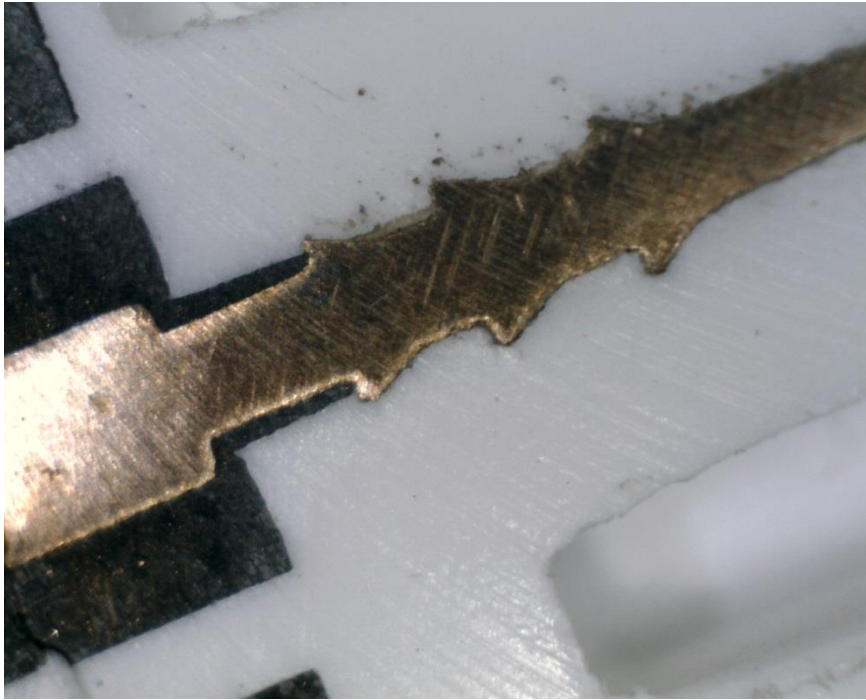
Sharp pin edges

The Napoli technicians pointed out that the barbs, necessary to secure the pins against axial thrust, are sharp edged. These should be rounded to avoid high fields.

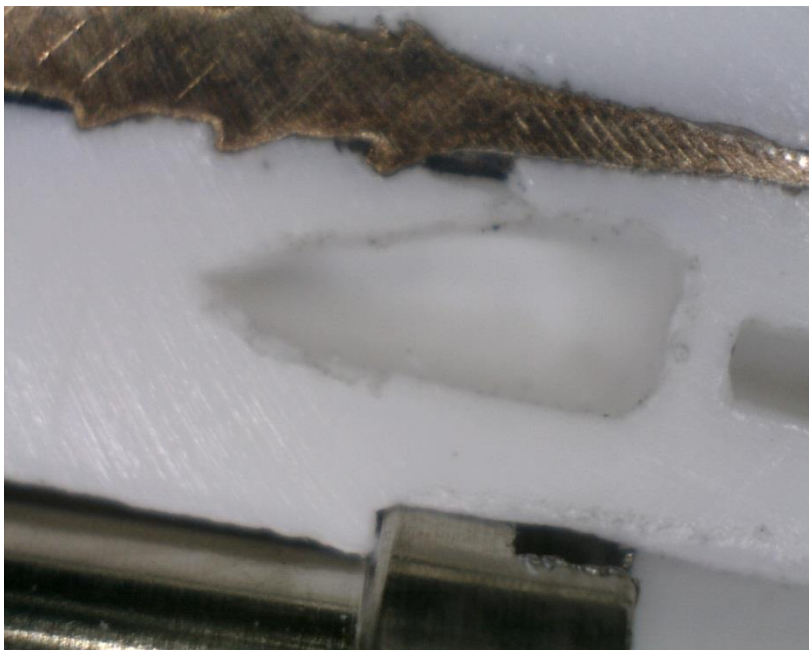
These are in proximity to the voids and the securing pins. The pin itself is not sharp edged BUT the screwdriver slot is not deburred AND has been damaged by the tool (too small ?) used to tighten the pin.

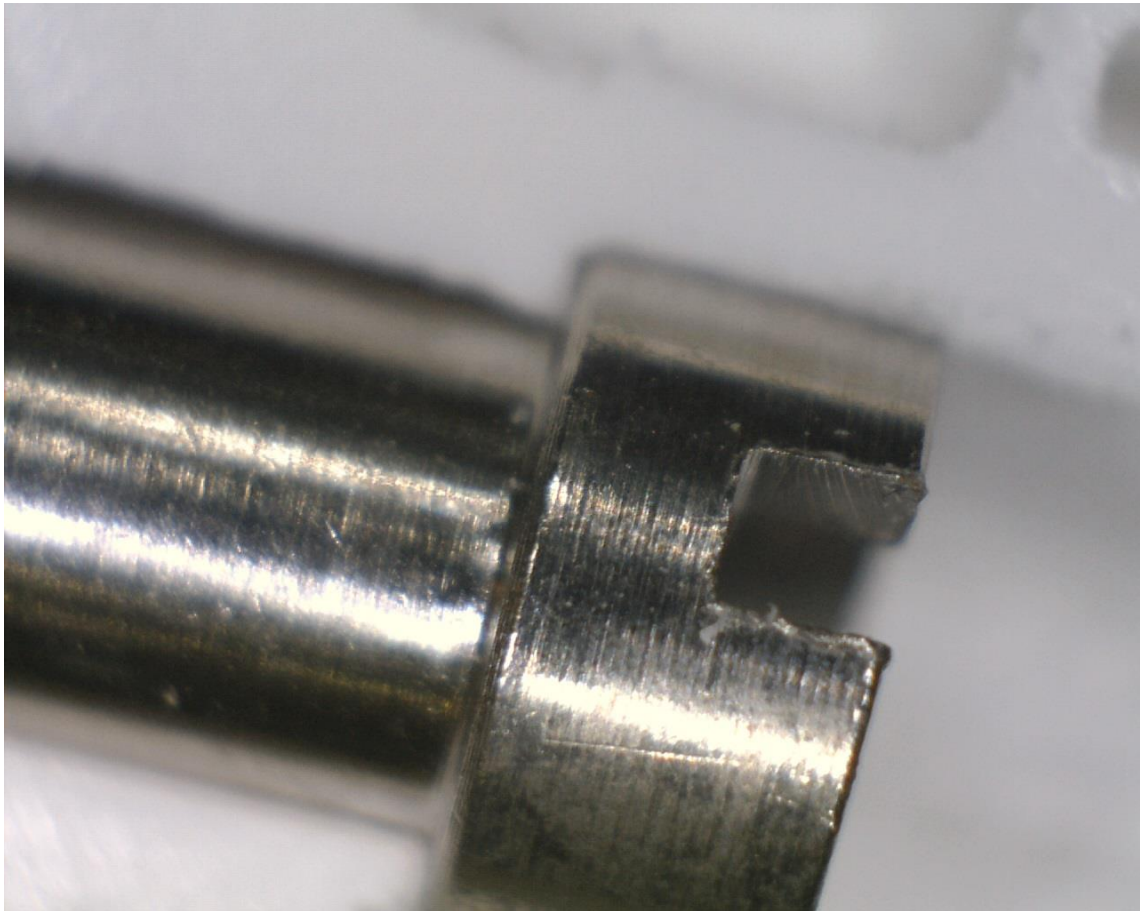
Rough slot edges giving high field.

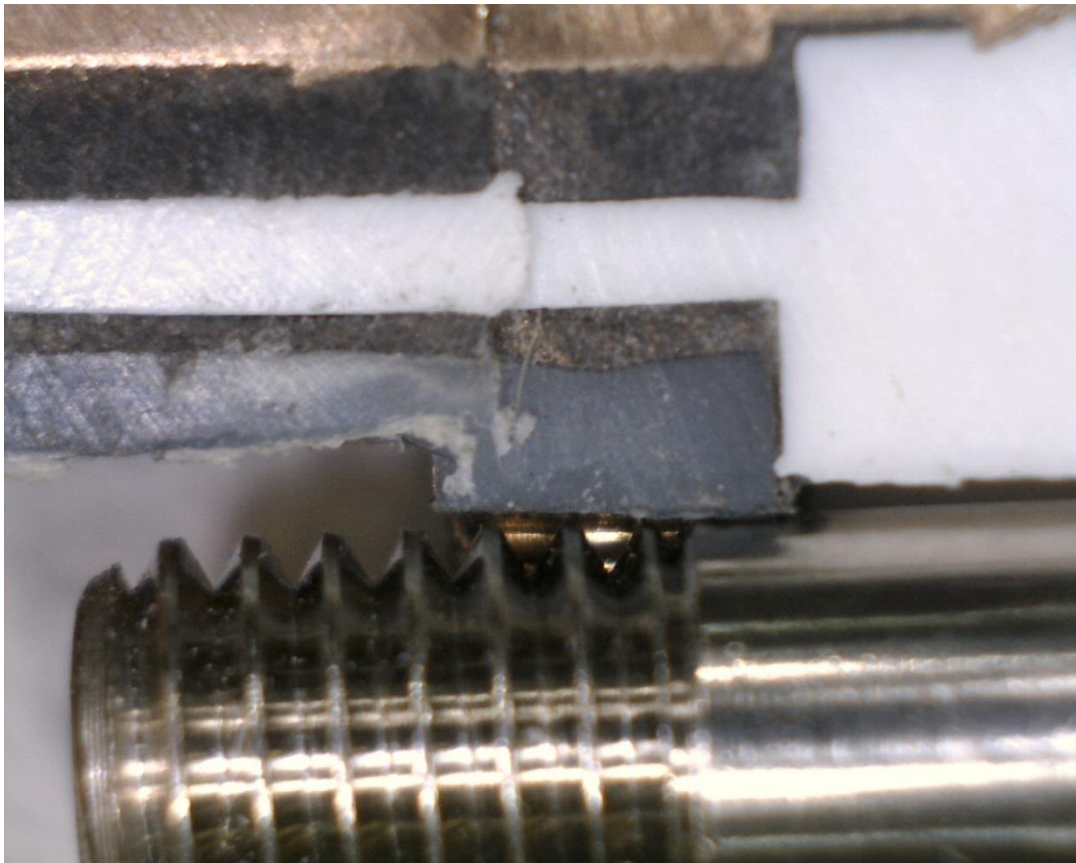
The screw thread is, in comparison, rather rounded off and is not so close to the sharp pin barbs.
