# Inspection of 3 pole connectors following 2 failures of July 2012 delivery

Failures of the first production made by Mrs Wang for RE1, 2 & 3.

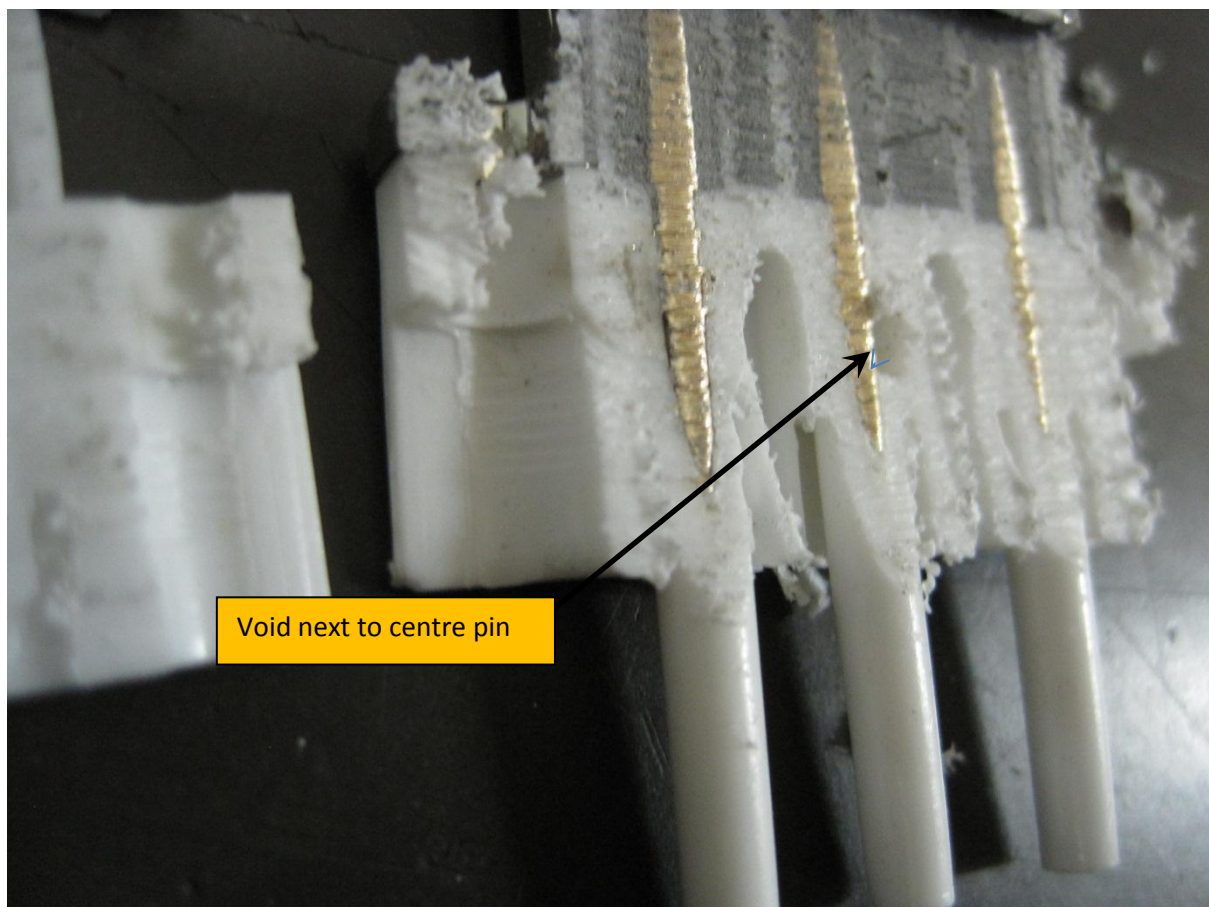
Below is an example of poor quality moulding showing a void. This will compromise the insulation although in this case the 0Volt pin is far away.

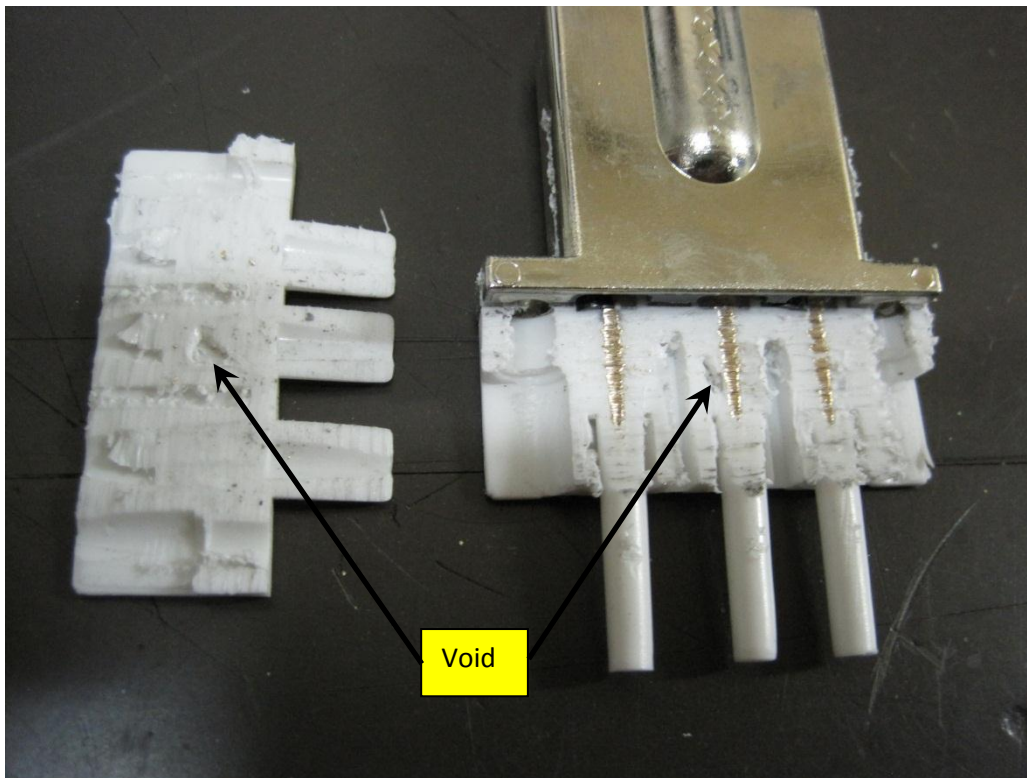
Another void next to centre pin

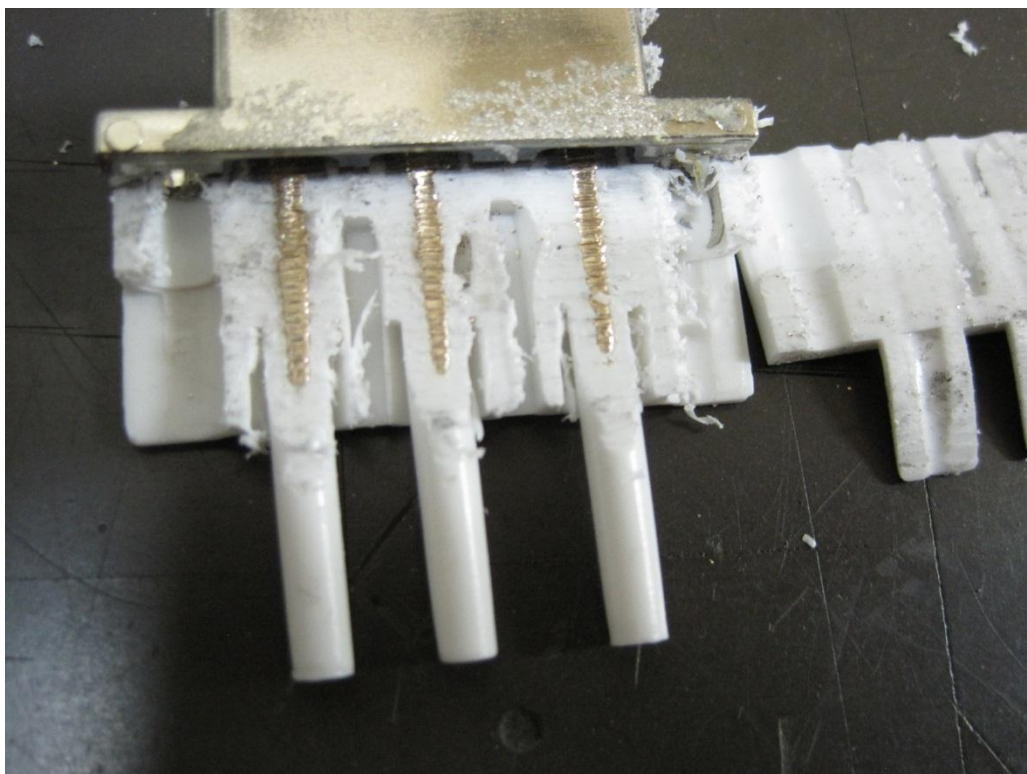
And another

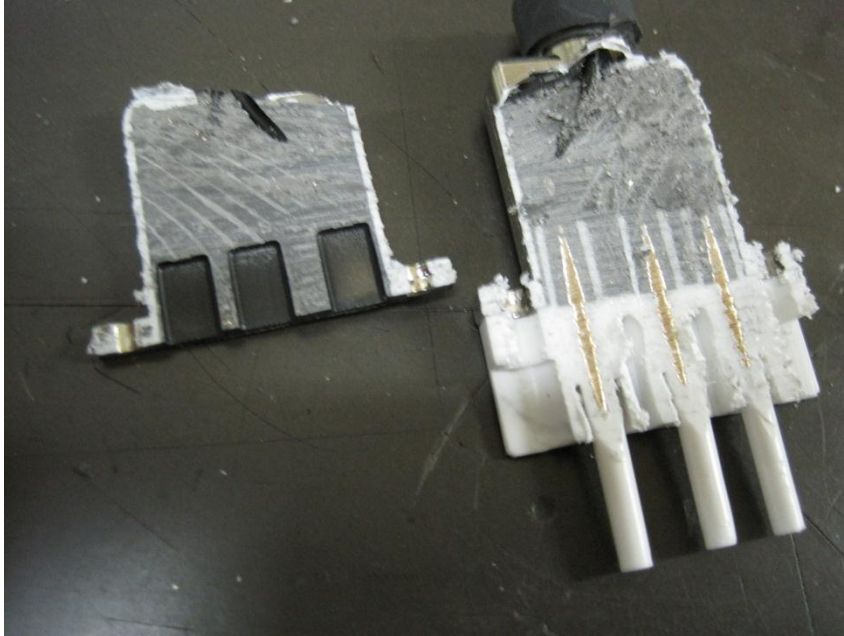
General view showing good filling of Stycast.

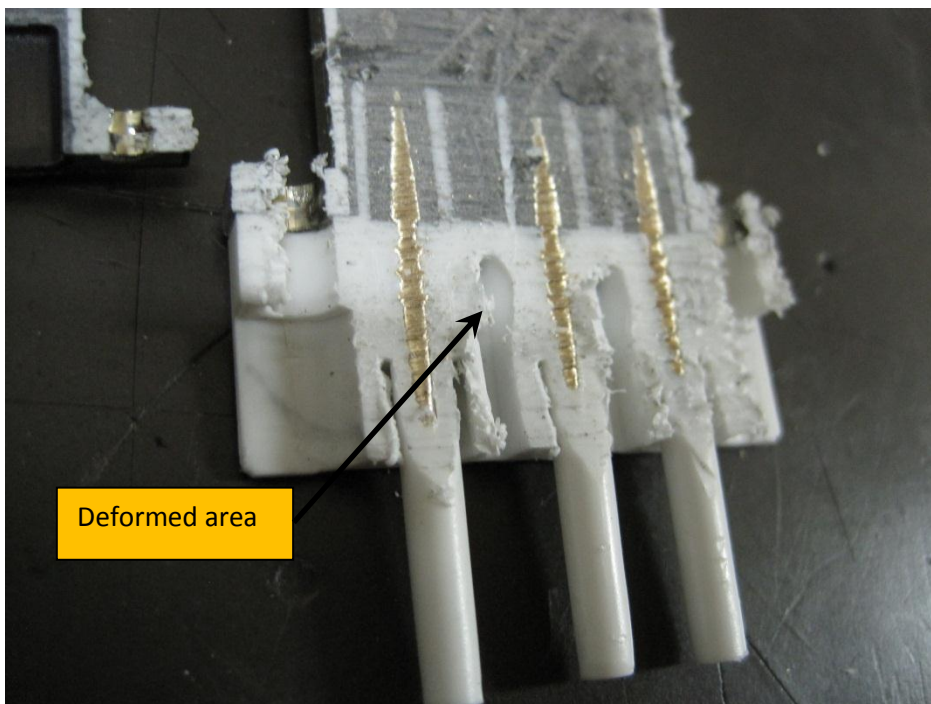
Close up showing poor deformed inter-pin spacings

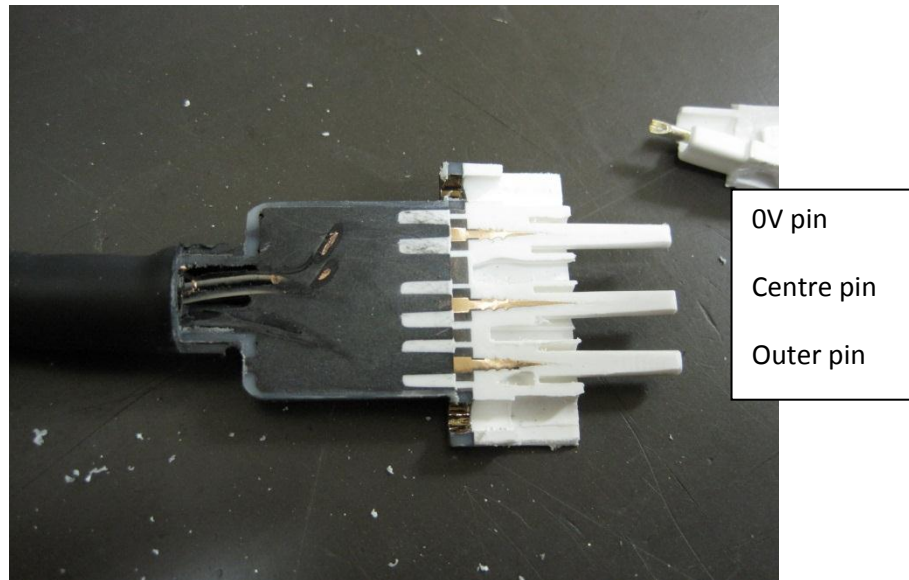
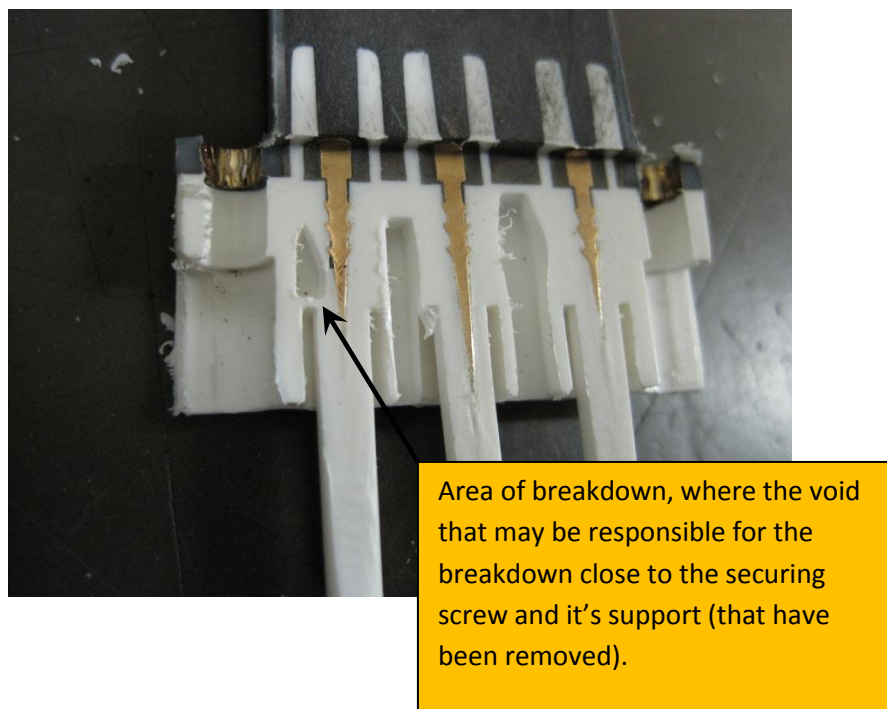
The first failure, 2 of 12, of the delivery this July 2012.

The connector failed before reaching 15kV, at approx. 13kV, on the outer of the 2 "live" pins. Loud cracking and light was visible through the white area of the connector close to the securing screw.

The connector was milled through, 0.5mm for each pass, by Jean Francois looking for the origin of the breakdown.

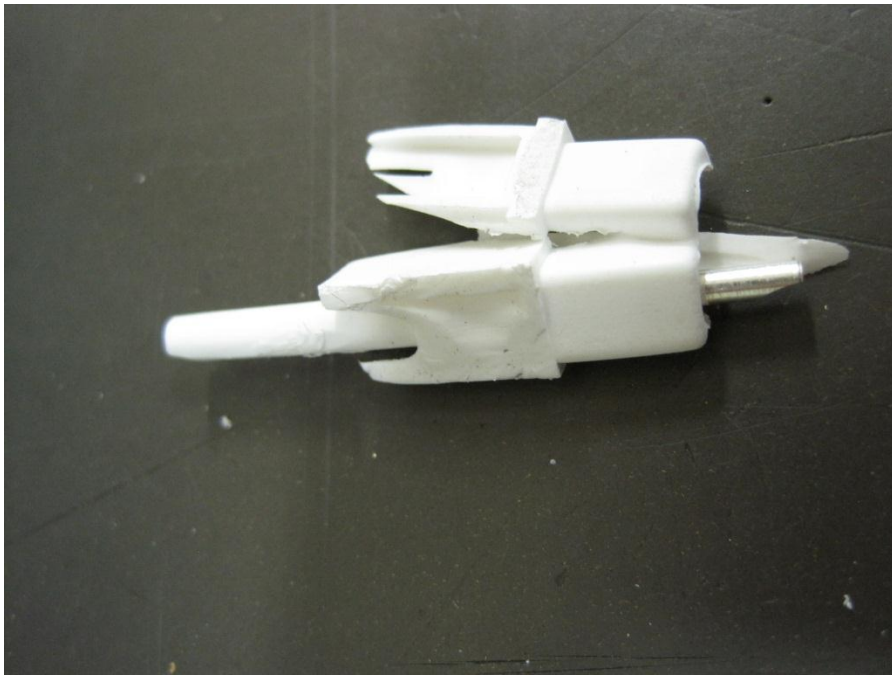
Examples of voids in similar locations

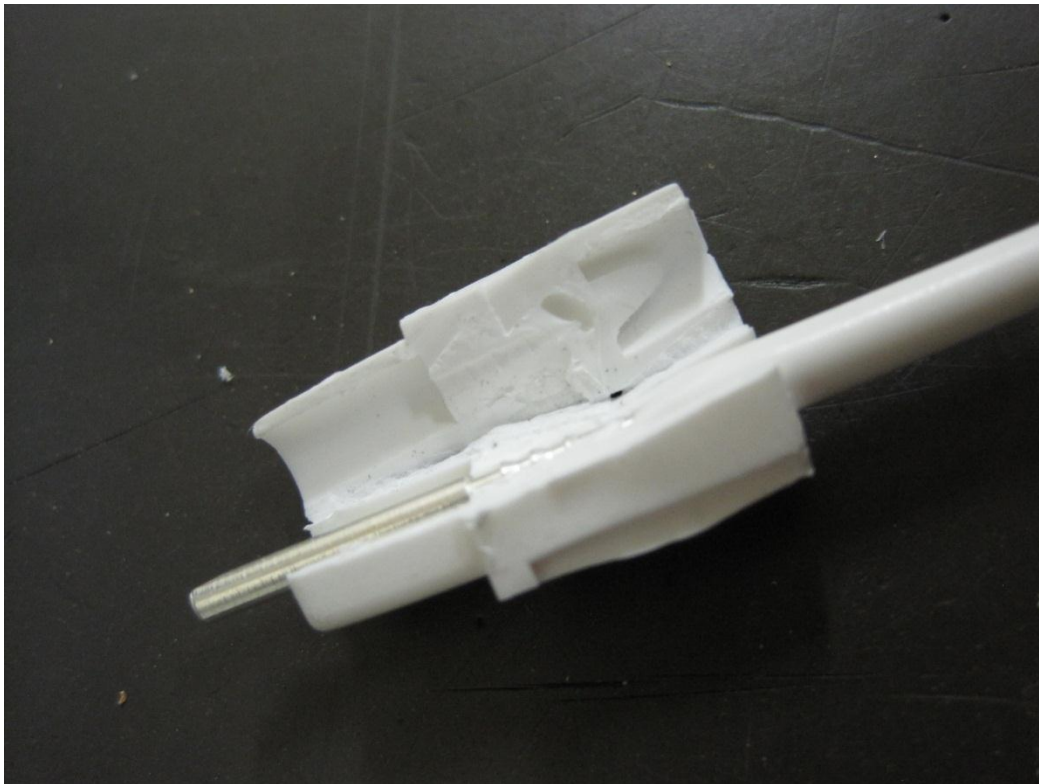
Another example. If these are outer pins or centre is not clear.

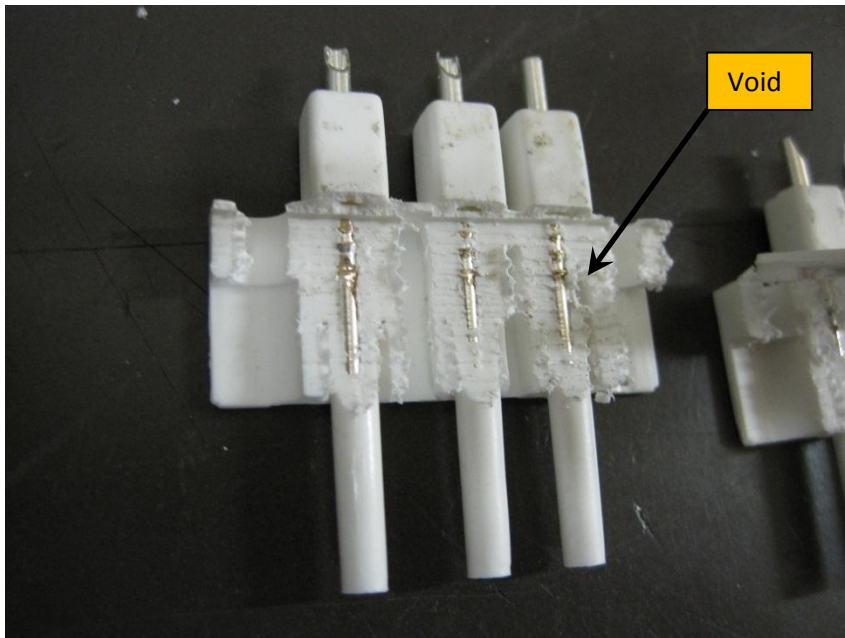
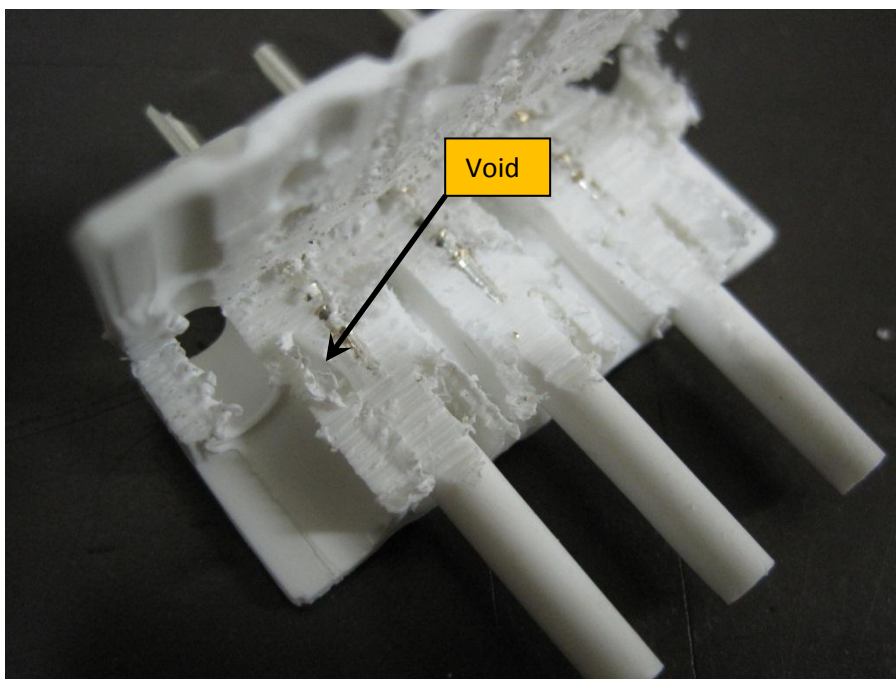
Two of the 5 opened by hand show voids between the outer pin and the securing screw emplacement. They are shown below.

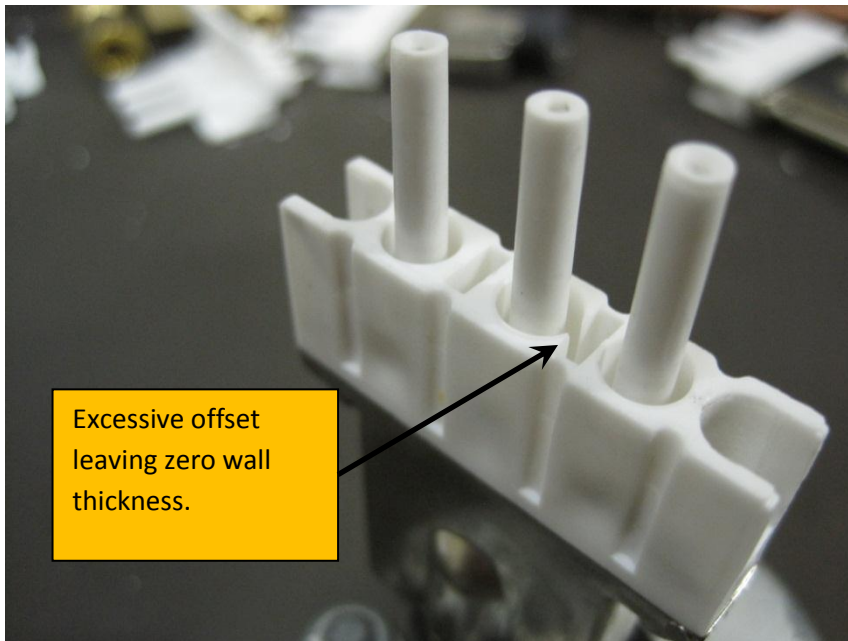
This bad mould geometry is inherent to all connectors of whatever age.

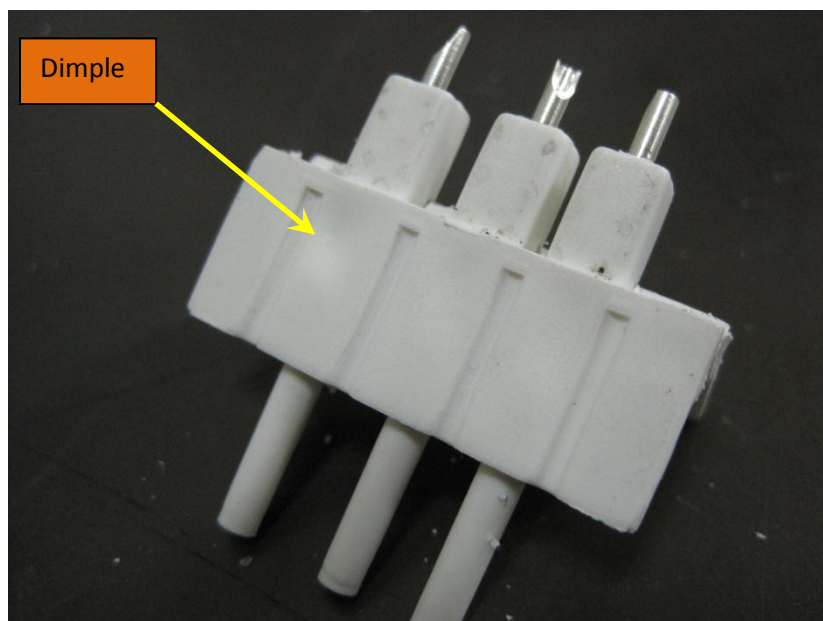
Dimples (sinkage) are present in many cases. They seem to coincide with the internal voids, as logically a lack of dimple implies that the material has not shrunk into the low density area but has remained in its initial condition so producing the voids.

Dimple is on the left and the void is on the RHS

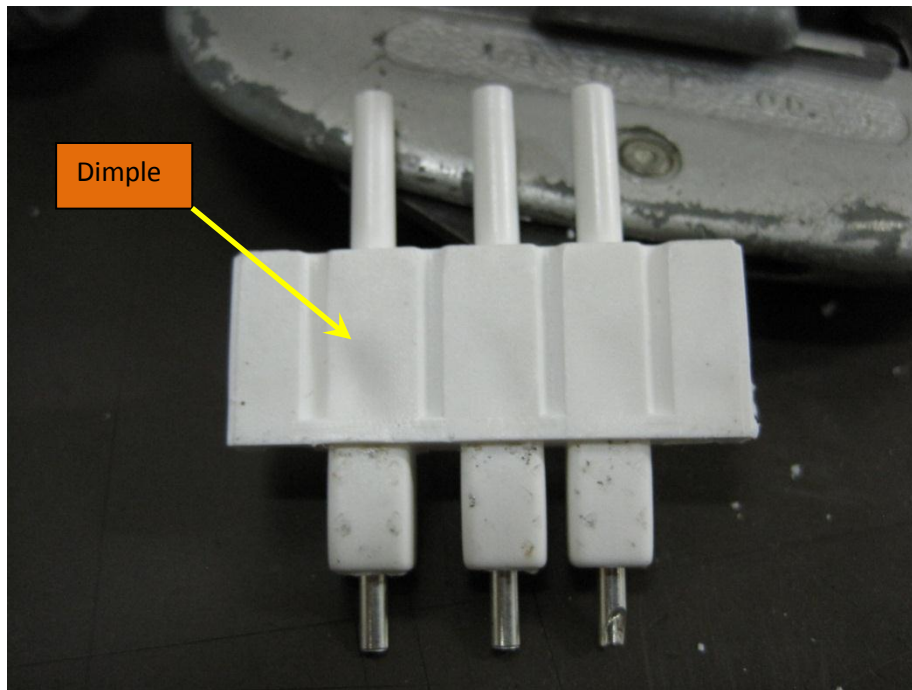
The second of 5 samples. The dimple is on the left and the void is on the RHS
