Discussion for QC steps Database & Leak-pop-spacer tests

K. S. Lee, S. Park, M. Kang, J. H. Yoon

Data for 13 RE4/2 test gaps in the CMS upslope database.
30 gaps with RE4/2 types with Batch 12 HPLs.
Destroyed ~ 20 gaps to investigate the inside oil condition.

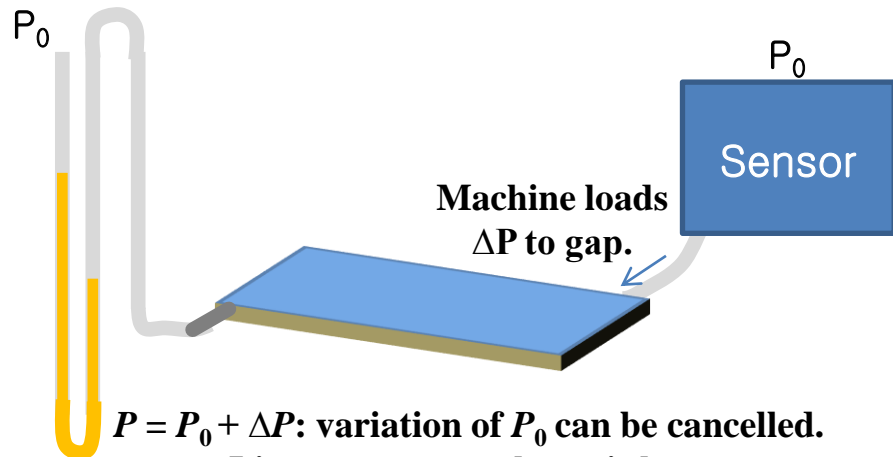
1. Test for leak and pop-spacers, selected one RE4/2 TW gap.

$P = P_0 + \Delta P$: variation of P_0 can not be cancelled.
Short line \rightarrow less sensitive to T variation

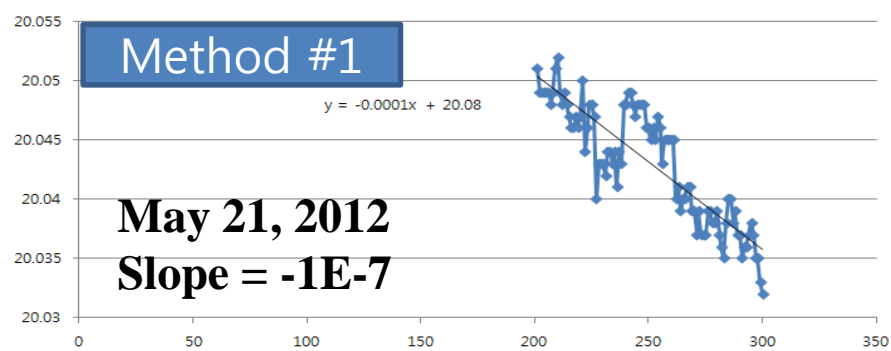
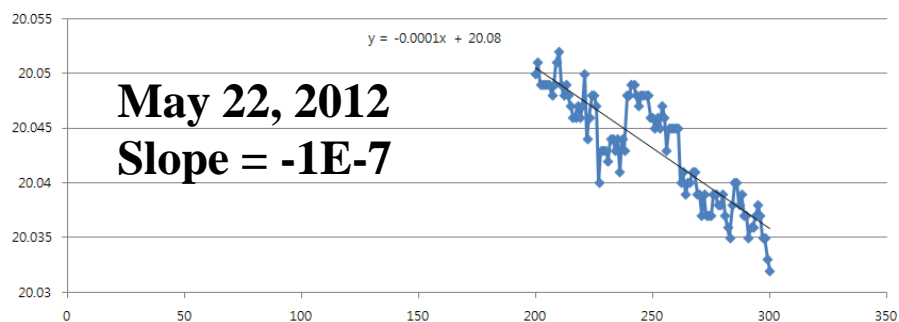
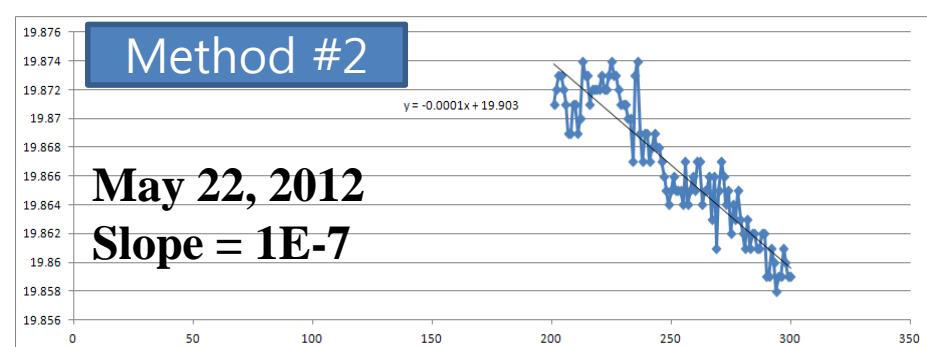
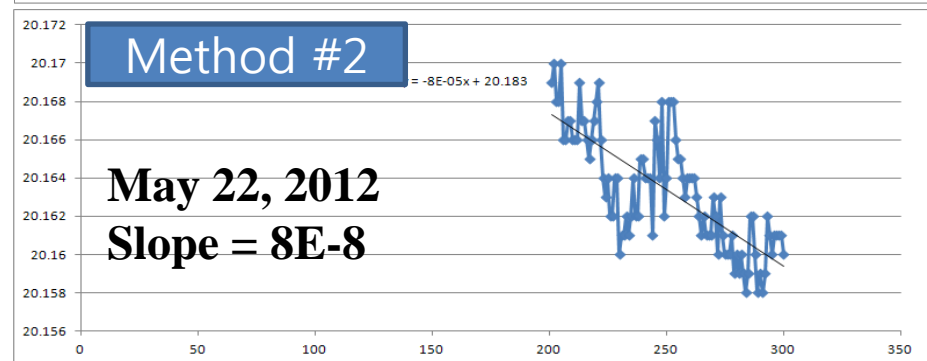
The variation of the pressure in the 2nd method seems to be smaller.

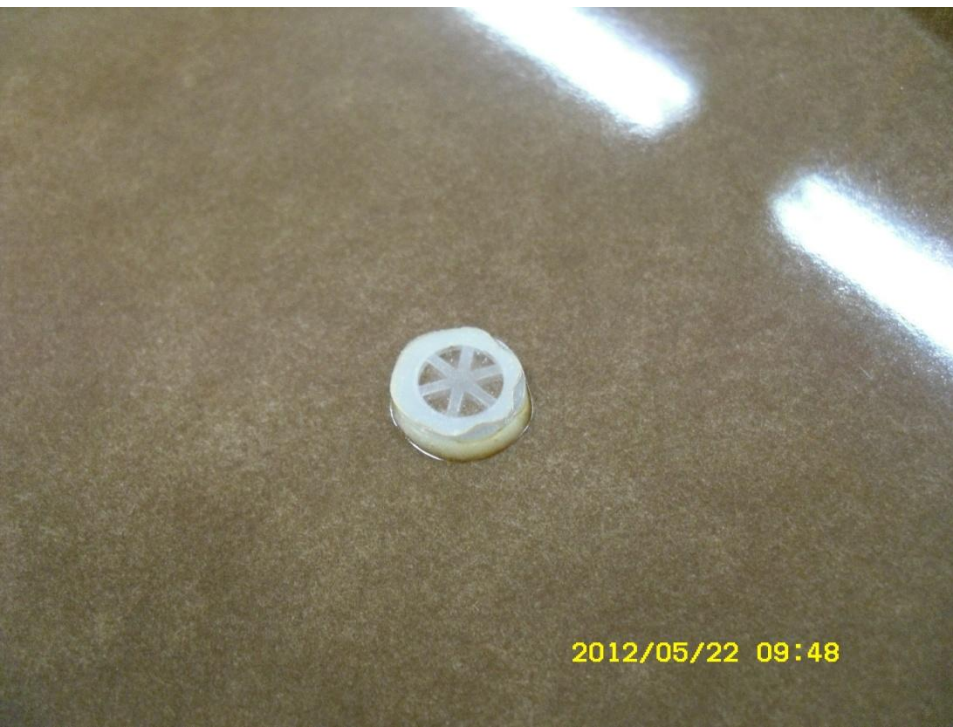
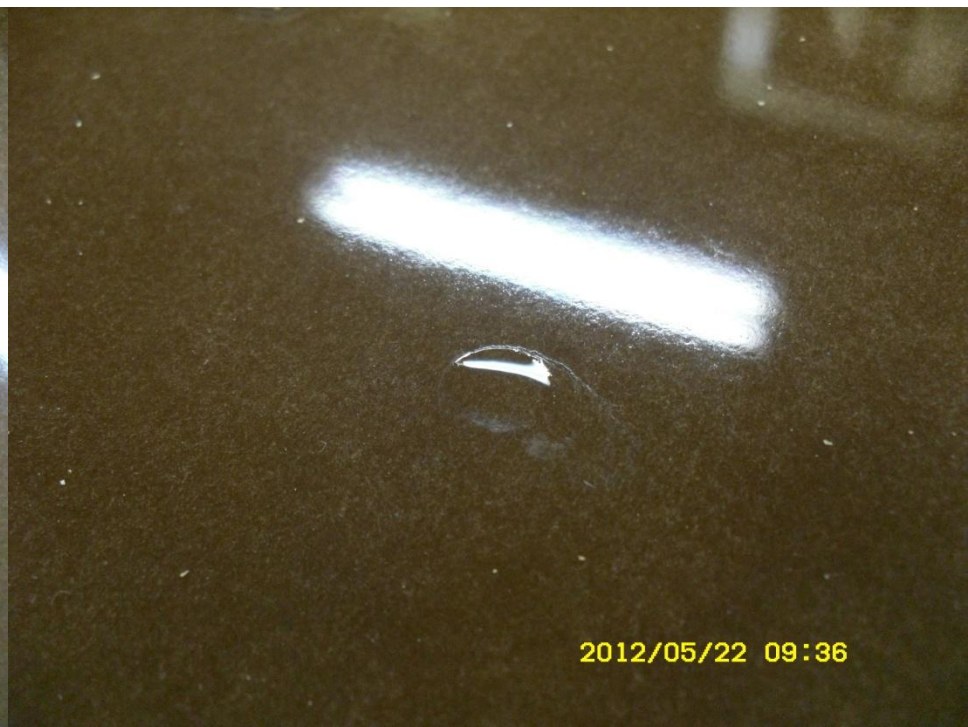
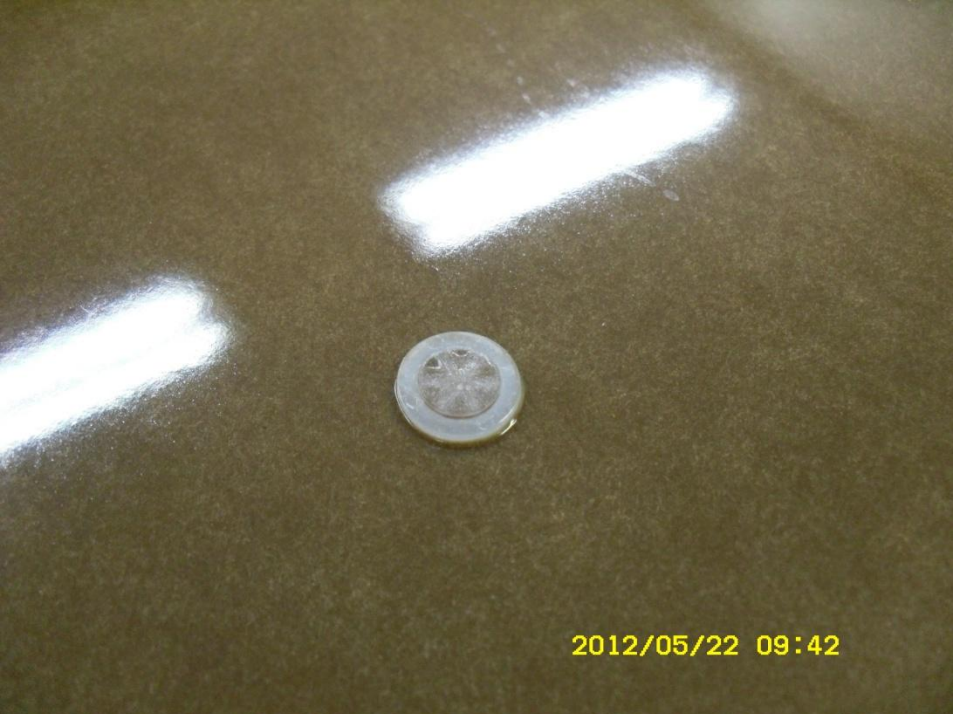
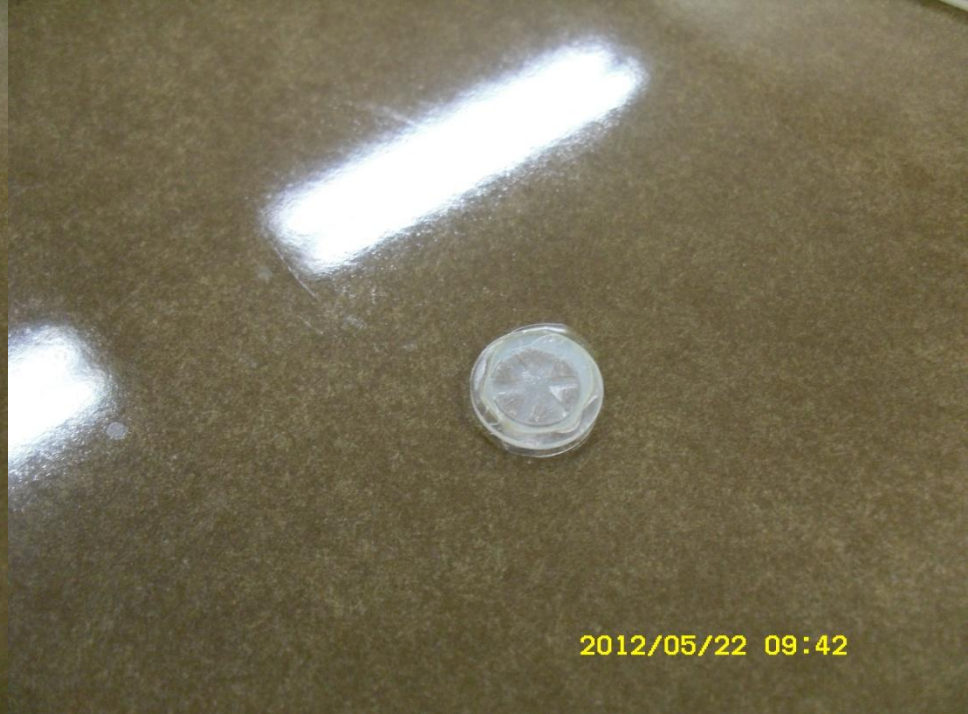
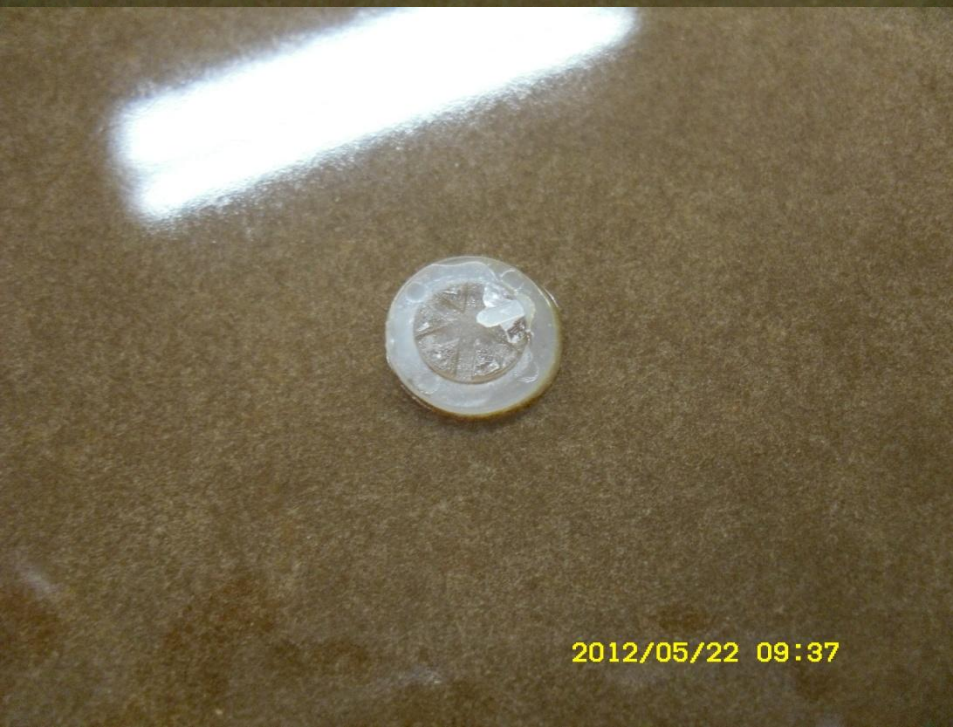
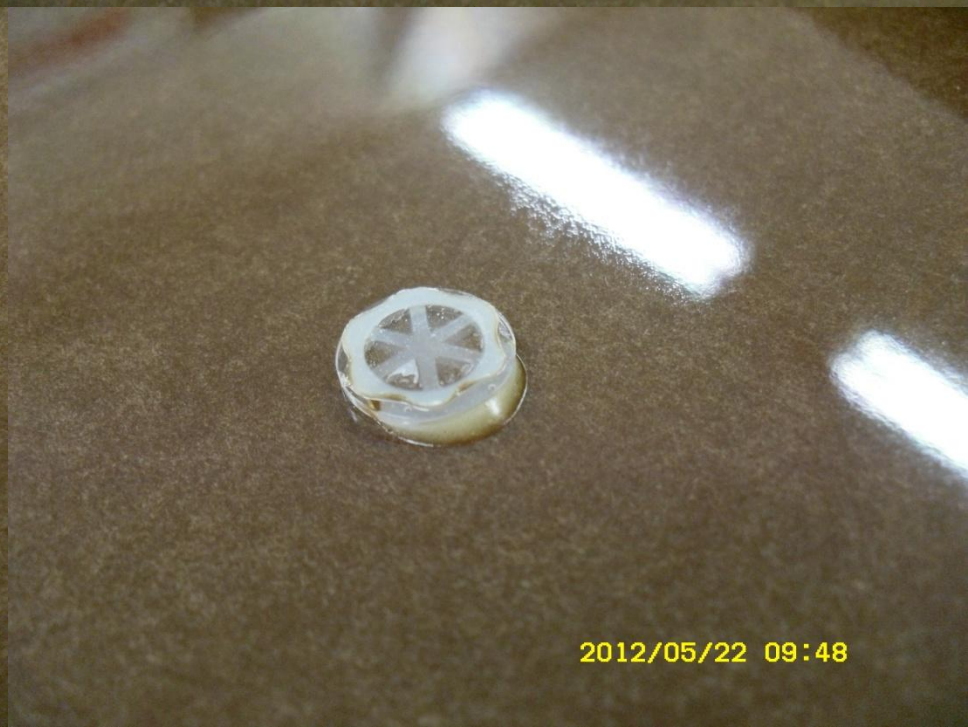
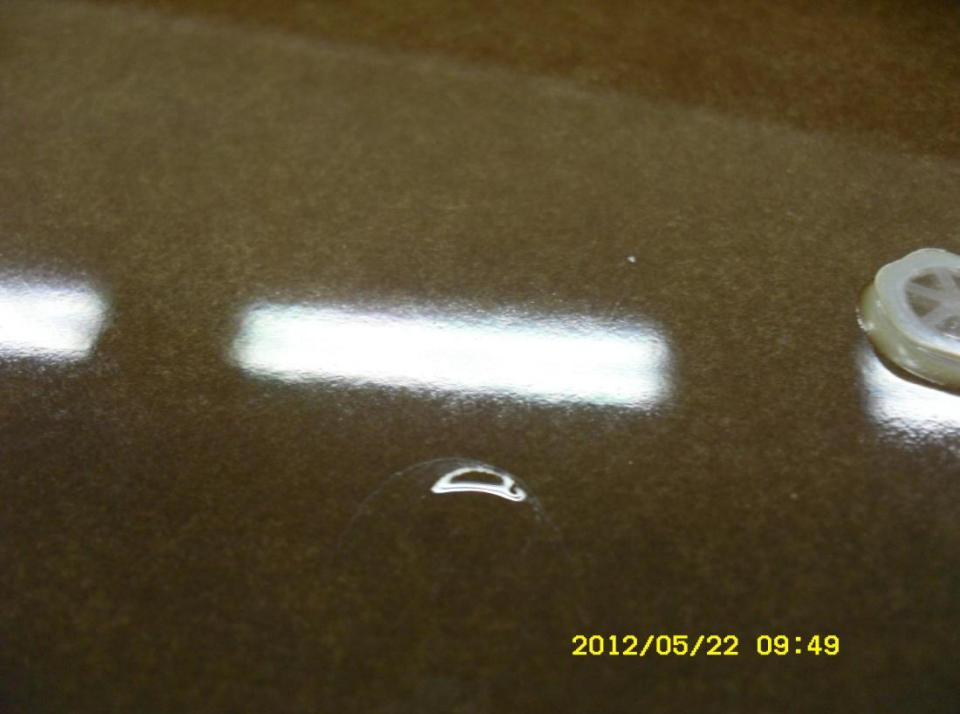
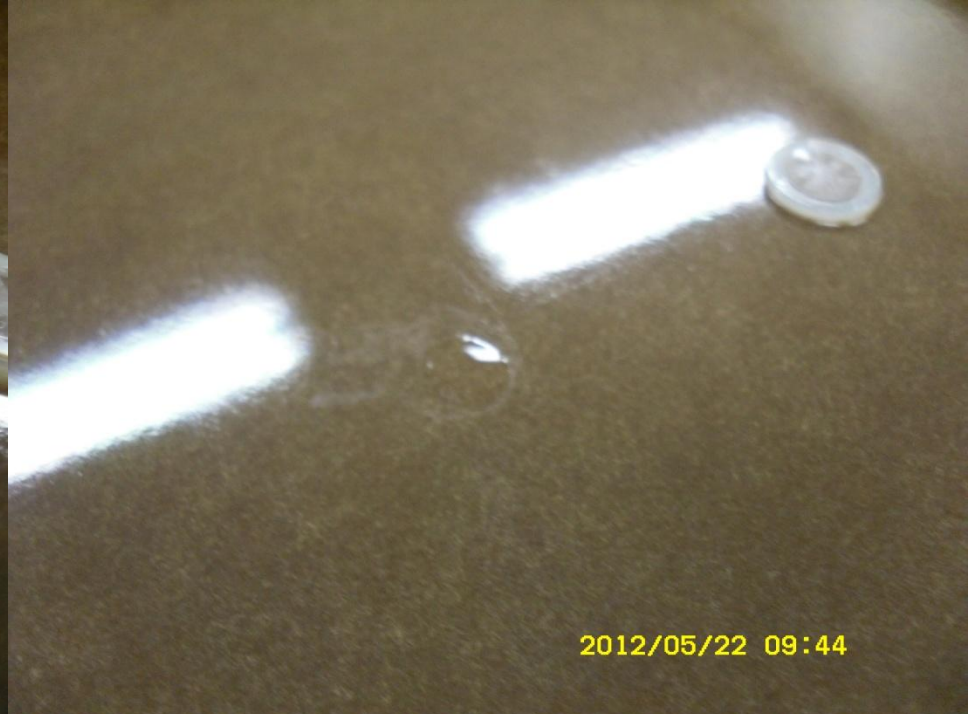
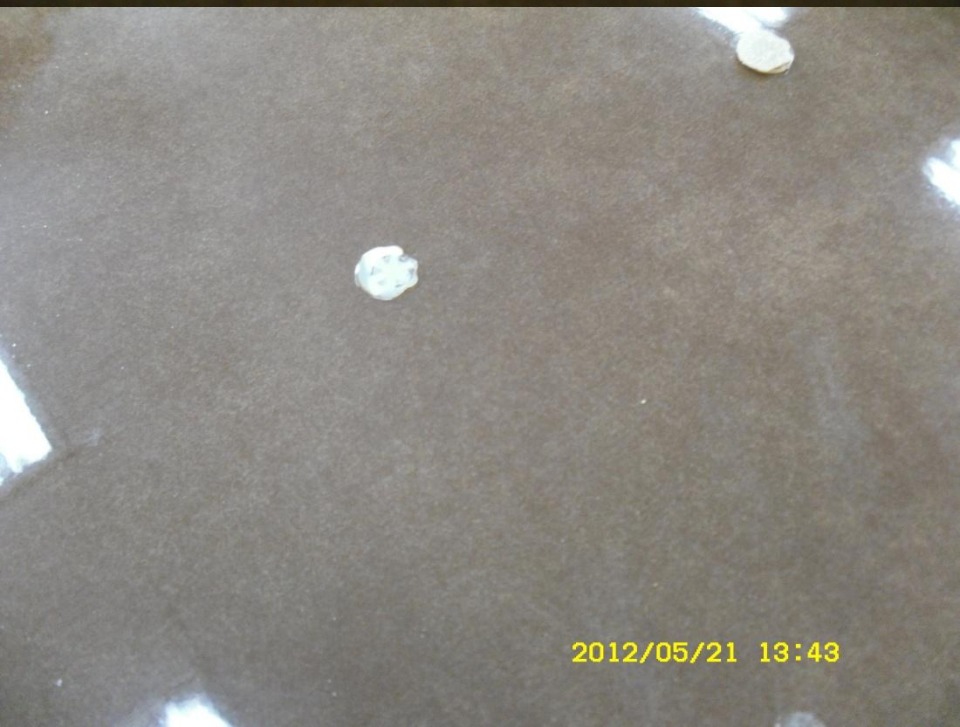
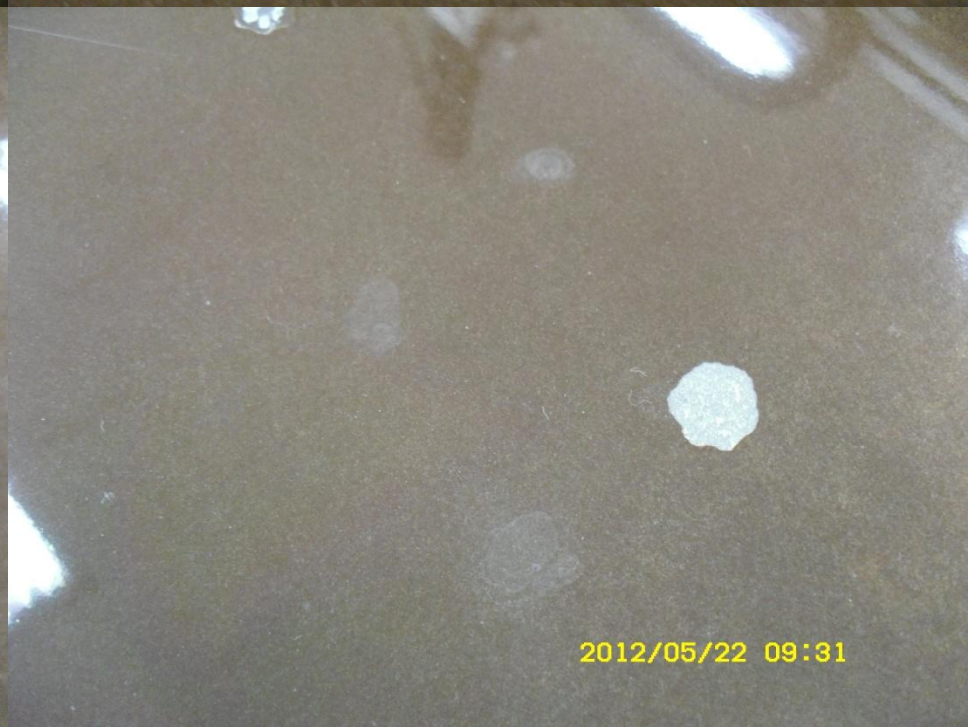
2. Linseed oil test for new washed HPLs

- Manufactured 6 gaps with 12 RE4/2 TW HPLs
- Oil was dried for 90 hours with air (H=50%)
- Pattern of oil layers was as good as the previous production.
- Tested with Chloroform → seems to be well polymerized.

Not-well dried oil layer → chloroform bubbles are quickly dried with fast chemical reaction.

Well dried oil layer → Chloroform bubbles stay on the oil layer and DO NOT quickly dried as if they are dropped on a desk.
