Production status of Test Gaps for RE4 RPCs in Upscope

K. S. Lee, S. Park @KODEL

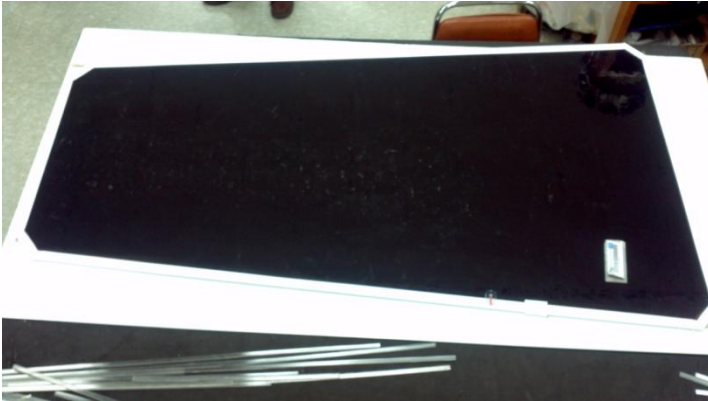
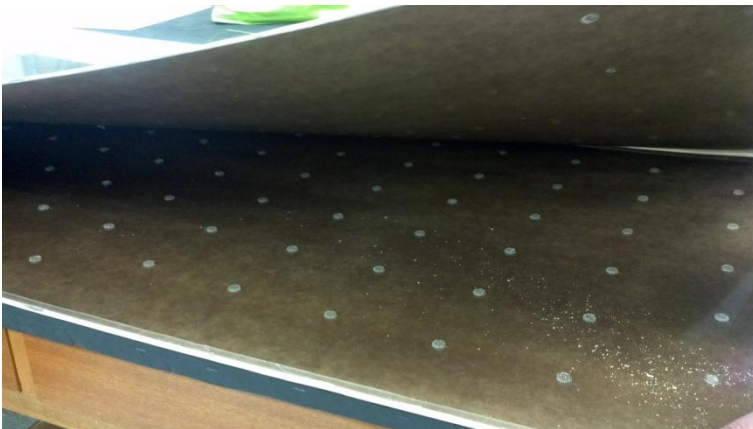
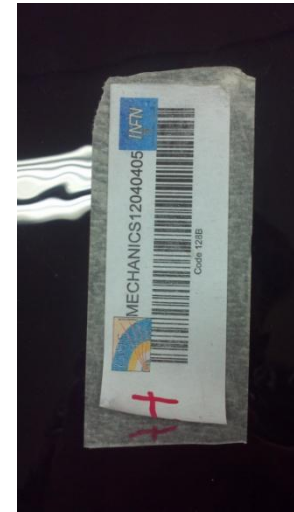
- Opened a RE4/2 test bottom gap (HPLs from batch 12)
- The bonding strength seems to be good enough, but the surface layer of the HPLs were easy detached like a stacked paper layer. (**HPLs are mechanically fragile !**)
 - > Phenol resin seems to be very poorly smeared into the craft papers.
Spacers were detached due to lack of the rigidity of the HPLs
- Places where the phenol resin was well smeared -> dark
Otherwise -> bright and having microscopic bright spots

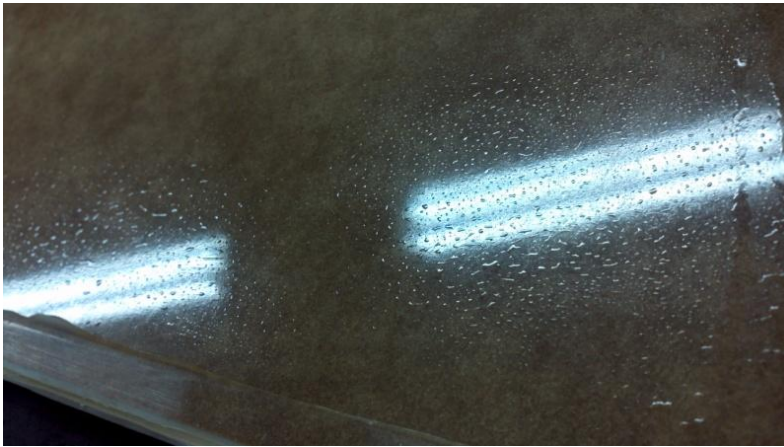
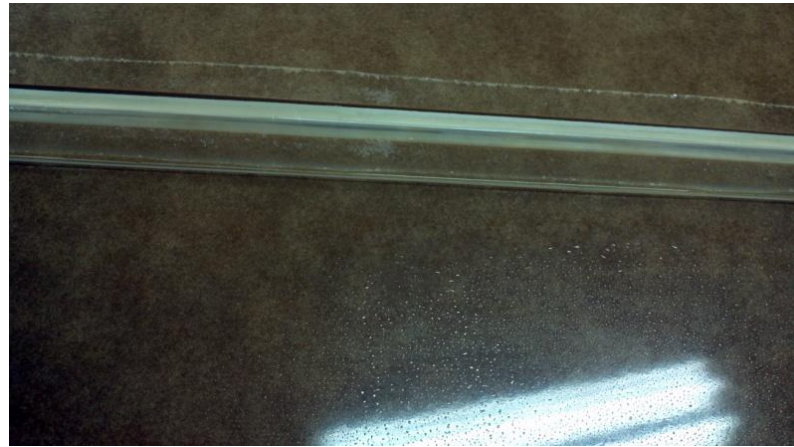
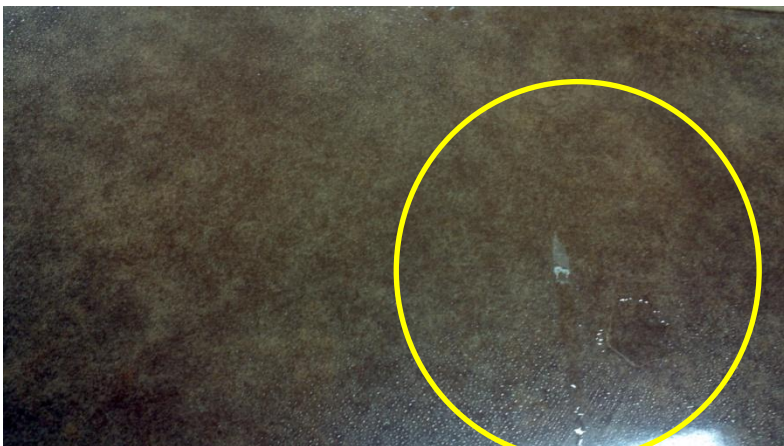
- Bad condensation of the oil could be due to two different factors

- 1) Oil dirt (microscopically thin layer remained even after cleaned by IPA and thinner)
(Still greasy even after cleaning by thinner & IPA)
- 2) Poor condition of smeared phenol resin into the craft papers
(The color is brighter and having white microscopic spots)

Bad oiled patterns especially on the places that the phenol was poorly smeared.

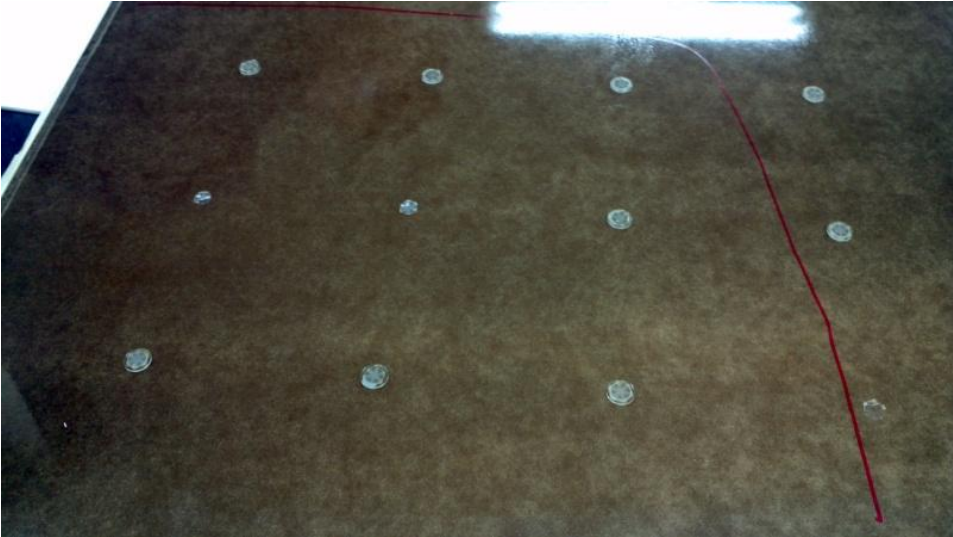
- We expect that the oil pattern could be nicely formed only when the oil/heptane is well attached on the phenol-covered surface of the HPL.

Good oiled patterns on the places that the phenol was relatively well smeared.

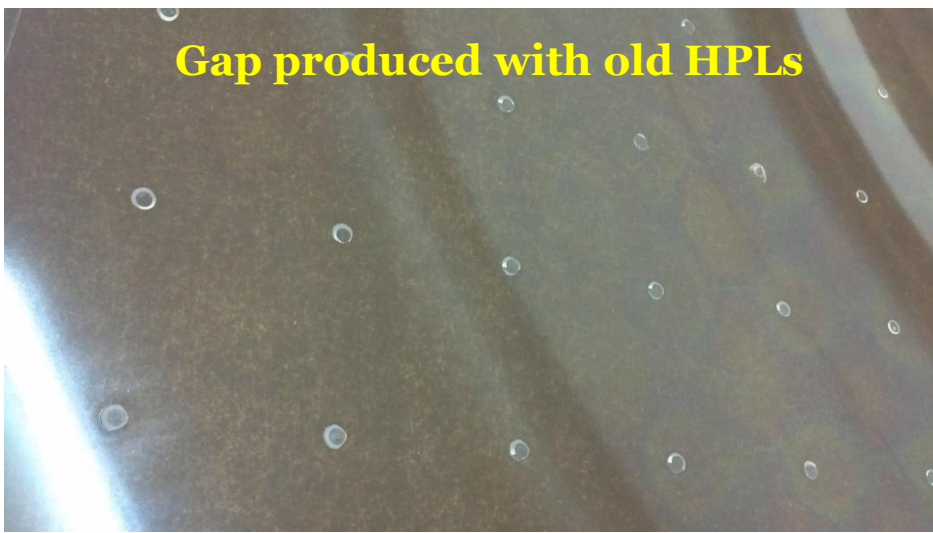
Gap produced with old HPLs

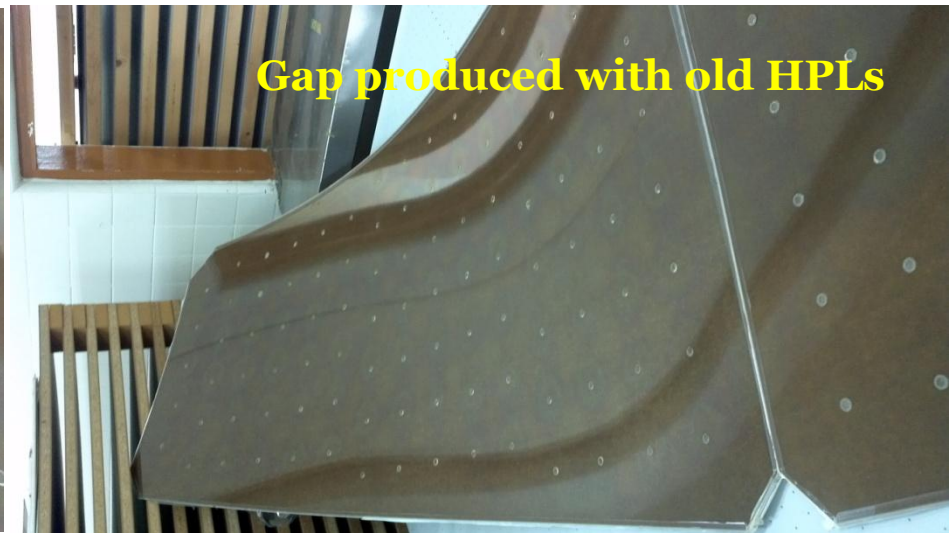
Gap produced with old HPLs

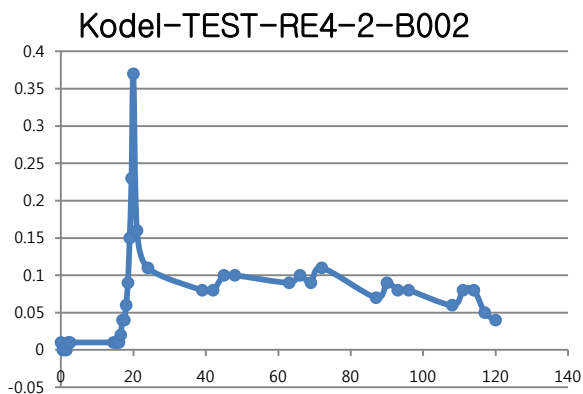
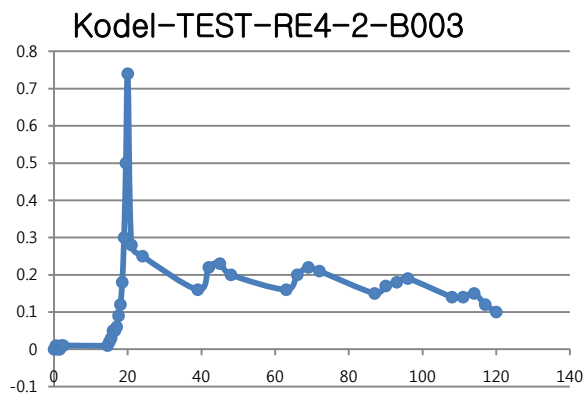
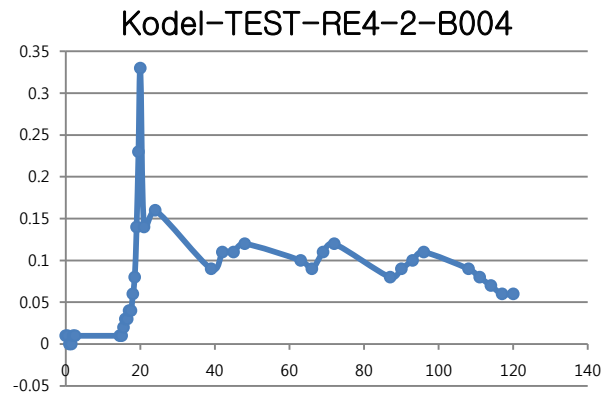
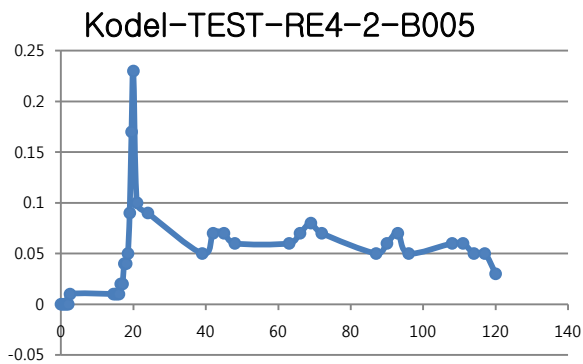
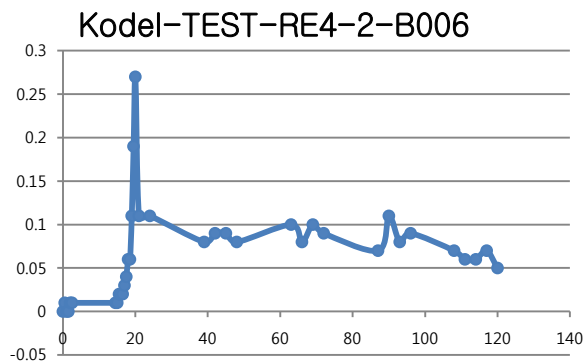
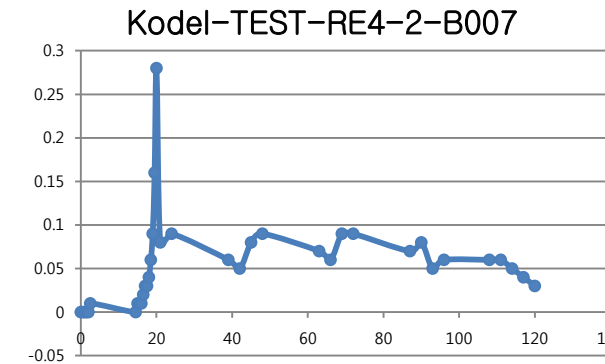
- At 6.0 kV, $i \sim 0.2 \mu\text{A}$ for all the gaps
At 10.0 kV, maximum $i = 0.74 \mu\text{A}$
 $i(120\text{h})/i(63\text{h}) < 1.0$ for all the gap

Set at 10.0 kV at $t = 20.0$ h, and at 9.6 kV from 21 to 120 h for the long-term test.

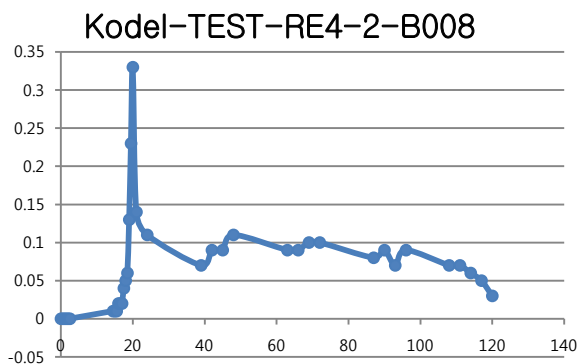
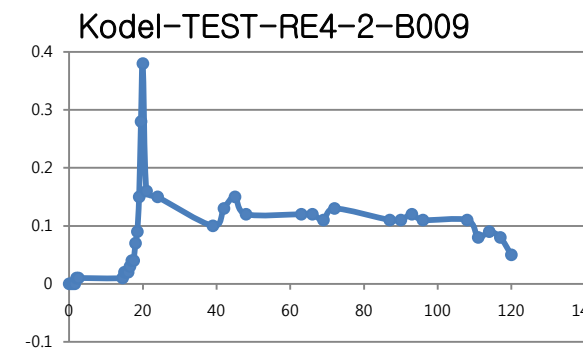
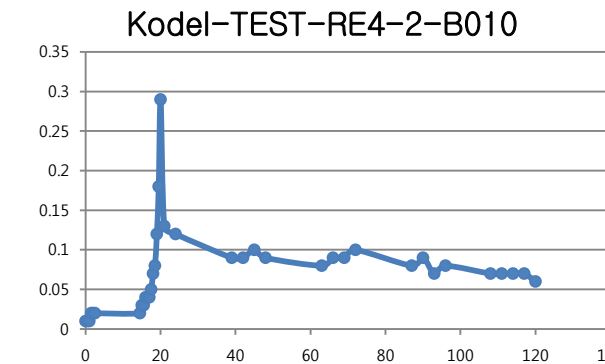
QC decision	Current Limits at 6.0 kV	RE4/2 TW	RE4/2 TN	RE4/2 BT	$i(14.5\text{h})$ at 6.0 kV	Final Decision	Certified	O	96 h test	x							
	1.5 μA	1.5 μA	1.5 μA	0.02													
	RE4/3 TW	RE4/3 TN	RE4/3 B	1.5 μA													
	1.5 μA	1.5 μA	1.5 μA	0.29													
	Current Limits at 10.0 kV	RE4/2 TW	RE4/2 TN	RE4/2 B	$i(20\text{h})$ at 10.0 kV												
	5.0 μA	5.0 μA	10.0 μA	0.29													
	RE4/3 TW	RE4/3 TN	RE4/3 B	5.0 μA													
	5.0 μA	5.0 μA	10.0 μA	0.08													
	Current Limits at 9.6 kV at t = 120 h	RE4/2 TW	RE4/2 TN	RE4/2 B	$i(63\text{h})$	0.08											
	2.0 μA	2.0 μA	3.5 μA	$i(120\text{h})$	0.06												
	RE4/3 TW	RE4/3 TN	RE4/3 B	Criterion $i(120\text{h})/i(63\text{h}) < 1.5$													
	2.0 μA	3.5 μA	5.0 μA	0.75
