Production status of Test Gaps for RE4 RPCs in Upscope

K. S. Lee, S. Park @KODEL

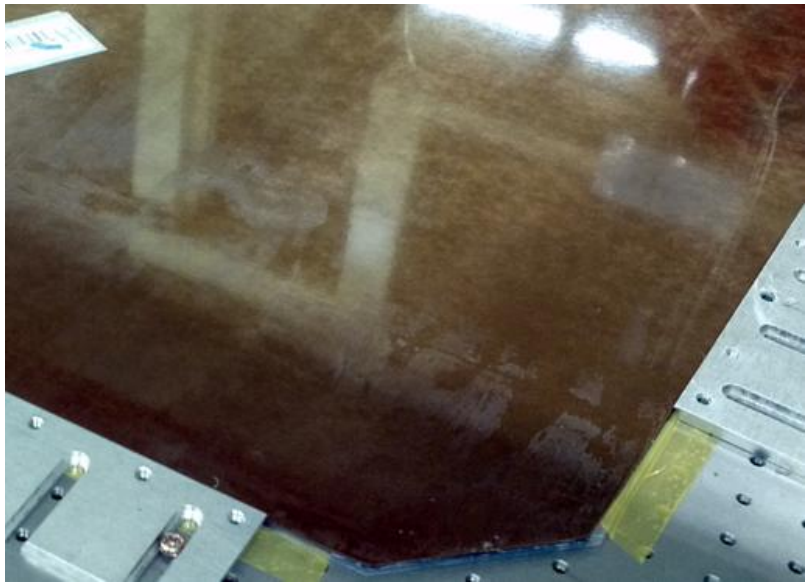
Before cleaning

Checked that oil dirt remained on all the HPLs (all batches)

- Found that the stripe pattern created by the cleaning procedure was barely visible and just partially performed.
- At some places of the HPL sheets , the oil dirt still remained was thick.

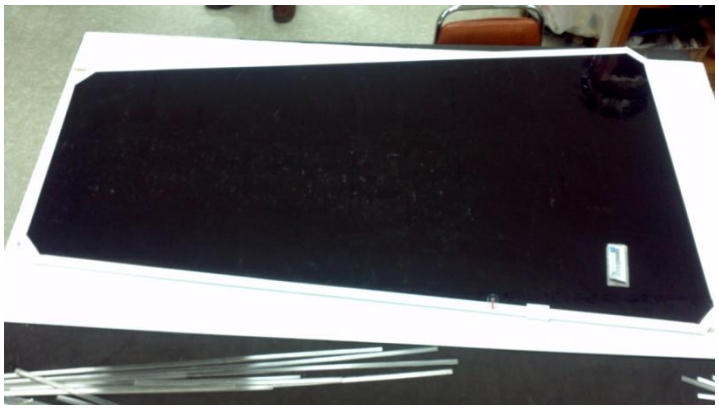
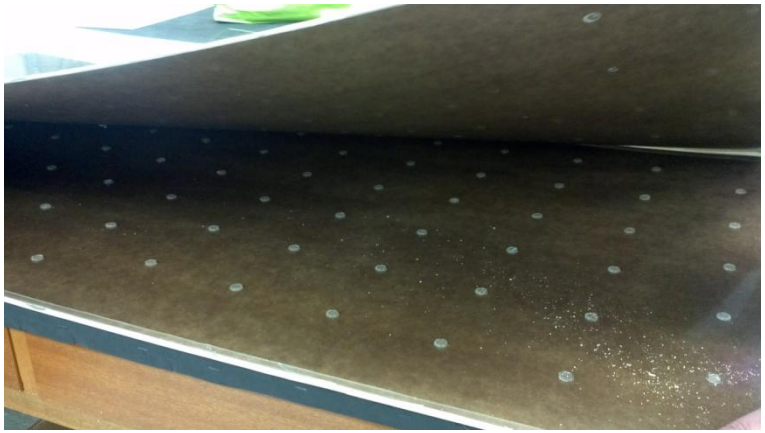
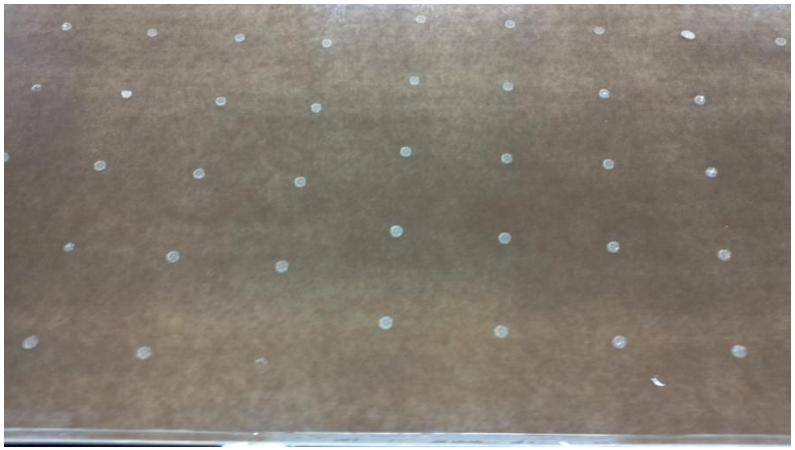
- Opened a RE4/2 test bottom gap (HPLs from batch 12)

- The bonding strength seems to be good enough, but the surface layer of the HPLs were easy detached like a stacked paper layer. (HPLs are mechanically fragile !)
  -> Phenol resin seems to be very poorly smeared into the craft papers.
  Spacers were detached due to lack of the rigidity of the HPLs
- Places where the phenol resin was well smeared -> dark
  Otherwise -> bright and having microscopic bright spots

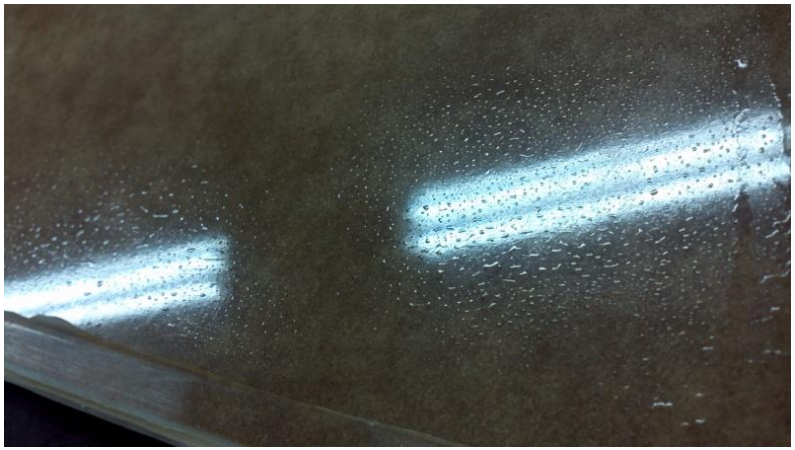
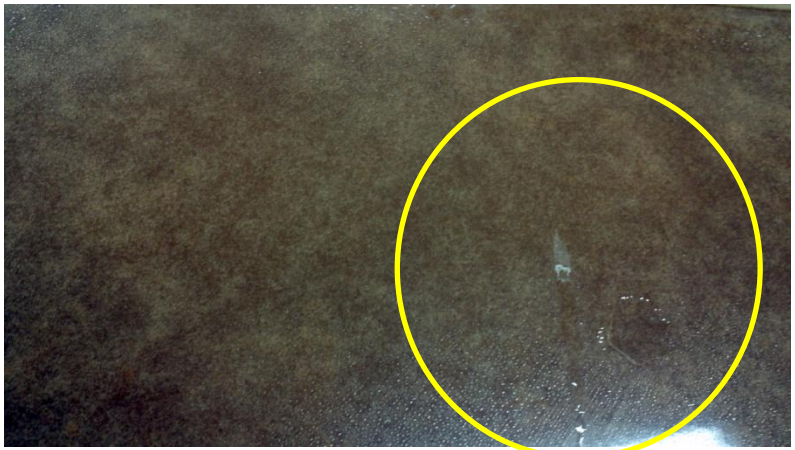
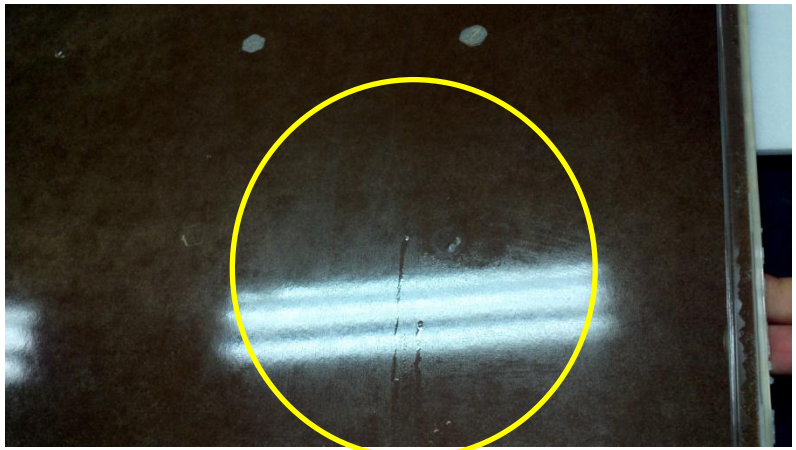
- Bad condensation of the oil could be due to two different factors
  1) Oil dirt (microscopically thin layer remained even after cleaned by IPA and thinner)
     (Still greasy even after cleaning by thinner & IPA)
  2) Poor condition of smeared phenol resin into the craft papers
     (The color is brighter and having white microscopic spots)

Bad oiled patterns especially on the places that the phenol was poorly smeared.

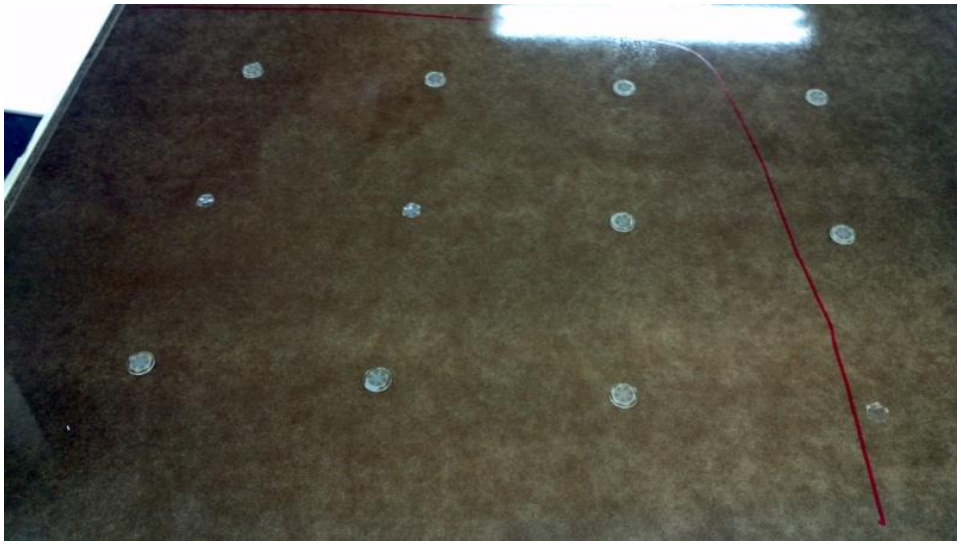
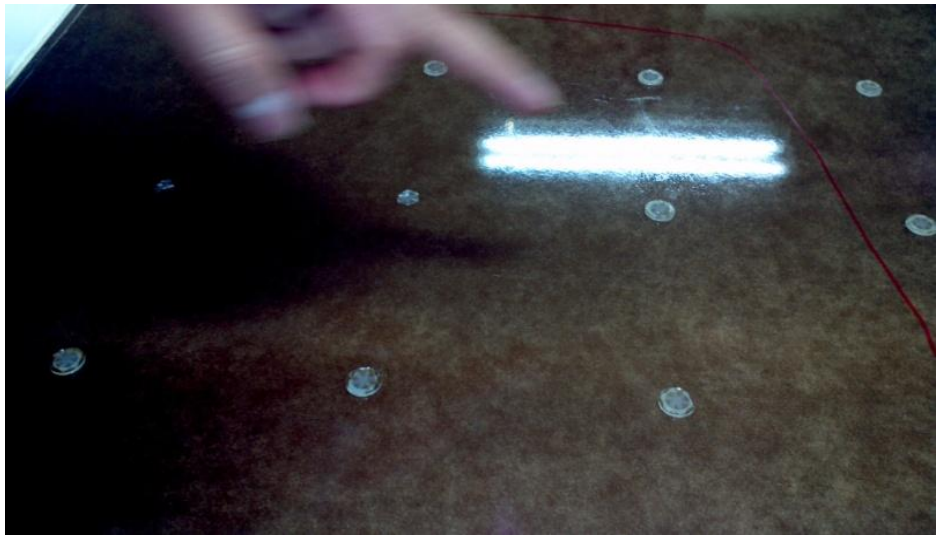
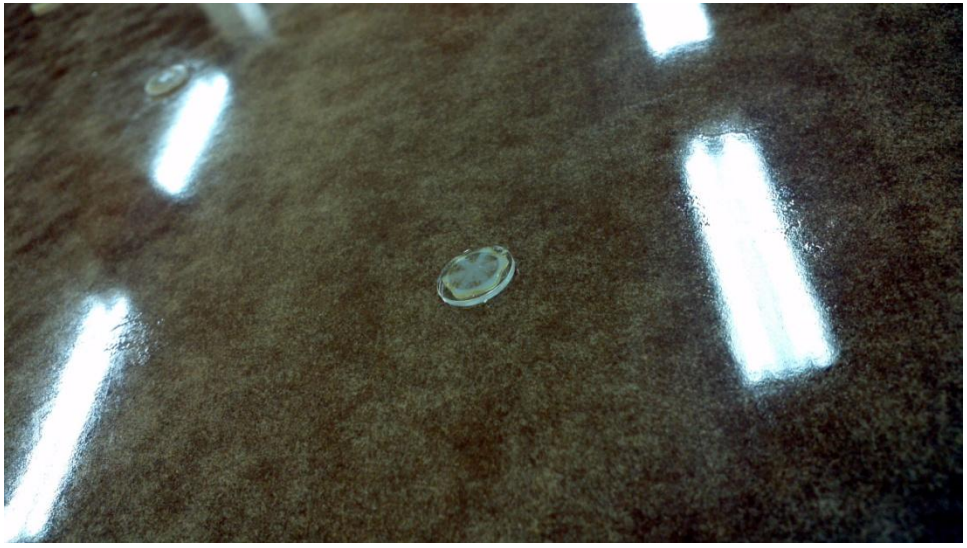
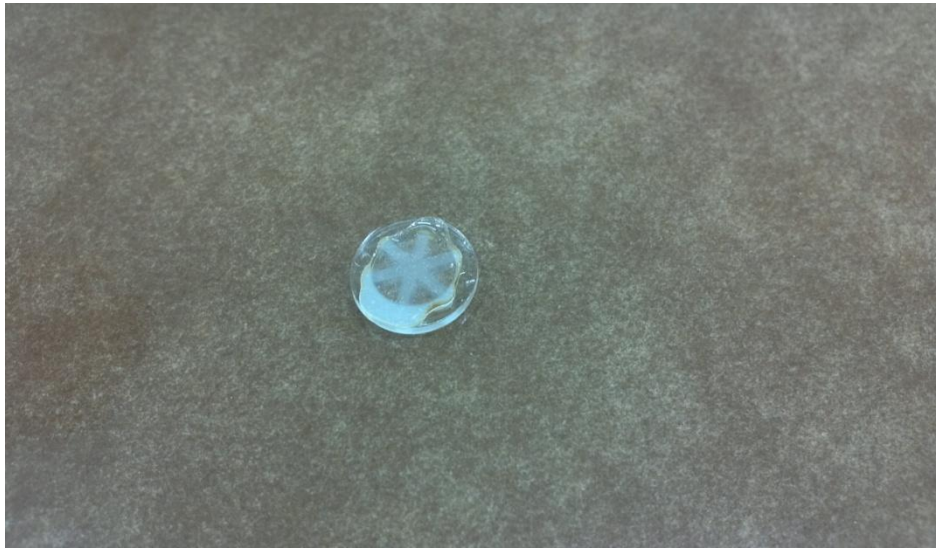
Good oiled patterns on the places that the phenol was relatively well smeared.

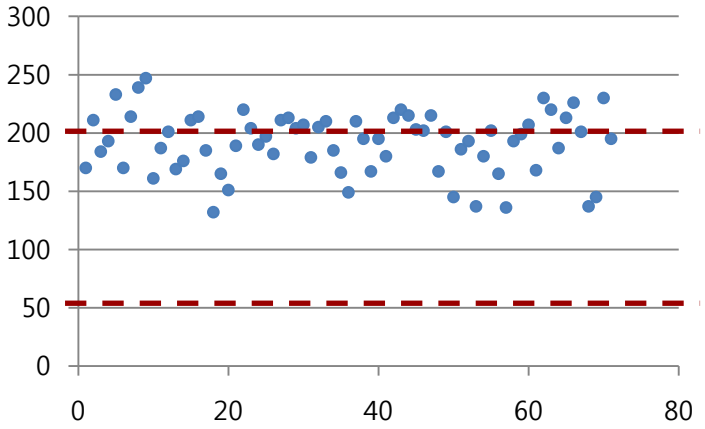
- **Mean value of the graphite surface resistivity = 191.6 ± 26.0 (sigma) kΩ/square**
- **The desirable value lies bet. 50 ~ 200 kΩ/square**
- **The value seems to be ~ twice larger due to cold weather (the temperature ranged 10 ~ 15 °C)**
- **The temperature was NOT well controlled during the January shutdown period.**
