Production status of Test Gaps for RE4 RPCs in Upscope

***J. H. Bae, M. H. Kang, Y. K. Jeng, K. S. Lee,
S. Park, S. S. Shin, & J. Yoon @ KODEL***

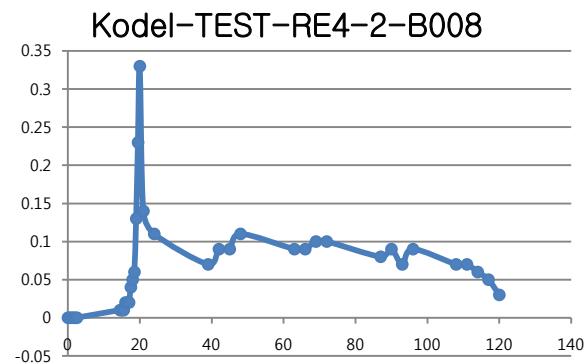
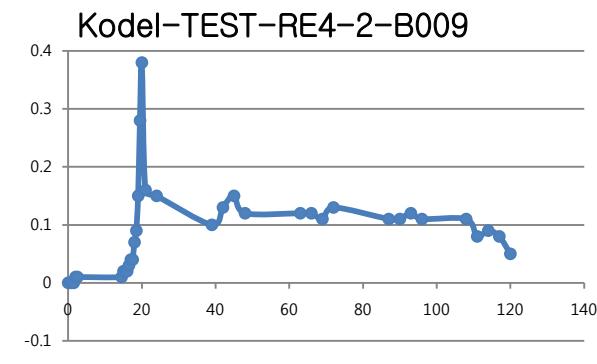
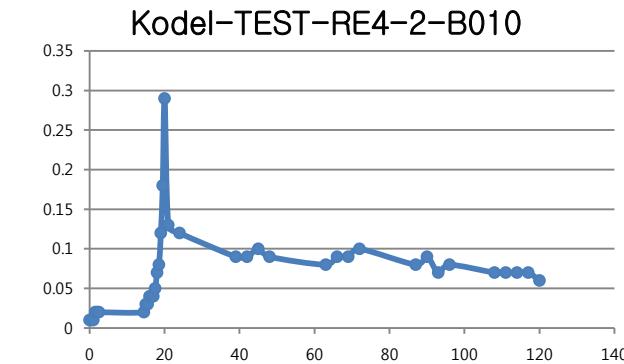
QC decision	Current Limits at 6.0 kV	RE4/2 TW	RE4/2 TN	RE4/2 BT	$i(14.5\text{h})$ at 6.0 kV	Final Decision	Certified	O			
		1.5 μA	1.5 μA	1.5 μA	0.02						
		RE4/3 TW	RE4/3 TN	RE4/3 B							
	Current Limits at 10.0 kV	1.5 μA	1.5 μA	1.5 μA							
		RE4/2 TW	RE4/2 TN	RE4/2 B	0.29		Not certified	x			
		5.0 μA	5.0 μA	10.0 μA							
	Current Limits at 9.6 kV at t = 120 h	RE4/3 TW	RE4/3 TN	RE4/3 B	Criterion $i(120\text{h})/(63\text{h}) < 1.5$						
		5.0 μA	5.0 μA	10.0 μA							
		RE4/2 TW	RE4/2 TN	RE4/2 B	$i(63\text{h})$	0.08					
		2.0 μA	2.0 μA	3.5 μA	$i(120\text{h})$	0.06					
		2.0 μA	3.5 μA	5.0 μA	0.75

Set at 10.0 kV at $t = 20.0$ h, and at 9.6 kV from 21 to 120 h for the long-term test.
